# CONDITIONS ASSESSMENT AND FEASIBILITY STUDY

8 BROOKFIELD ROAD  
STURBRIDGE, MA 01566

April 14, 2015

Prepared for:  
Town of Sturbridge, Massachusetts

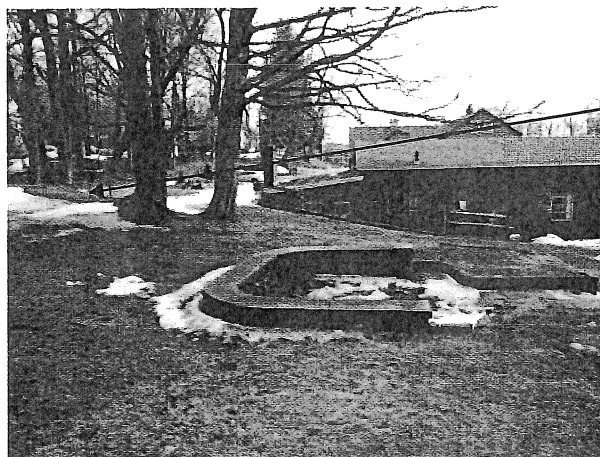
Earth Berm North of Building

Overall the site drainage follows the grade and flows south from Church Street to Main Street. There is a drainage system with catch basins in Church Street that collect runoff from the roadway; however, portions of Church Street drain onto the property due to lack of curbing. The northern grassed area appears to be graded to divert stormwater runoff around the building by a small earthen berm and a swale. This area appeared to be in a stable vegetated condition. Earthwork appears to have occurred at the northeastern corner of the building to install a flat paved dumpster pad. This area should be properly graded and stabilized with pavement or grass when weather permits.

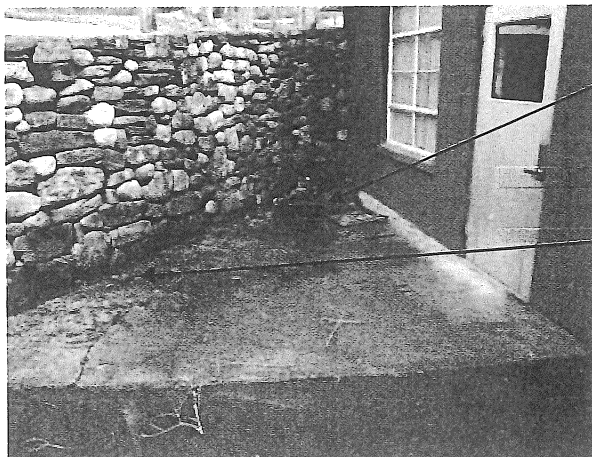
Catch Basin at Toe of Stone  
Masonry Retaining Wall

An onsite drainage system consists of a catch basin at the western stone masonry retaining wall, a manhole with an open drain and a second catch basin located on the southern edge of the parking lot. The parking lot catch basin was not observed due to a snow stockpile. Greg Morse, Sturbridge DPW Director indicated that the drainage at the building had work done to it and was in operating condition with no known issues with the system or with water entering the building due to faulty drainage. He indicated that the drainage system connected with the drainage system crossing Main Street. The catch basin at the toe of the stone masonry retaining wall was in fair operating condition and appeared to properly collect seepage from the retaining wall. The manhole with open drain west of the building appeared to function properly; however, the manhole top is elevated above the pavement and may cause a trip or snowplow hazard. If improvements are made to the parking lot, modifications to the manhole structure to allow the replacement of the manhole top with a catch basin frame and grate should be investigated.

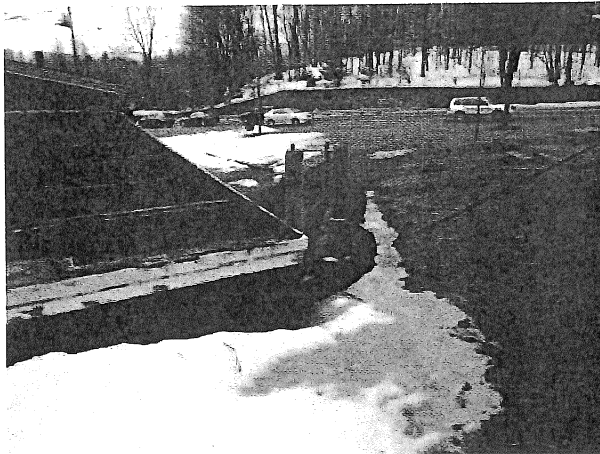
Paved Swale for Roof Runoff  
draining West

The building does not have gutters to control roof runoff. A paved swale made of hot mix pavement was installed to convey stormwater runoff draining from the northern roof edge. The paved swale is split at the chimney to convey flows east to the restaurant parking lot and west to the manhole with open drain. Both swales appear to be functioning; however, there aesthetic appearance and functionality could be improved by replacement or an overlay of new pavement. The discharge point of the eastern swale appears to have been disturbed during earthwork to install a newly paved dumpster pad. The discharge point should be reviewed at the time of any building or parking lot improvements to determine if repairs are warranted.

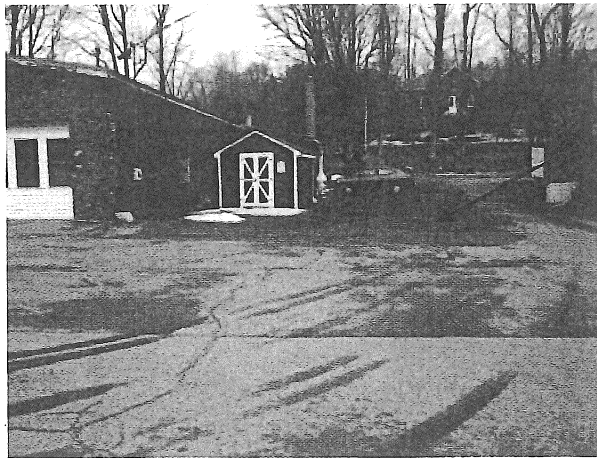
Area of Millings East of  
Building

Millings were placed east of the building, adjacent to the restaurant property. This area appears stable, but should be reviewed at time of building repair to ensure that proper grades are set to drain surface runoff away from the building.

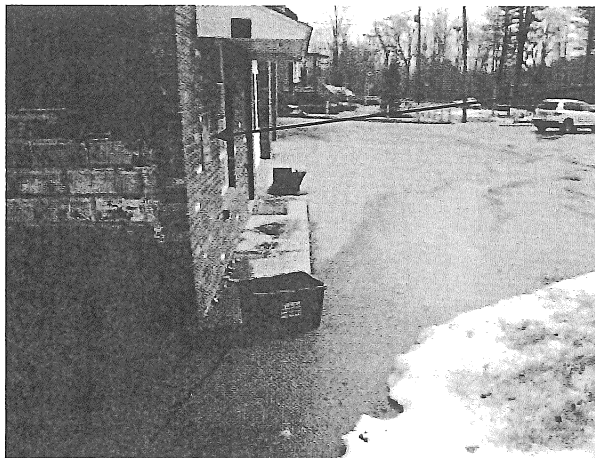
Handicap Parking Sign

Parking space striping is no longer apparent in the parking lot and should be replaced once parking and traffic flow is designed. A handicap parking sign is located on the west side of the front of the building. No handicap space or loading striping is present. A handicap van space and loading area must be installed in accordance with the future site design as required by the Massachusetts Architectural Access Board (AAB).

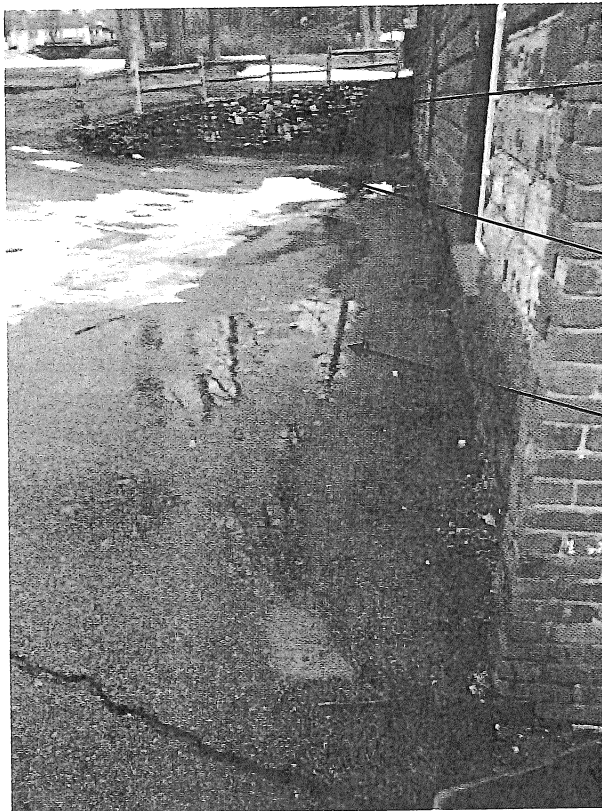
Stone Masonry Retaining  
Wall on the West Side of the  
Building

The stone masonry retaining wall appears to be in good condition. Seepage was present at the toe of the wall. The seepage was clear and did not appear to be piping soil from behind the wall. A small void was present at the toe of the wall north of the catch basin. This void should be further investigated and patched with rock and mortar. The void does not appear to be a structural issue.

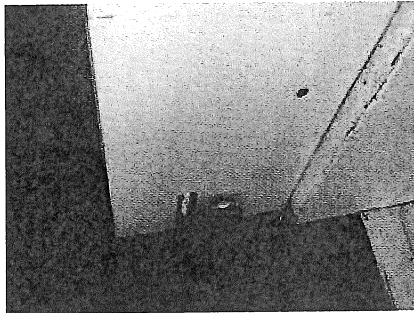
The sanitary system is original to the building and appeared to be in bad condition with disconnected piping at the kitchen sink. Debris and deterioration is present on the exposed piping.

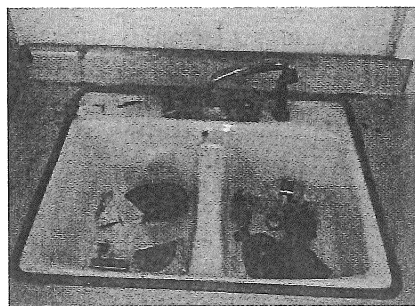
The kitchen has a double bowl ceramic sink. It appears to be in bad condition with deterioration and leakage present. Sanitary piping to the fixture is disconnected and the domestic piping has deterioration.

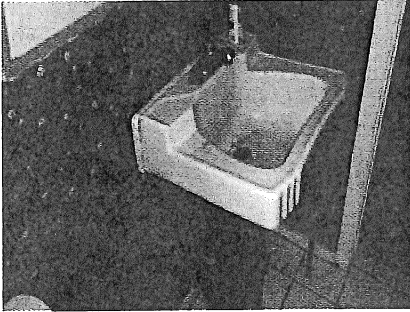
The bathroom located adjacent to the kitchen has a wall mounted lavatory and faucet. The drain cover/faucet/piping has deterioration and appeared to be in poor condition. The ceramic basin has cracking/heavy stains and appeared to be in bad condition. The domestic hot/cold piping underneath the fixture is not insulated and appeared to be in poor condition.

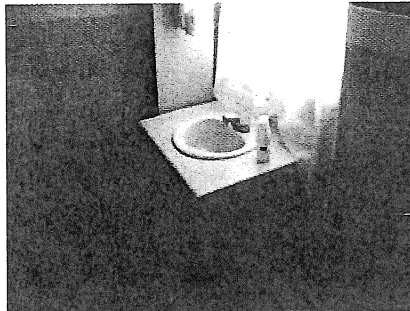
The large bathroom has a wall mounted lavatory and faucet. The drain cover/faucet/piping has deterioration and appeared to be in poor condition. The ceramic basin has cracking/light stains and appeared to be in poor condition. The domestic hot/cold piping underneath the fixture is not insulated and appeared to be in fair condition.

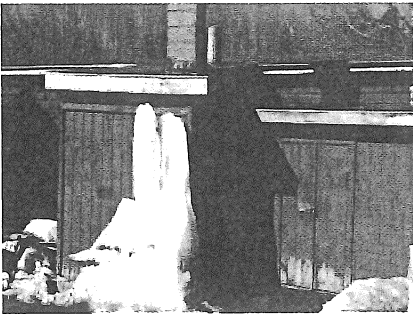
The above ground #2 fuel oil tank is located in a exterior shed. The fuel oil tank appears to be in fair condition with deterioration present on the enclosure and piping.

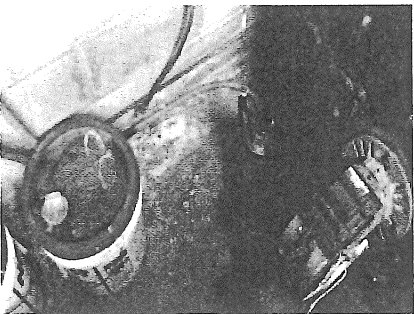
The fuel oil supply line to and from the boiler are routed to the exterior closet. The supply lines and filters appear have leakage present and appeared to be in bad condition.

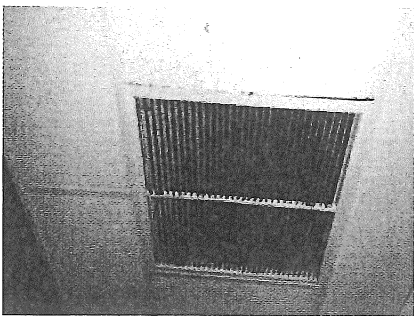
The return air for the space is directed back through a 24"x24" ceiling mounted return grille. The grille appeared to be in fair condition with debris present within the grille.

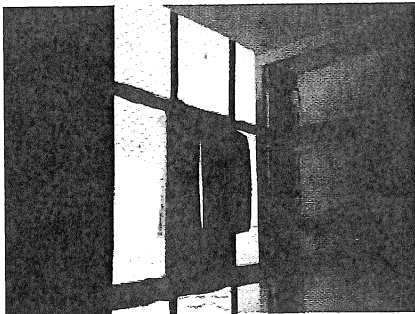
The second fan located in the kitchen is manufactured by the Nutone Company and did not appear to be operational. The unit has deterioration and appeared to be in bad condition.

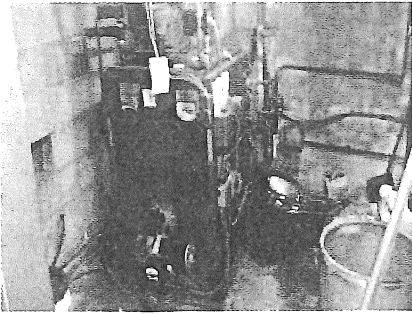
A hot water oil-fired boiler manufactured by the HB Smith Company is located in the mechanical room. The boiler provides hot water to the baseboard radiation located throughout the building. The boiler has cast iron sections and a domestic hot water coil. The boiler appears to be over fifteen (15) years old in fair condition with deterioration present throughout.

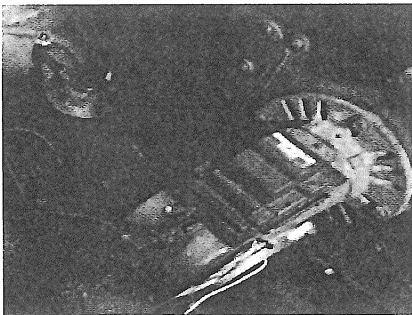
The oil-fired burner for the boiler is manufactured by the Carlin Company model 150FRD-1H and is rated for 2.00 -4.50 gallons per hour. Overall the burner components appeared to be over fifteen (15) years old and in poor condition with leakage present.

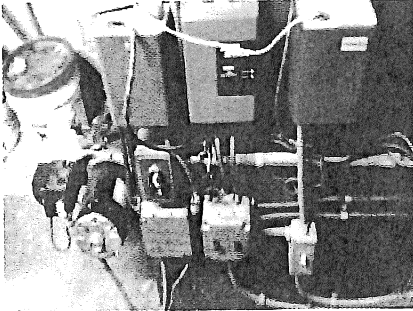
Three (3) hydronic zones are controlled by a zone controller manufactured by the Taco Company. The wiring for the controller appeared to be loose and the controller appeared to be in good condition.

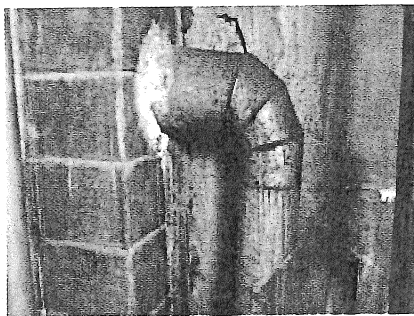
Breeching for the boiler is routed to the chimney stack located on the right side of the building. A barometric damper is located on the breeching provides the required draft. The breeching appeared to be in poor condition with deterioration.

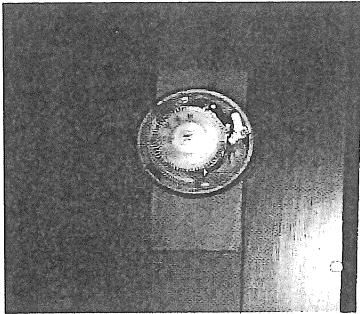
A wall mounted thermostat manufactured by the Honeywell Company controls the hydronic zone for the office areas via a relay in boiler room. The thermostat appeared to be over twenty (20) years old and in poor condition.

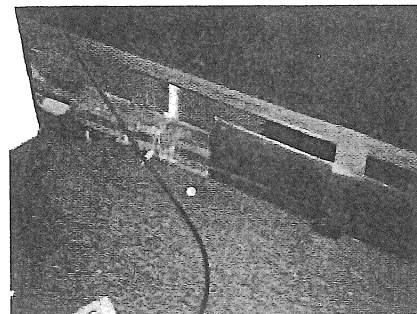
Baseboard radiation is located on the perimeter of the building. The fin tube appeared to be in bad condition with sections being damaged. The enclosures appeared to be in poor condition with debris and deterioration.

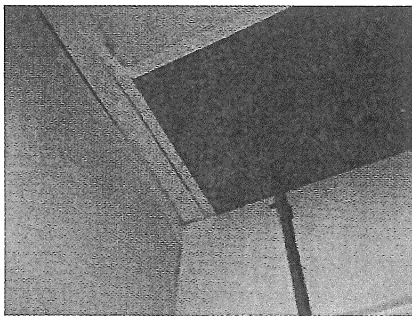
In addition, wiring was observed above the suspended ceiling which not terminating in an electrical box. This wiring just has the conductor ends capped with a wire nut and electrical tape.

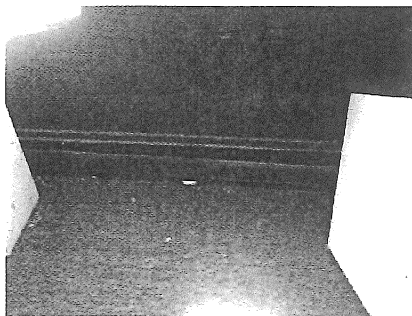
Plug mold was observed within the office areas of the building and was in fair to poor condition. No GFCI duplex receptacles were located in the restrooms as required by Code. Only receptacles observed were part of a fluorescent vanity light which was in poor condition and an incandescent vanity light. No GFCI receptacle was located near the exterior condensing unit as is also required by current Code.

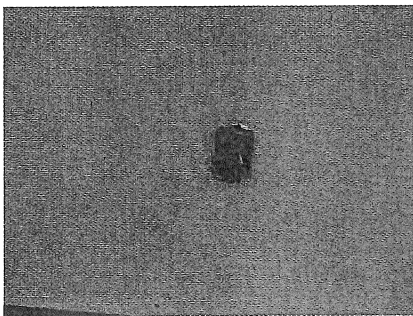
A number of recessed electrical boxes in the addition room at the rear of the building have no devices installed and were missing cover plates thereby leaving the wiring exposed.

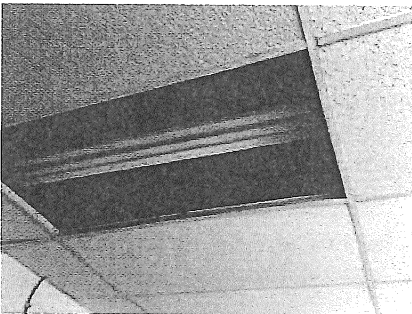
The condition of these fixtures varied greatly from good to very poor. A few 1'x4' fluorescent fixtures have broken lens, a 2'x4' fixture was missing lamping and its lens.

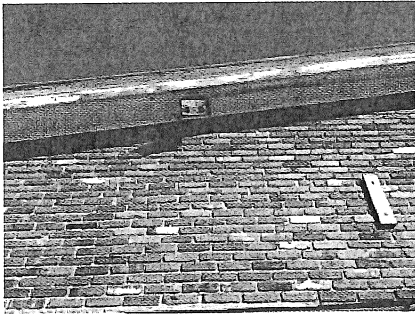
Exterior lighting consisted of two (2) High Intensity Discharge (HID) fixtures located under the front eave of the building. It appears as these fixtures are aimed to illuminate the parking area of the building. These fixtures are missing lamping, lens and their framing was damaged.

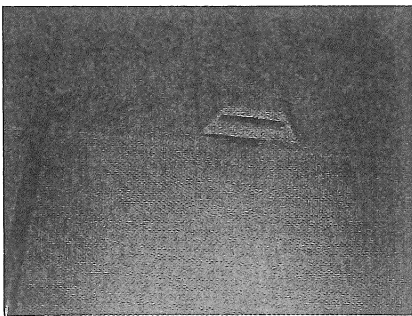
The building does not contain a fire alarm system. Fire protection is provided by local smoke detectors. Only four (4) smoke detectors were observed. One (1) wall mounted to an office area wall, one (1) ceiling mounted at one end of the main room and two (2) located in the addition room at the rear of the building. The detectors seem to have been in place a number of years.
