# Town of Sturbridge, Massachusetts

## Phase 2 report

## Inflow and Infiltration Mitigation Plan

Re: Inflow and Infiltration mitigation plan phase 2 report

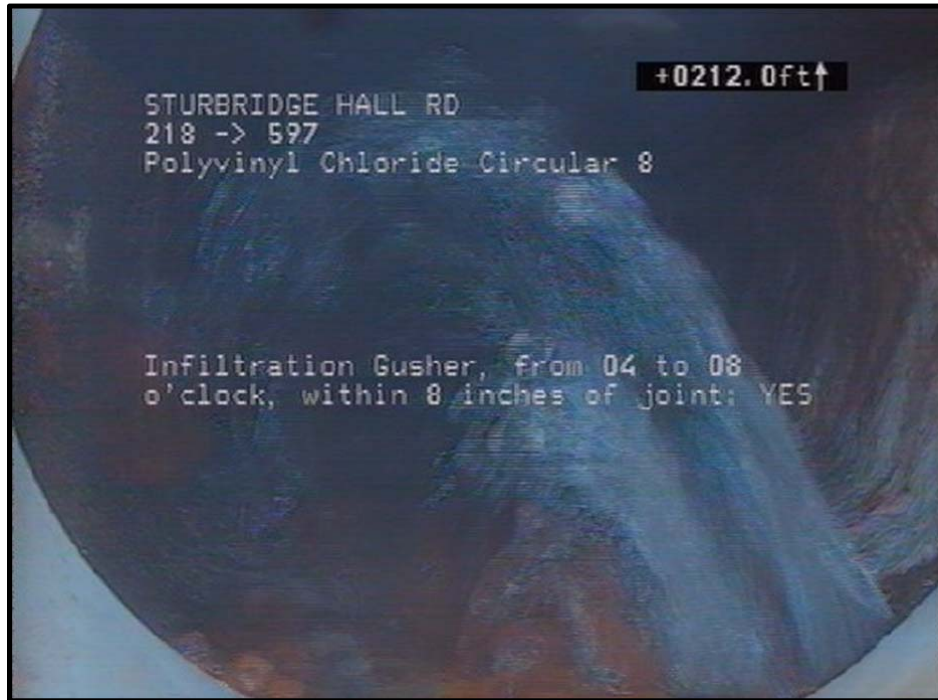
Street	Upstream MH ID	Downstream MH ID	Distance from US MH (ft)	Defect Code	Estimated Infiltration (gpm)	Criticality (1-5)	Recommended Repair
Hall Road	218	597	212	(IG) Infiltration Gusher	4	5	Hydraulic grouting

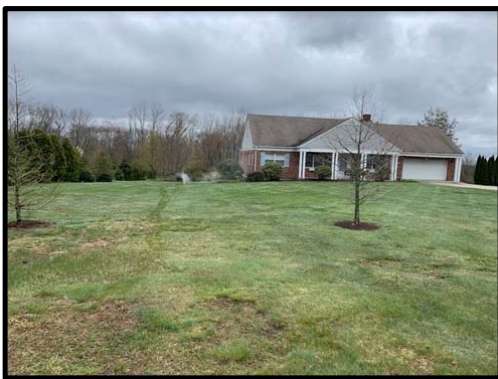
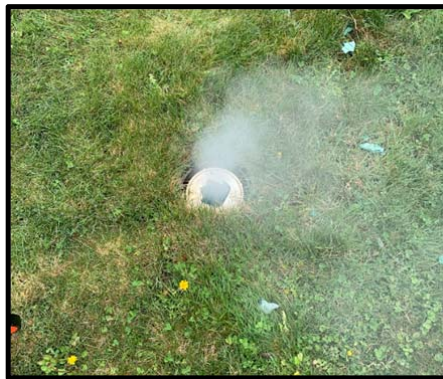
1. 80 Fiske Hill Road - Broken cleanout cover

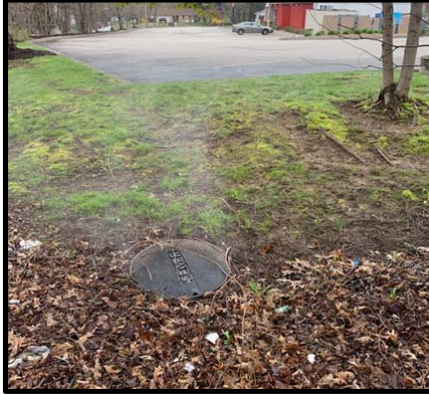
2. Hall Road - Wendys private manhole - Vented manhole cover

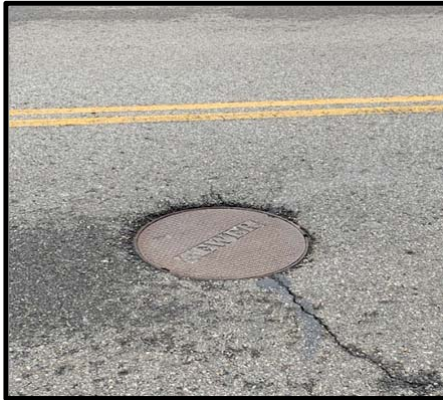
3. Hall Road - Manhole ID 212 - Vented manhole cover

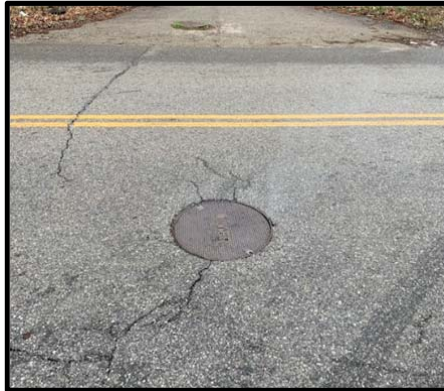
4. Hall Road - Manhole ID 213 - Vented manhole cover

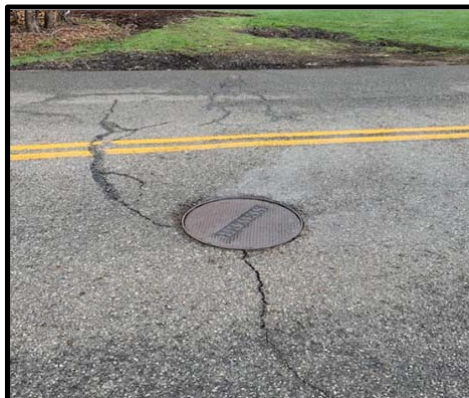
5. Hall Road - Manhole ID 214 - Vented manhole cover

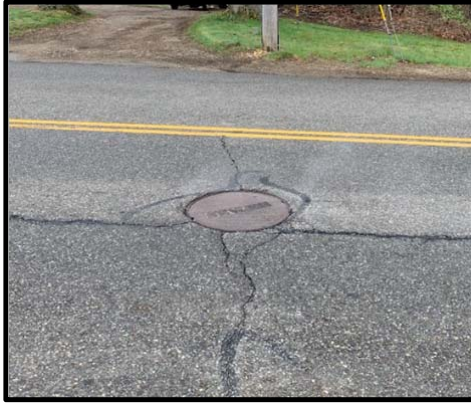
6. Hall Road - Manhole ID 1026 - Vented manhole cover

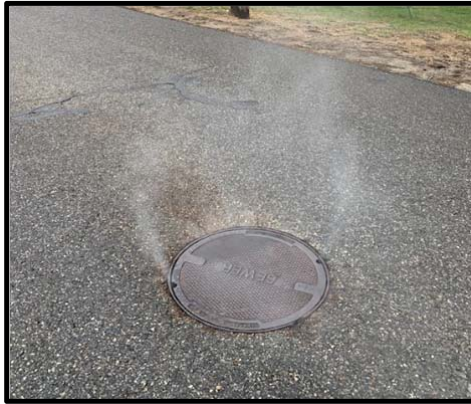
7. Hall Road - Manhole ID 215 - Vented manhole cover

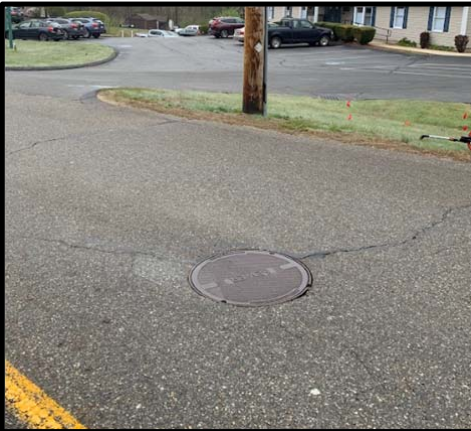
8. Hall Road - Manhole ID 216 - Vented manhole cover

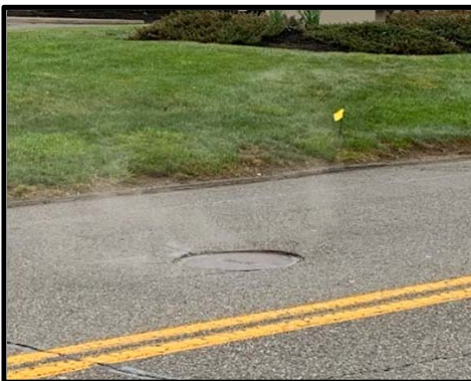
9. Hall Road - Manhole ID 217 - Vented manhole cover

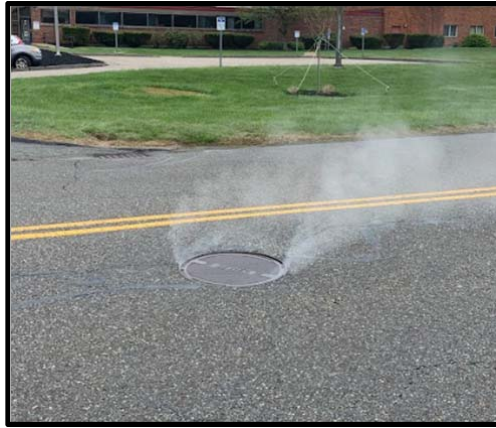
10. Hall Road - Manhole ID 597 - Vented manhole cover

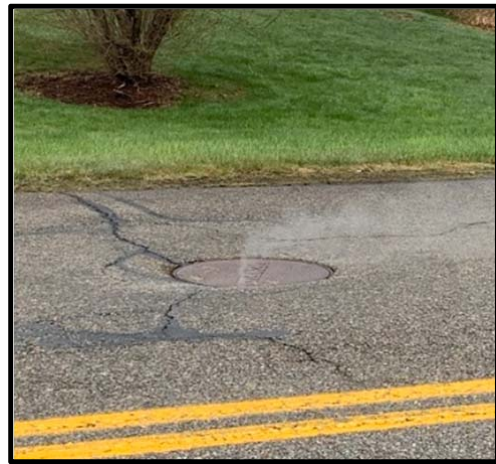
11. Hall Road - Manhole ID 218 - Vented manhole cover

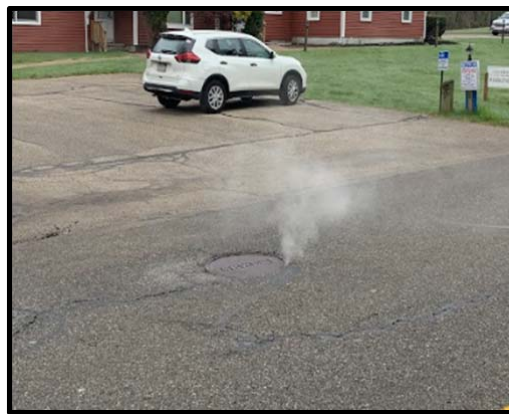
12. Hall Road Manhole ID 219 - Vented manhole cover

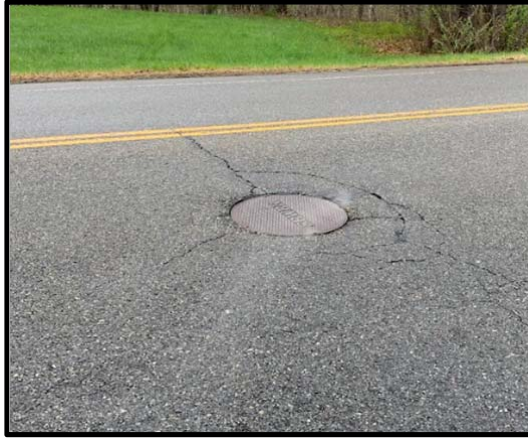
13. Hall Road - Manhole ID 221 - Vented manhole cover

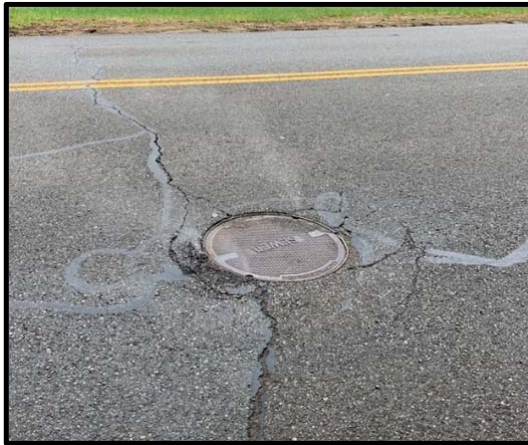
14. Hall Road - Manhole ID 222 - Vented manhole cover

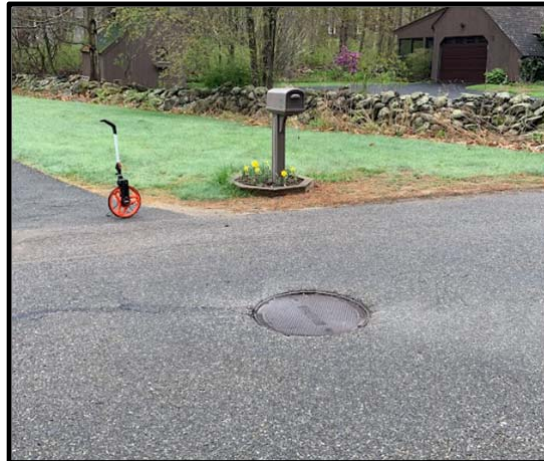
15. Hall Road - Manhole ID 223 - Vented manhole cover

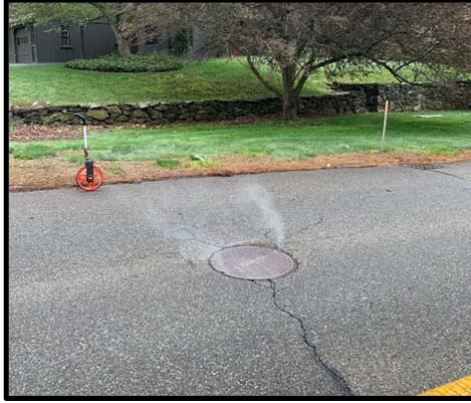
16. Hall Road - Manhole ID 225 - Vented manhole cover

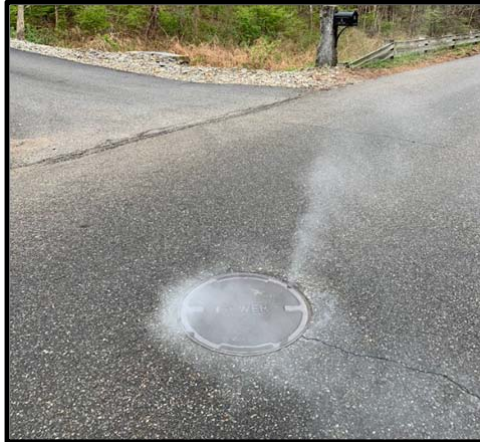
17. Hall Road - Manhole ID 226 - Vented manhole cover

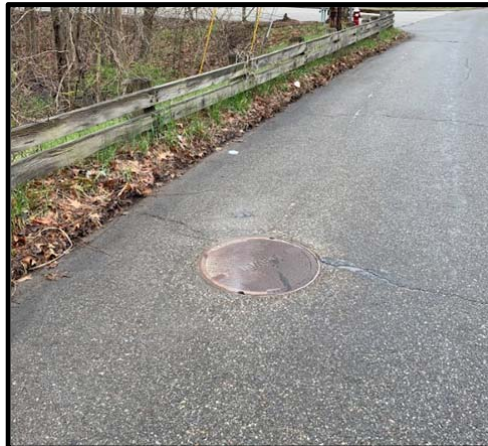
18. Hall Road - Manhole ID 227 - Vented manhole cover

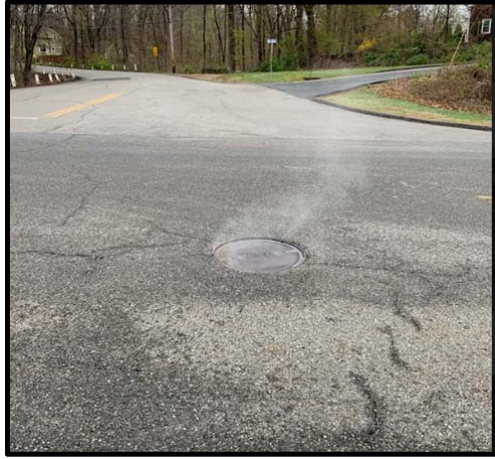
19. Hall Road - Manhole ID 120 - Vented manhole cover

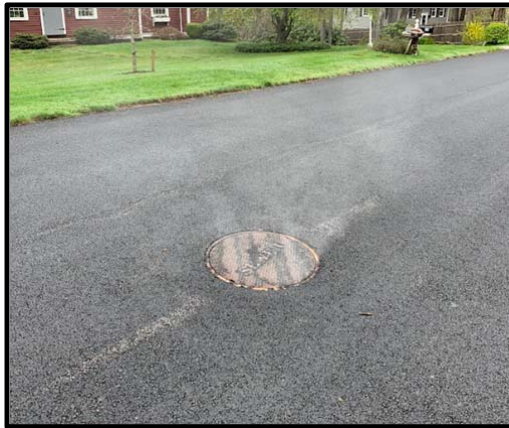
20. Hawthorne Road - Manhole ID 377 - Vented manhole cover

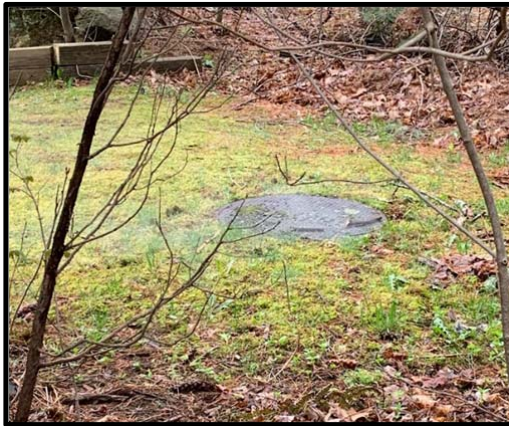
21. Hawthorne Road - Manhole ID 378 - Vented manhole cover

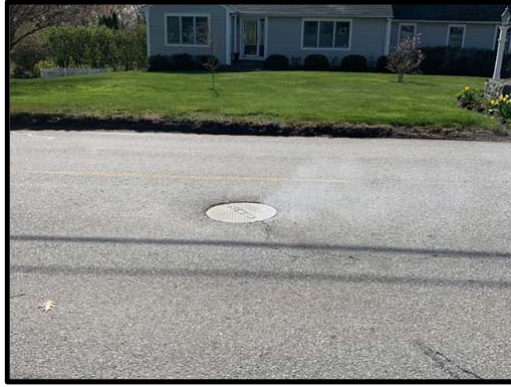
22. Old Farm Road - Manhole ID 598 - Vented manhole cover

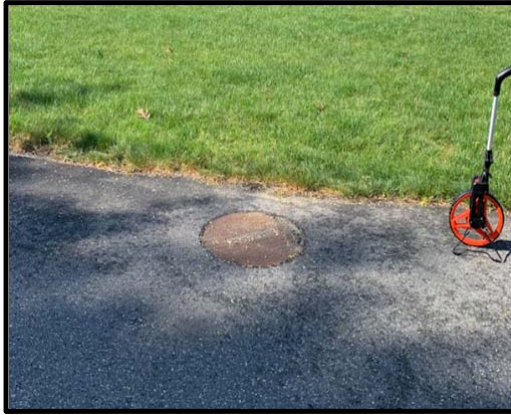
23. Old Farm Road - Manhole ID 1120 - Vented manhole cover

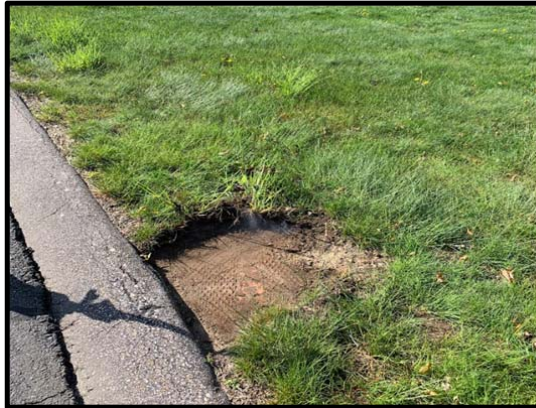
24. Old Farm Road Easement - Manhole ID 635 - Vented manhole cover

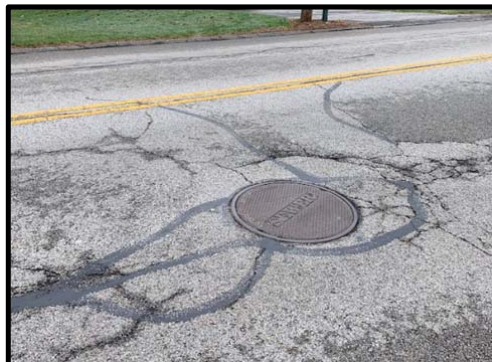
25. Whittemore Road - Manhole ID 116 - Vented manhole cover

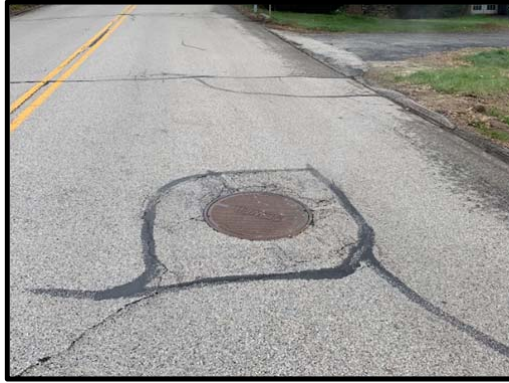
26. Whittemore Road - Manhole ID 114 - Vented manhole cover

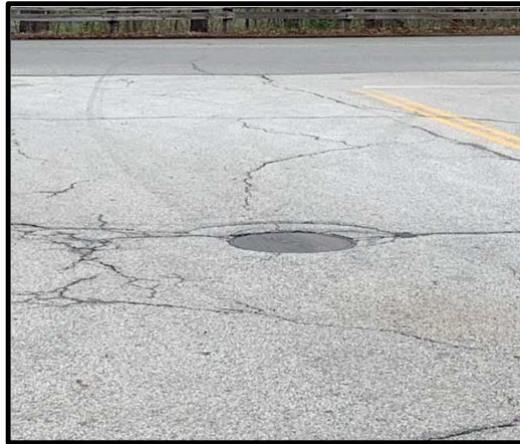
27. Whittemore Road - Manhole ID 138 - Vented manhole cover

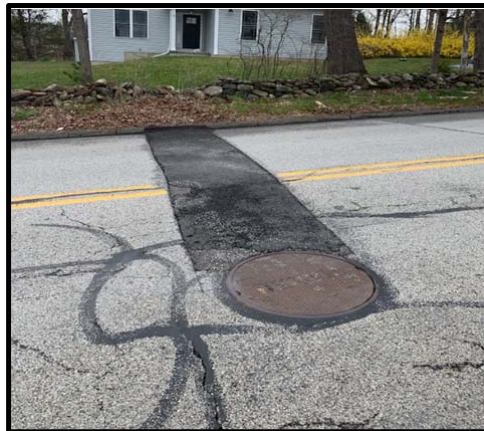
28. Whittemore Road - Manhole ID 108 - Vented manhole cover

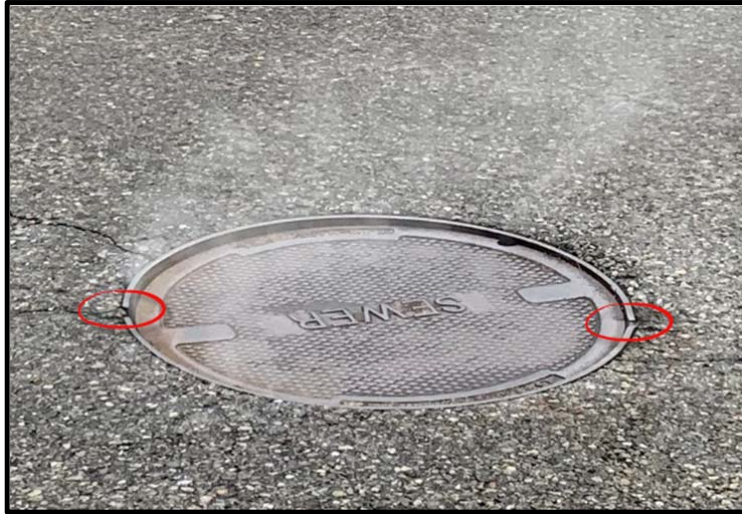
1. Hall Road - Manhole ID 120 - Broken adjustment ring

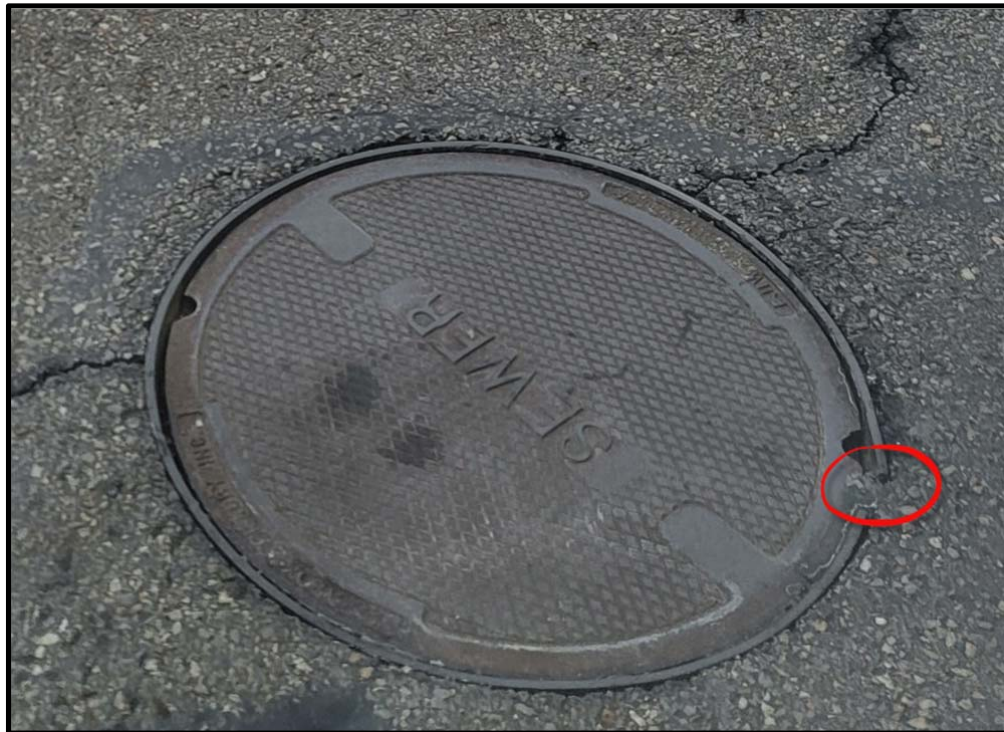
2. Hall Road - Manhole ID 597 - Broken adjustment ring
