Massachusetts Department of Environmental Protection
 Bureau of Resource Protection - Wetlands
WPA Form 8A – Request for Certificate of Compliance
 Massachusetts Wetlands Protection Act M.G.L. c. 131, §40

Re. 118 Leadmine Lane, Sturbridge – Restoration Report/Request to Lift Enforcement Order dated 10/28/2020

RE: *Request for Certificate of Compliance*
Kellaher, Gary & Sherry
118 Leadmine Lane
Sturbridge, Massachusetts
Massachusetts DEP File #300-684

Existing Grade, Inc. (EGI) conducted a final site inspection February 01, 2024 of the recently re-constructed driveway and restoration area located at 118 Leadmine Lane, Sturbridge MA. The work is shown on the design site plan entitled "Proposed Restoration Plan for 118 Leadmine Lane – Remaining Land, Sturbridge, Massachusetts" prepared by Existing Grade, Inc, dated March 29, 2021 and last revised June 28, 2021.. The inspection and supplied site documentation was conducted to ensure the proposed work has been constructed in compliance with the original Order of Conditions Mass DEP File #300-684, recorded at the Worcester County Registry of Deeds Book 40933, Page 197 and dated April 04, 2007. The proposed work was also conducted to r

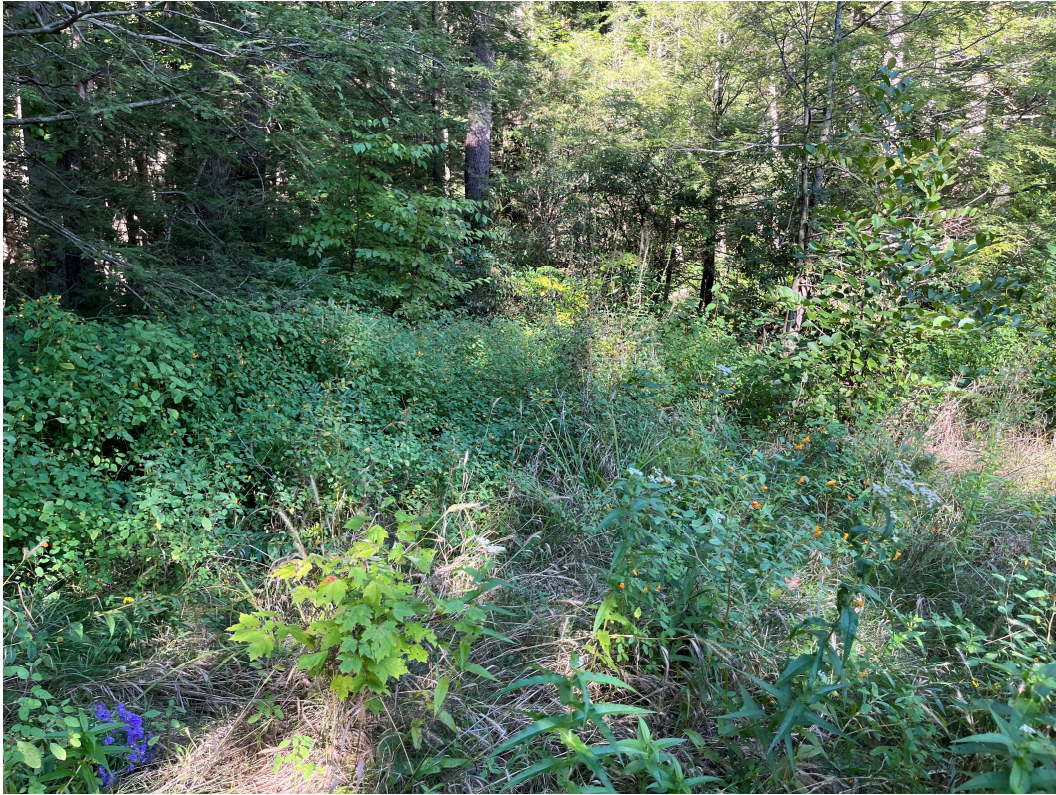
- The applicant proposes to create 893.0 square feet of BVW on historically filled wetlands on the north side of the road.
 - The approved plan, revised dated 6/28/2021, called for 443.2 square feet of BVW restoration. Originally (shown on the plan revised dated 5/31/2021) we had the figure shown above, 893.0 square feet. Although SCC required the original outlying boulders adjacent to the wetland to be moved inward toward the road there was never any restoration of historically filled wetlands between the originally placed boulders and the newly placed boulders. The distance between the old boulders and the more recently placed boulders accounted for the additional 449.8 square feet of restoration. If EBT, Inc. had left the old gravel on filled wetlands in place there would have been natural wetlands and restored wetlands separated by a strip of old gravel. Working with the contractor on 8/28/2021 we removed the old fill down to the original A/O horizon and then brought the elevation up approximately 4” above the water elevation in order to plant the tree shrub wetland we proposed. To accomplish what was just stated the wetland consultant placed an oak stake at an elevation 4” above the existing water elevation adjacent to the natural wetland and utilized a digital laser transit with rod to shoot spot elevations as the final organic material was being placed to ensure we had consistent hydrology across the restored wetland (see Photo 1 & 2).

Photo 1 taken by EBT, Inc. on 9/17/2023 – Showing the restoration of historically filled wetland across Leadmine Road from 118 Leadmine Road.

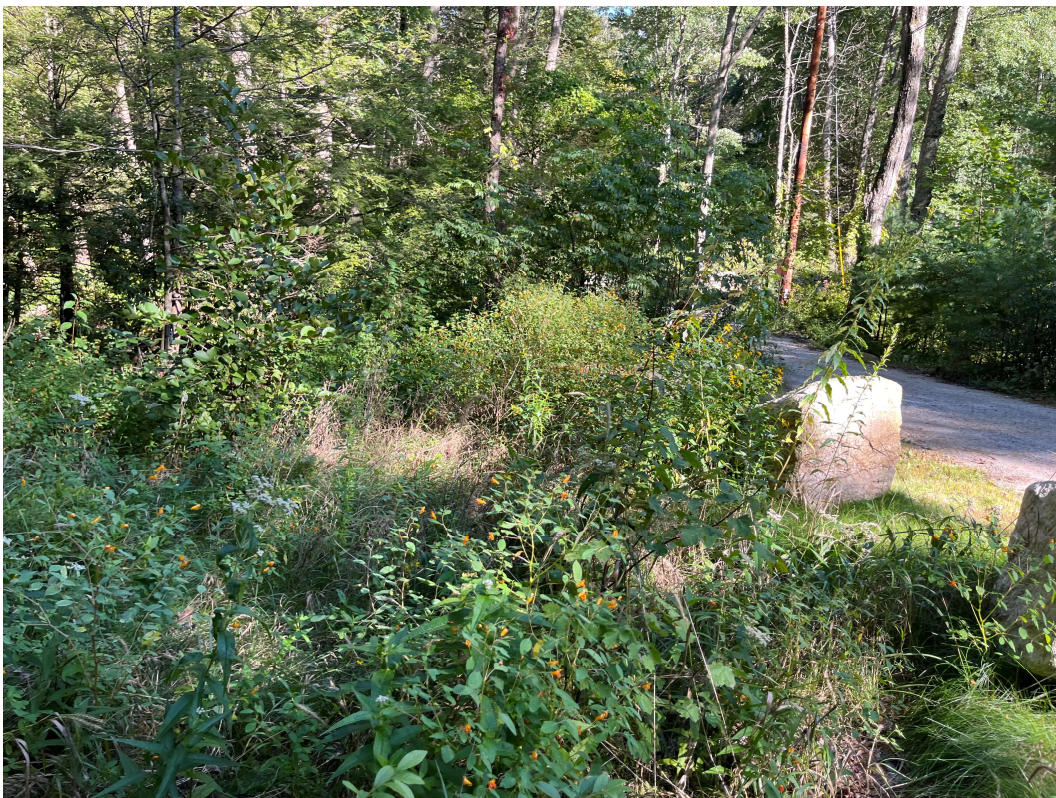
Photo 2 taken by EBT, Inc. on 9/17/2023 – Showing the restoration of historically filled wetland across Leadmine Road from 118 Leadmine Road. Also showing a couple of the boulders along the road preventing access into the restoration area.

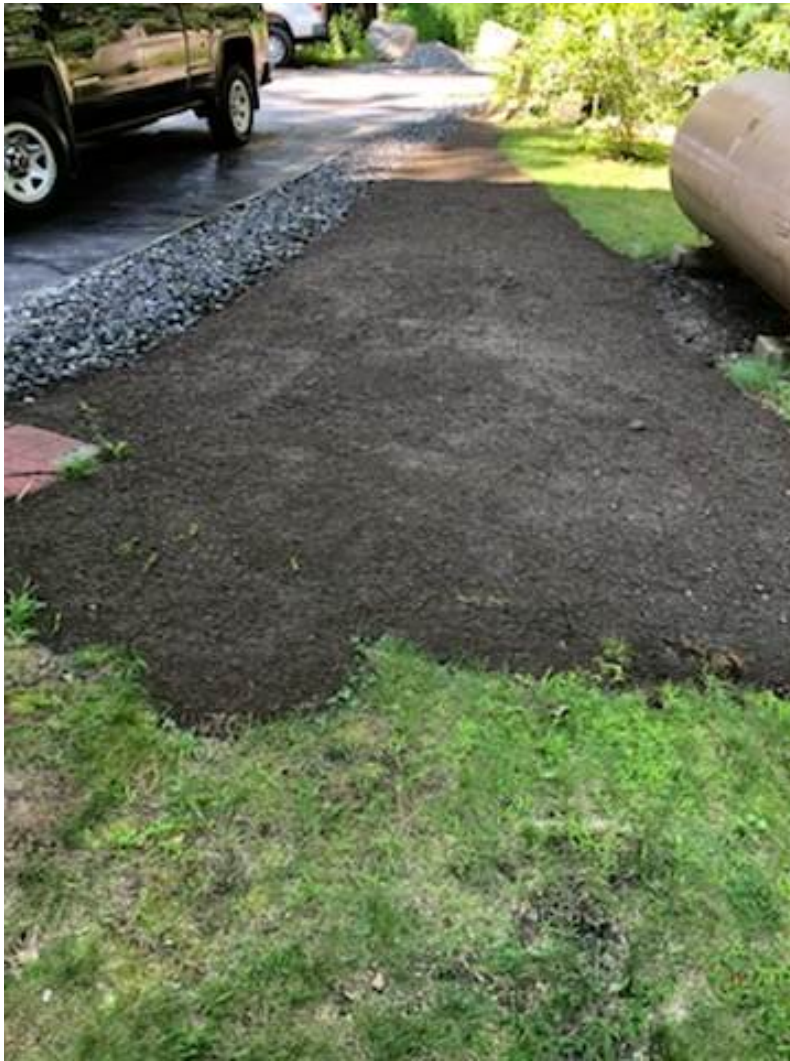
- The applicant proposes to create a 1' by 1' Mirafi fabric lined drip strip on the east and west side of the driveway.
 - The drip strips were created 2' wide and 1' deep to accept more water (see Photo 3).

Photo 3 taken by EBT, Inc. on 9/7/2021 – Showing the 2' wide by 1' deep drip strip on the east side of the driveway.

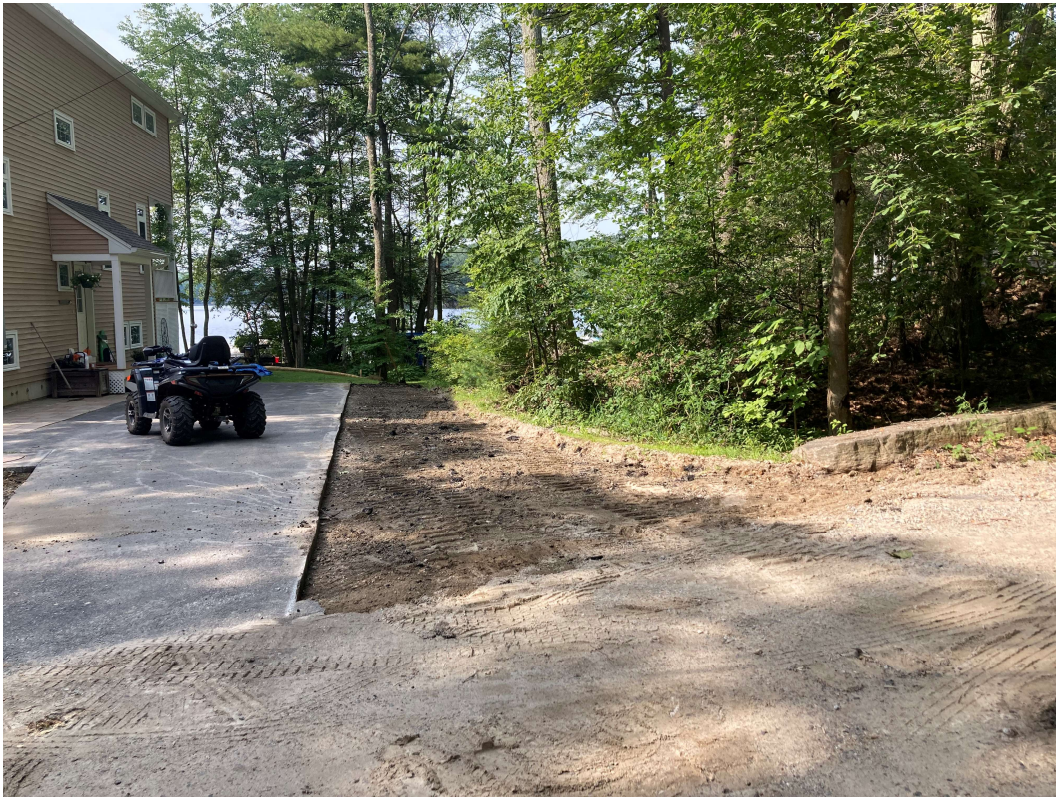
- In addition to what is described above, 498.7 square feet of bituminous concrete was removed on the west side of the driveway and 6 inches $\frac{3}{4}$ " crushed stone was placed. Completed and now growing lawn (see Photo 4 showing the 498.7 square feet removed on the east side of the drive).

Photo 4 taken by EBT, Inc. on 8/7/2021 – Showing the 498.7 square feet of asphalt was removed and replaced with ¾” crushed stone.

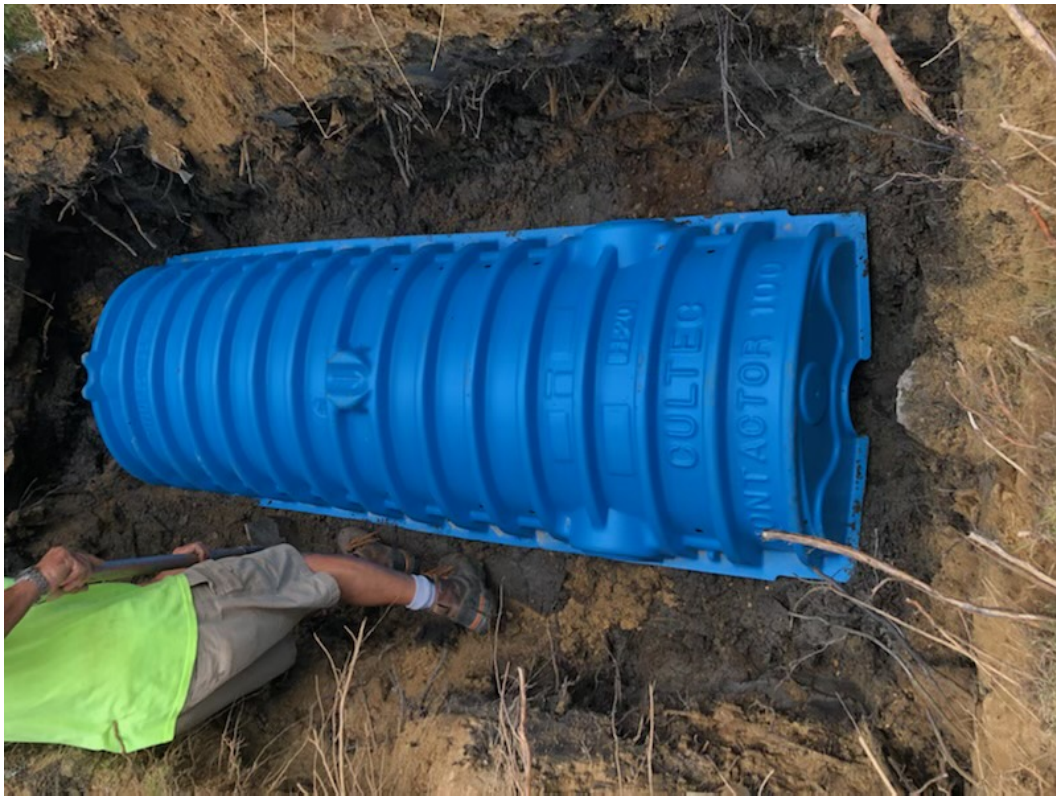
- The applicant proposes to install 1 C-100HD Cultec unit designed for a 1" storm event.
 - Completed (see Photo 5).
- The applicant proposes to place 10"-12" diameter boulders in the two undercut areas within the perennial stream to stabilize the bank.

Photo 5 taken by EBT, Inc. on 9/7/2021 – Showing the installation of the C-100HD Cultec unit on the southwest corner of the house which receives roof runoff.

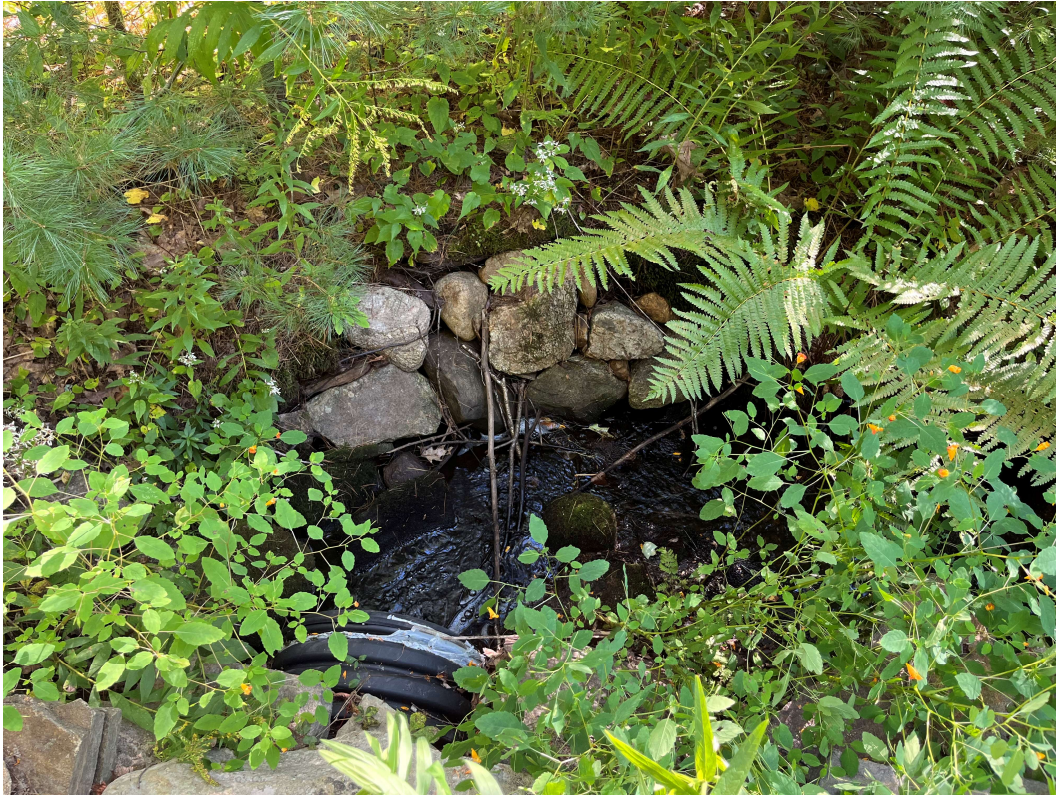
Photo 6 taken by EBT, Inc. on 9/17/2023 – Showing the 10”-12” diameter boulders in the undercut area within the perennial stream at the outflow of the Leadmine Road culvert directly east of the house to stabilize the bank.

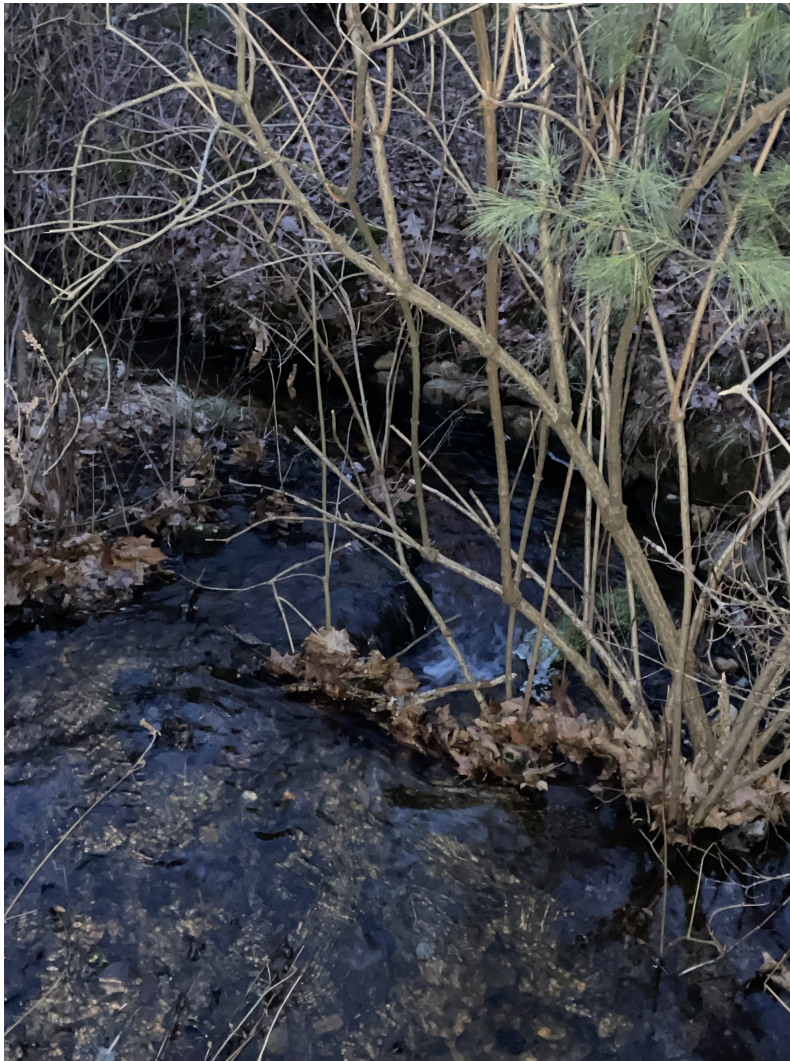
- Completed (see Photo 6 & 7).
- The applicant proposes to repair ~18' of historic stone wall with missing capstones. The wall is to be rebuilt 2"-3" above the road grade to prevent roadway overland flow from discharging directly into the stream.

Photo 7 taken by Gary Kellaheer in 11/2023 – Showing the 10”-12” diameter boulders in the undercut area within the perennial stream located approximately 25’ downstream of Photo 6 the house to stabilize the bank.

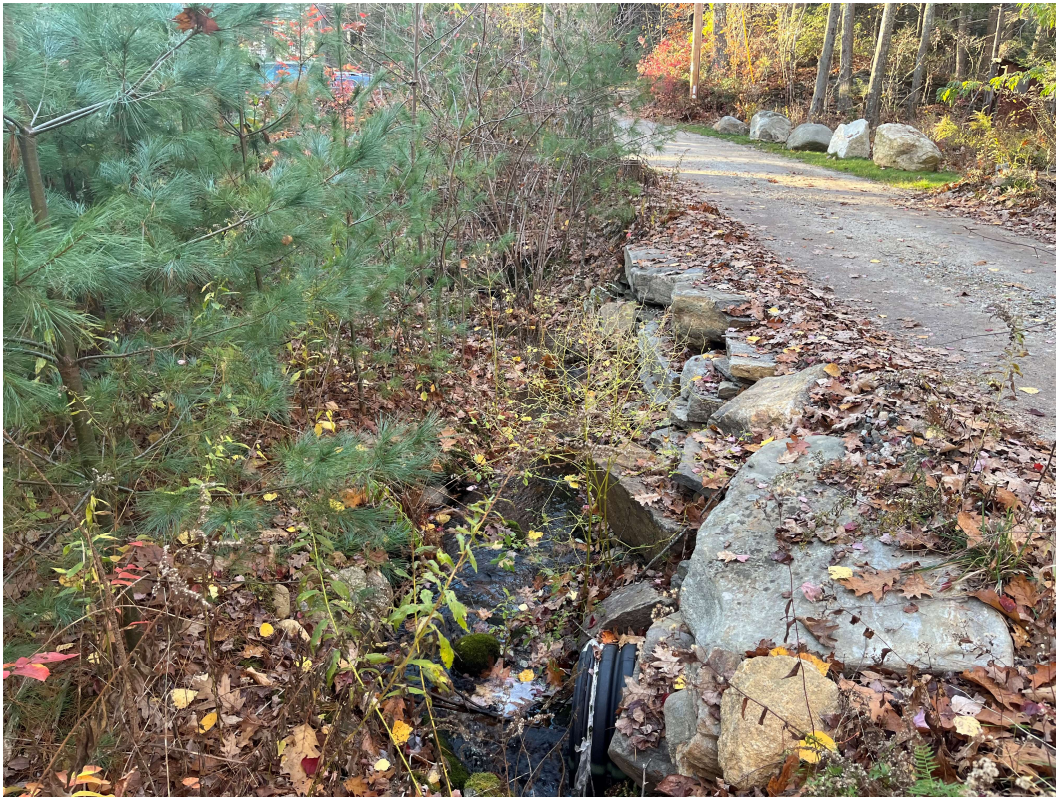
Photo 8 taken by EBT, Inc. on 10/29/2022 – Showing the repair & replace of the ~18’ of historic stone wall which holds the road in place and was missing capstones.

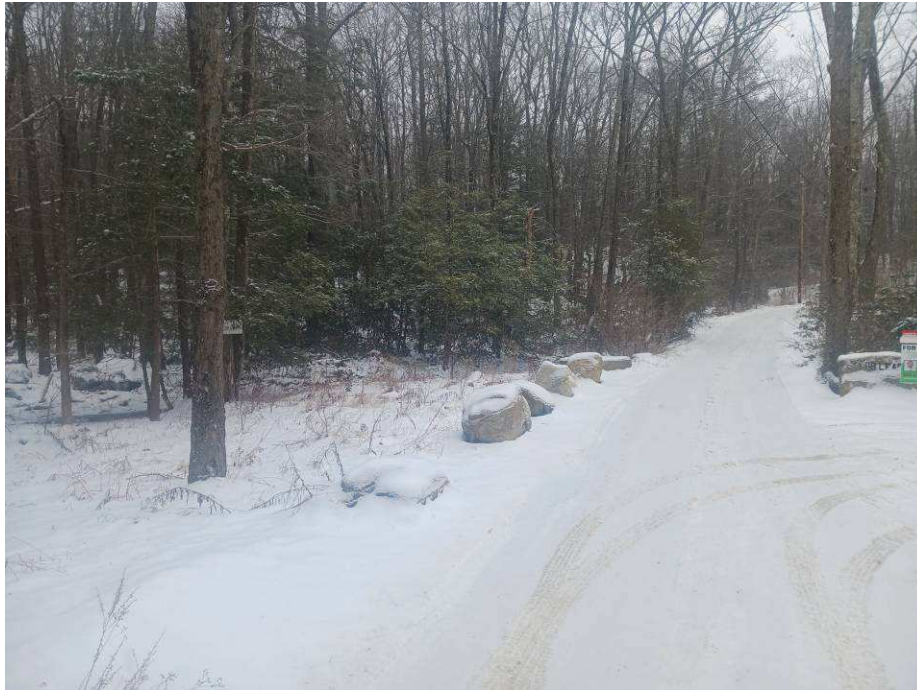
Figure 1: Boulder barrier along edge of travel way

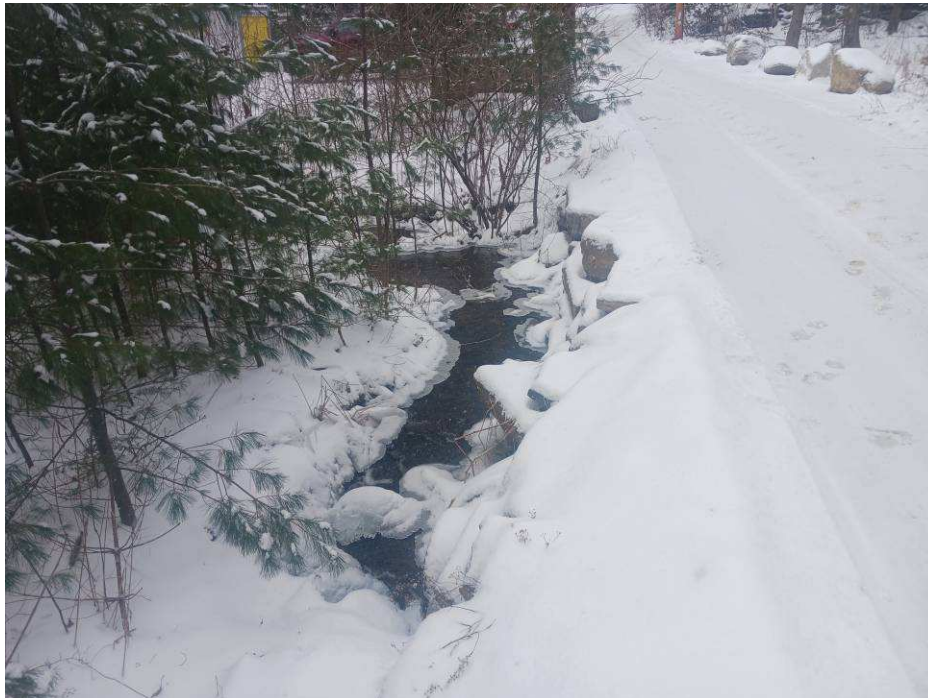
Figure 2: Rebuilt Stone wall

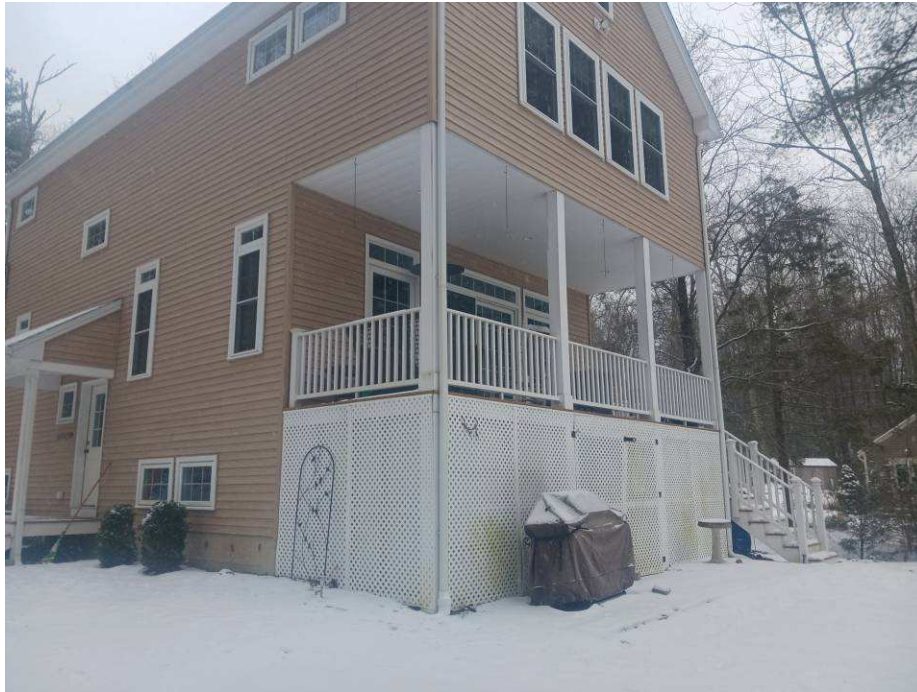
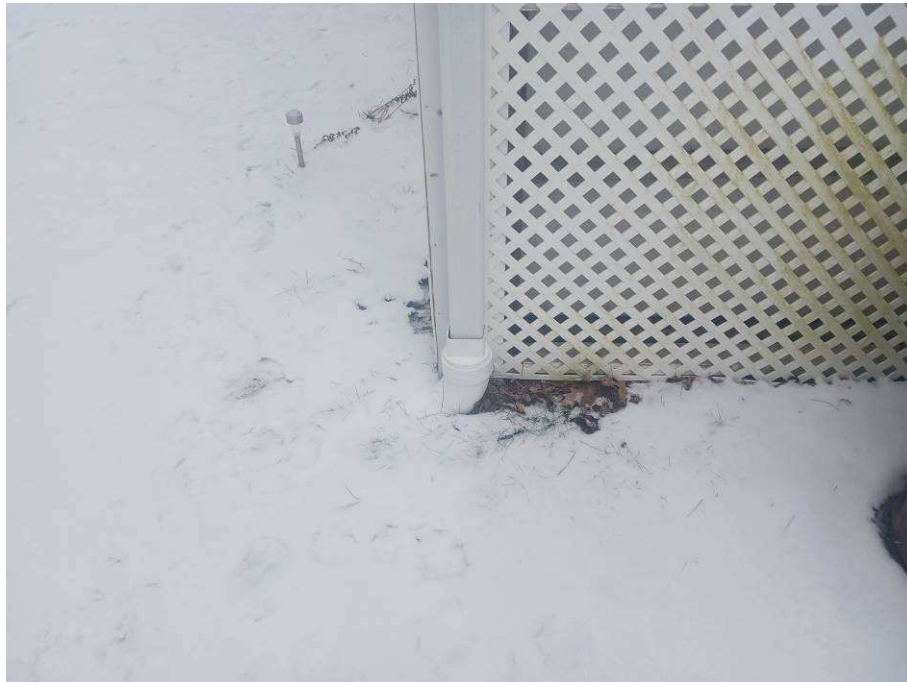
Figure 3: Roof Discharge to Cultec Drywell

Figure 4: Roof Discharge to Cultec Drywell

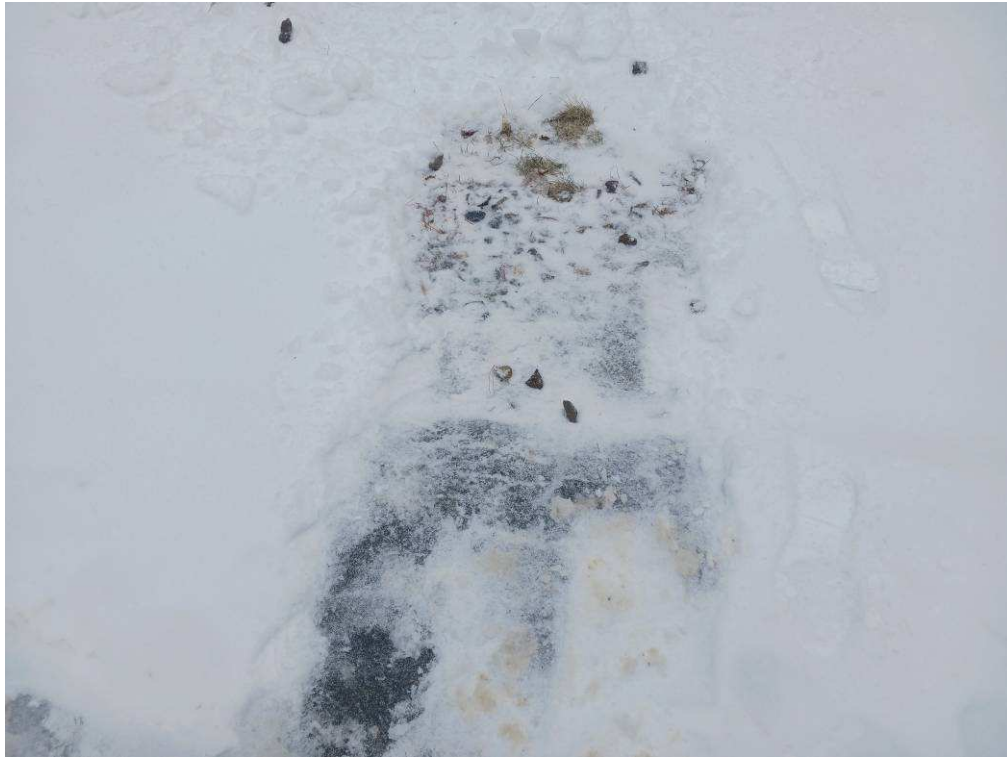
Figure 5: Cleared edge of driveway showing gravel stone diaphragm
