Existing Building Investigation & Evaluation Report

Prescriptive Compliance Method

123 Main Street
Anytown, MA 00001

August 24, 2016

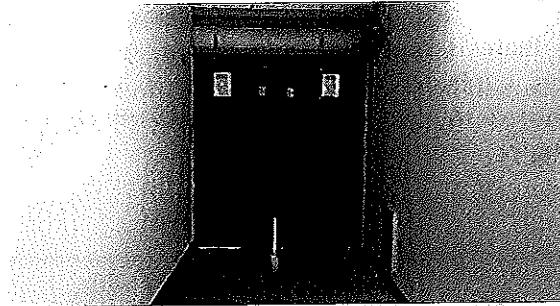
Assessment: Currently, there are six (6) points of entry and exit from the building. Some conditions do not comply with current or previous code editions as illustrated below. However, means of egress patterns, exit and entry doors will be totally reconfigured in conformance with 780 CMR, Ninth Edition, to accommodate the new *Bulk Storage Merchandising Building* use requirements. Construction documents for the renovation project will establish new means of egress patterns.

No Exit Signage
