Existing Building Investigation & Evaluation Report

Work Area - Alteration Level 3 Compliance Method

456 Main Street
Anywhere, MA 00002

August 31, 2016

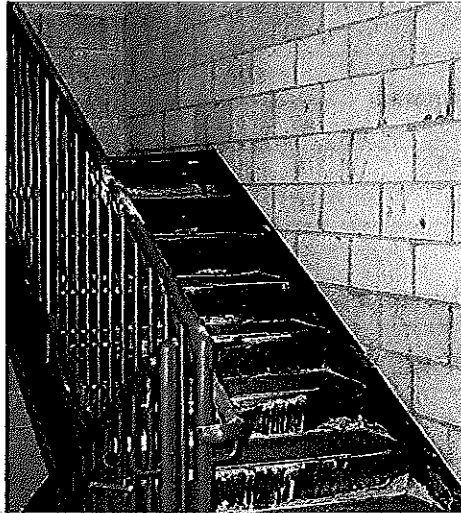
Damage at North Stair

Assessment: The maximum design occupant load for the building is 495 occupants. Two (2), fully enclosed, fire-rated stairways, remotely located are provided in accordance with Table 1006.3.1. However, noticeable concrete spawling was observed at the north stair posing tripping hazards under normal use. Additionally, stair lighting levels do not meet minimums required by 780 CMR, Section 1008.2.1 which establishes that "... means of egress illumination level shall be not less than 1 footcandle at the walking service". Each deficiency is due to lax maintenance and each will be appropriately remedied during the project renovation.
