# FORM B – BUILDING

Address: 55 Fiske Hill Road

Historic Name: Harry G. Estabrook House

STU.F STU.255

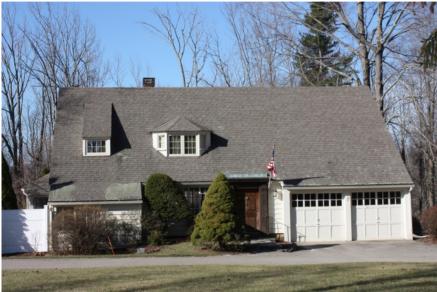
The main, eastern facing façade is dominated by the steeply pitched roofline, which extends to the first story. The section near the southeastern corner extends out from the foundation line and has overhanging eaves and a window towards the corner, obscured by landscaping but with at least 18 visible lights. There is a second, prominent window towards the center of this façade, also obscured. The central, wood paneled door is emphasized with squared pilasters and a transom with divided lights. An off-centered dormer, with a hipped roof, is within the main roofline and positioned above the first story window (near the entry). There is also a shed roof dormer with a rectangular window and eight divided lights, to the south. The incorporated two-car garage, with upper divided lights, was an adaptation of Colonial Revival style introduced by 1940.<sup>1</sup>

Photo 1: Main, eastern facing façade

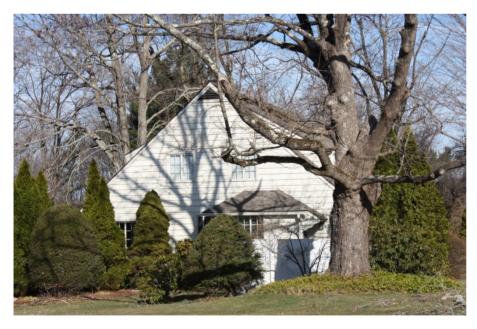
The southern side elevation has a first story ell, towards the southeastern corner, and additional first story windows towards the southwestern corner. Two upper story windows, which appear to be casements, each have a total of 12 divided lights.

Photo 2: Southern side elevation
