# CONSERVATION COMMISSION DETAILED AGENDA

Date: January 26, 2023

**Date:** December 8, 2022  
**To:** Sturbridge Conservation Commission  
**From:** Roux Associates, Inc.  
**Subject:** Wetland Restoration Fall 2022 Inspection Report  
UPS Sturbridge – RTN 2-20994; DEP File # 300-1071  
I-84 Sturbridge, MA

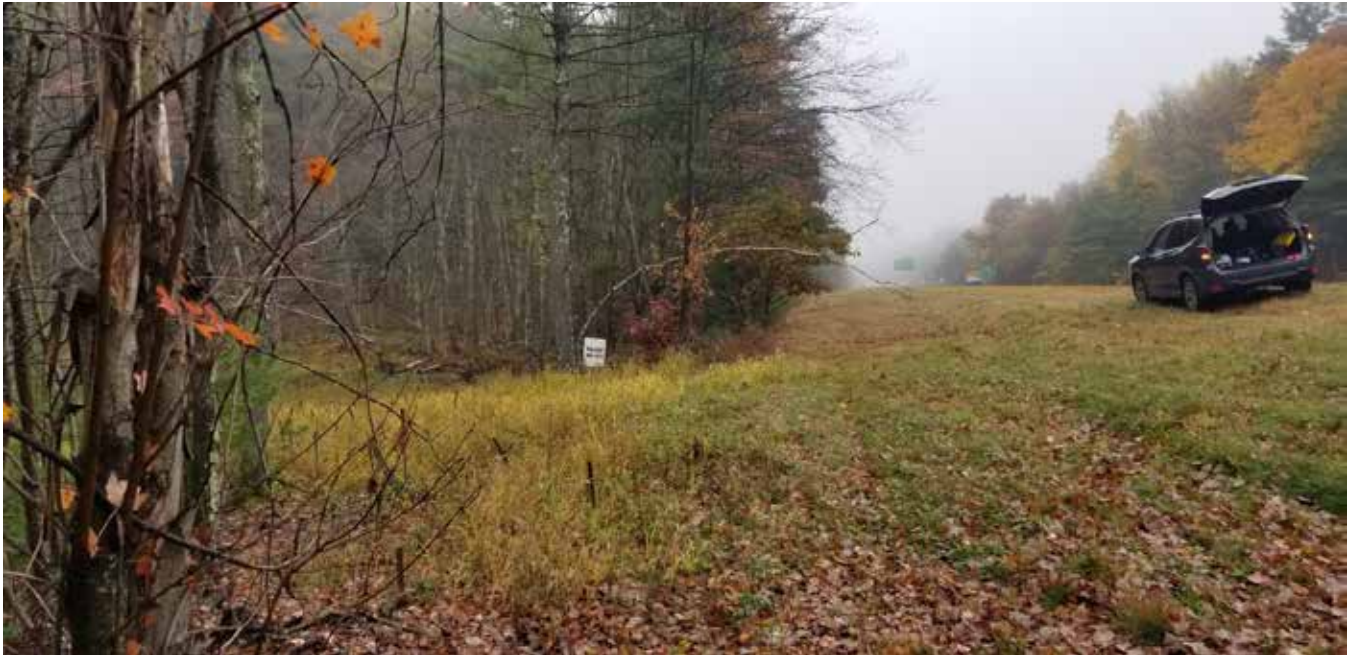
An evaluation of the erosion control measures indicated that jute mats remained well secured by the wooden stakes, and despite several stakes having fallen over, no evidence of erosion was observed. All erosion control measures were in place during the Fall 2022 inspection, with the exception of some of the wooden stakes at the top of the slope closest to the road, which were observed to be displaced during the Fall 2021 inspection. Previous maintenance mowing activities had knocked over some of the wooden stakes closest to the highway, but the jute mats were still well secured and herbaceous vegetation was growing in to cover the ground. Towards the bottom of the slope, a small area (approximately 6 square feet) of semi-bare soil was observed. This marked a healthy increase of ground cover growth compared to the 75 square feet of semi-bare soil observed during the Spring 2022 inspection. The herbaceous growth from the planted seed mix along with native grasses and wildflowers were found to cover the ground in this location. No signs of soil erosion (e.g., silt deposits, turbid water quality) were observed. Both the wetland seed mix and the roadside matrix/upland seed mix had germinated successfully, with herbaceous growth covering nearly the entire ground surface.

**Photograph 1:** View of I-84 Eastbound and erosion control mats on edge of highway, looking northeast.

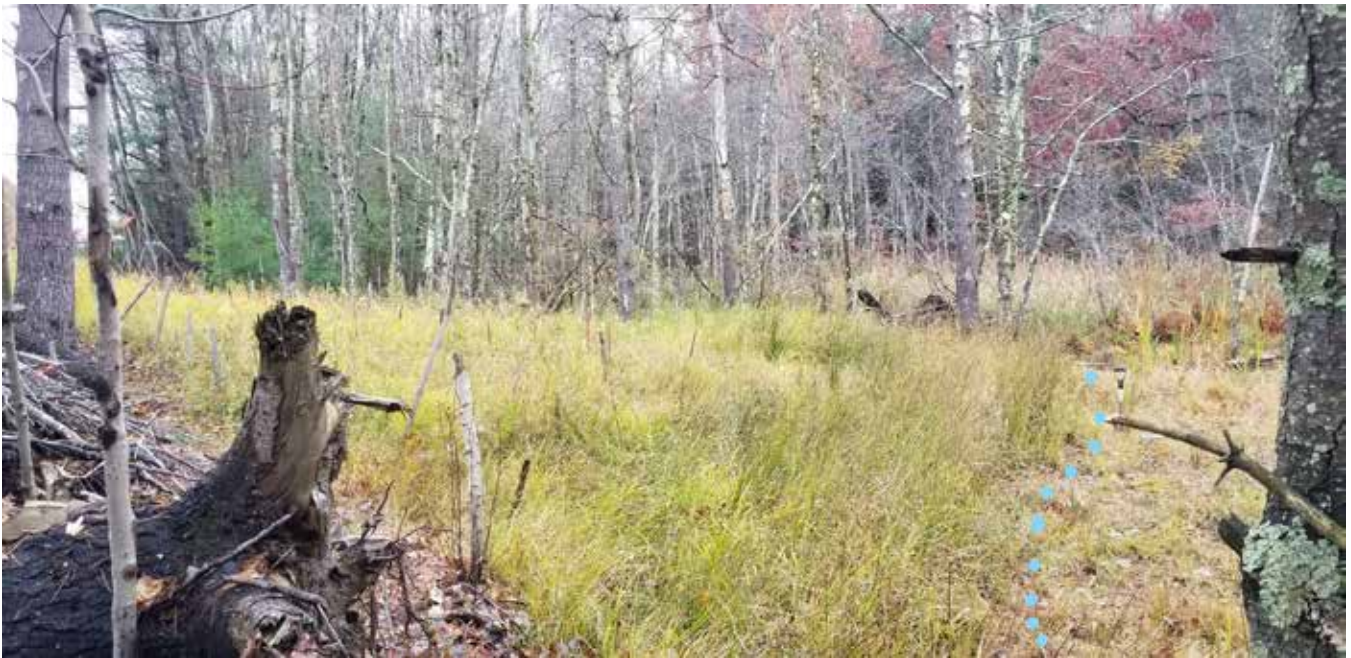
With respect to the herbaceous growth, the tussock sedge individuals fully colonized the toe of the slope as a contiguous unit. Substantial growth was observed in the average tussock sedge height and spatial coverage in comparison to the Spring 2022 inspection. Additionally, the tussock sedge plants spread up the slope to fully colonize the area where cinnamon fern individuals were planted. No planted cinnamon fern plants have since been observed within the plot; however numerous cinnamon fern fronds were observed within the receded waterline at the toe of the slope. The spatial coverage of hydrophytic herbaceous plants observed in the Fall 2022 inspection represents 100% coverage, meeting the restoration goal. As mentioned above, the seed mixes for both the wetland restoration area and the roadside area have successfully germinated and established an understory herbaceous cover.

**Photograph 5:** View of low elevation portion of planting area, looking west, abundant tussock at water's edge. Approximate seasonal waterline annotated.

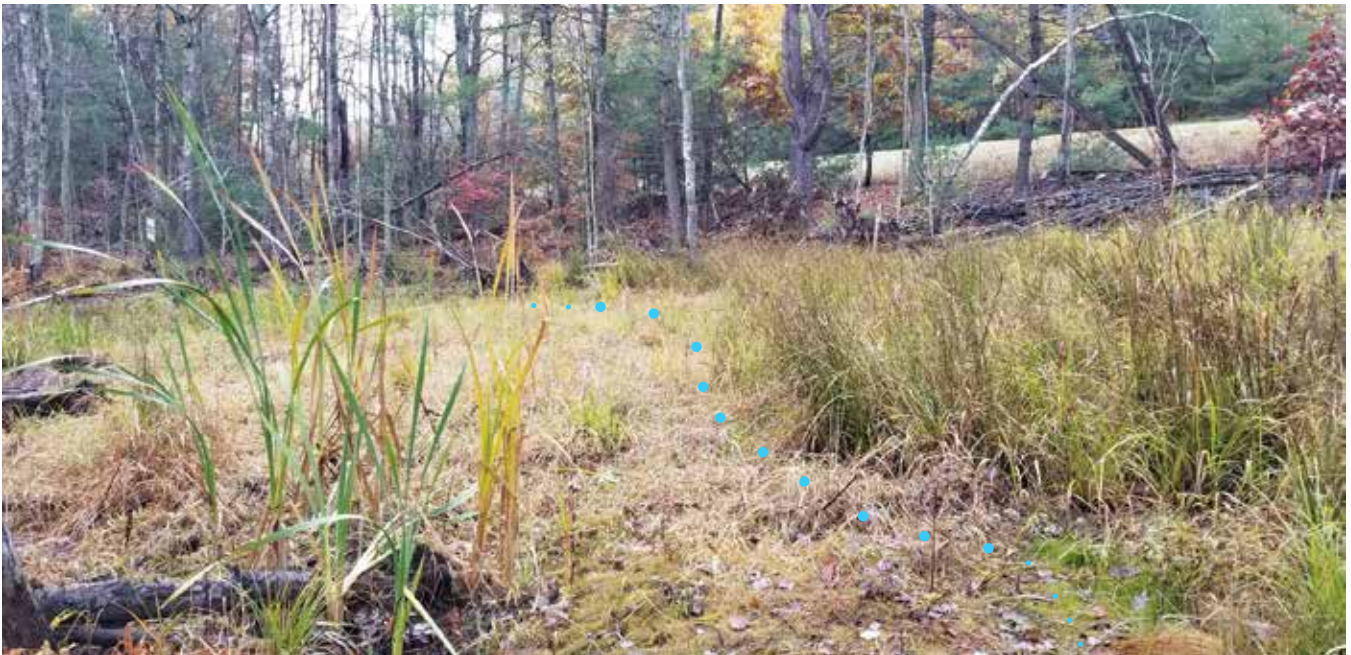
**Photograph 6:** View of low elevation portion of planting area, looking east, abundant tussock at water's edge. Approximate seasonal waterline annotated.

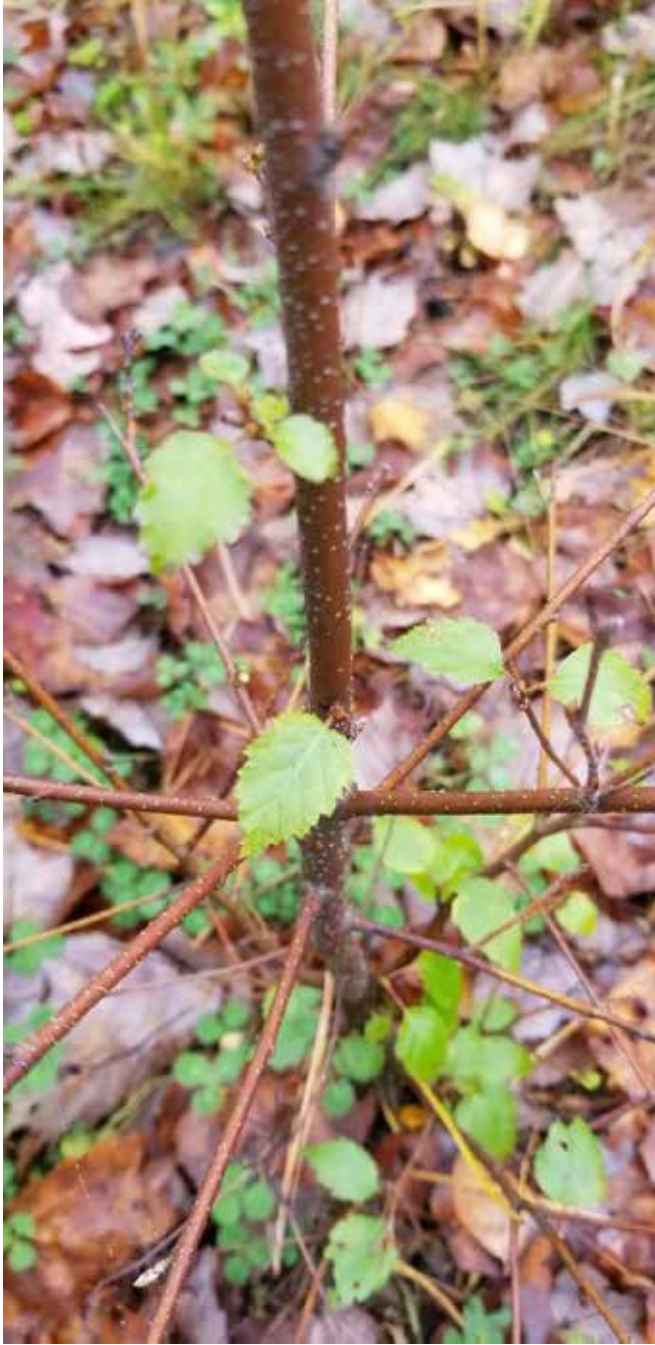
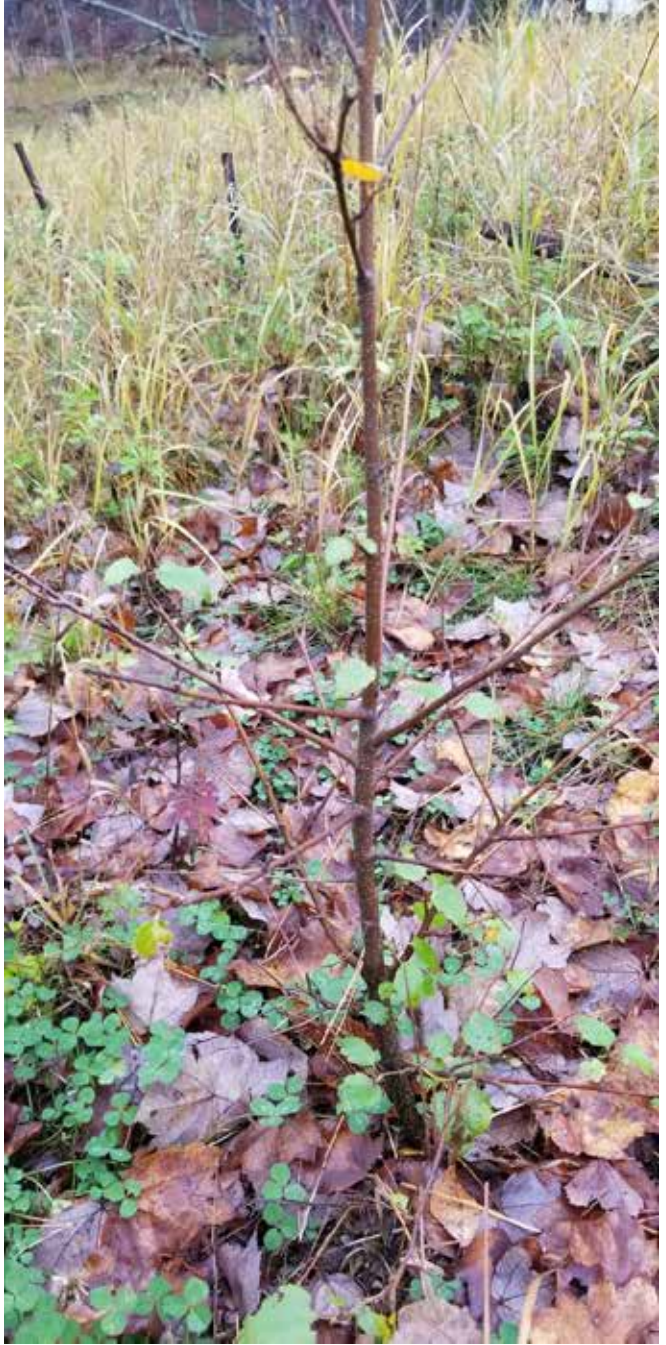
**Photograph 7:** View of paper birch foliage during Fall 2022 inspection, healthy leaves with very minor pest damage.

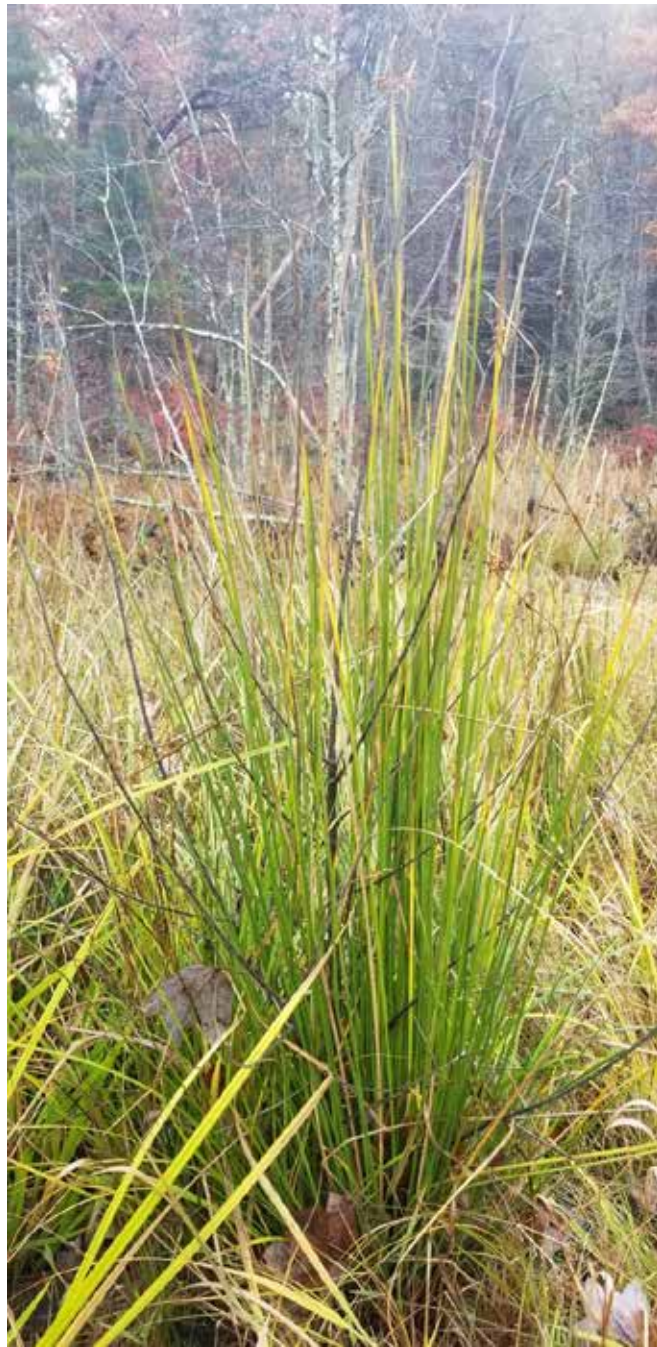
The restoration seed and plantings are progressing as expected following the two growing seasons since installation. During the Fall 2022 inspection, one buttonbush shrub was deemed missing, and one grey birch sapling was deemed dead. The remaining planted saplings and shrubs generally exhibited good vital signs and displayed resilience in dealing with minor insect damage and/or deer herbivory. Despite prior impacts of the sawfly larvae on the buttonbush leaves during the Spring 2021 inspection, no evidence of their presence was observed during the Fall 2022 inspection. Although the cinnamon fern planted individuals were again not visible during this inspection, the tussock sedge plants have abundantly colonized the restored wetland toe of slope. Therefore, Roux does not consider the lack of cinnamon ferns as a hindrance to achieving the survivability or spatial coverage goals for the overall restoration project.

**Photograph 9:** View of Grey Birch displaying no recent growth, leaf-out or buds, being overtaken by proliferating tussock sedge during Fall 2022 Inspection.

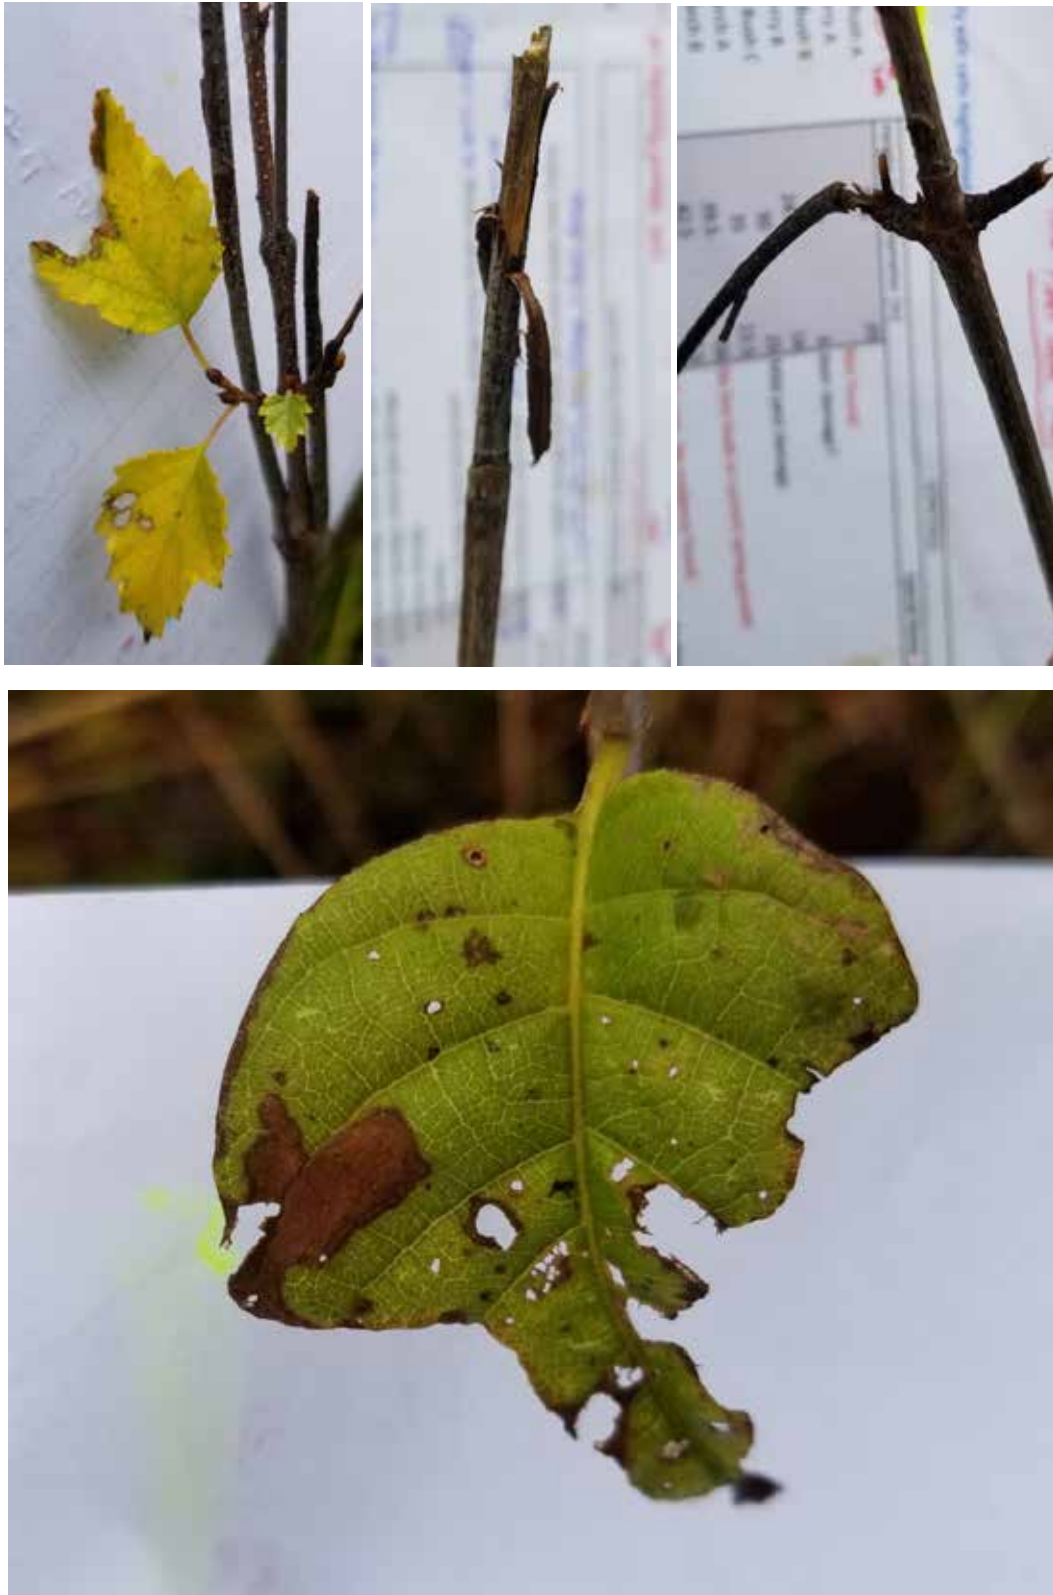
Compared to the Spring 2022 sapling and shrub measurements, the Fall 2022 measurements were generally consistent in height and diameter. Localized damage was observed along the ends of most of the sapling and shrub branches (e.g., snapped snags/bite marks), which is likely attributable to deer grazing. Abundant deer tracks were observed in the mucky areas of the receded waterline, confirming the presence of deer. In addition, one buttonbush shrub was not located during the Fall 2022 inspection. Given the increased height and spatial coverage of the nearby tussock sedge and the low height measurement of this buttonbush during the Spring 2022 inspection (7.5-in), it is possible that the buttonbush was outcompeted by the abundant tussock sedge. The remaining two buttonbush shrubs appeared healthy and displayed only minor evidence of pest and herbivory impact. Overall, minor pest damage and herbivory impacts to the saplings and shrubs were observed throughout the plot. The majority of branch herbivory impacted the tree stratum's diameter, with only one notable bite/break of the apical meristem on a red maple, reducing the average tree height.

**Photograph 10:** View of leaf pest damage, branch herbivory observed during Fall 2022 inspection.

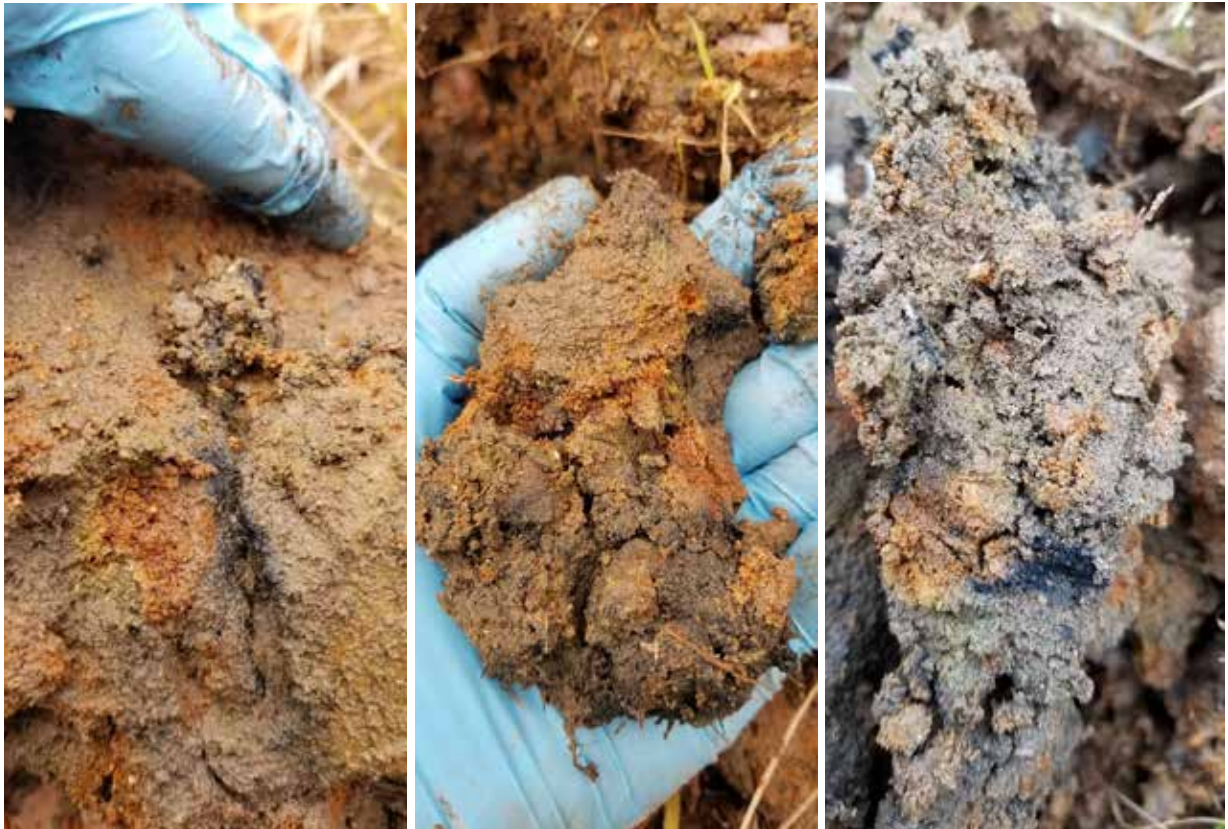
Roux's wetland specialist visited the Site on October 25, 2022, for the Fall 2022 inspection at the end of the second growing season. The weather was overcast, with temperatures in the low-60s degrees Fahrenheit. Wetland hydrology was observed at the bottom of the restored slope, which was consistent with the wetland delineation findings from 2020. Ponded surface water is consistently present in wetland portions of the Site (and surrounding wetland areas) and the water levels were typical for the time of year. Soils within the edge of the main wetland area were exposed at the surface where they were previously saturated to the surface of the soil profile. This inspection resulted in the second observation of redoximorphic features in the restored wetland soils. Iron concentrations with a Munsell color of 10YR 4/6 were observed along root channels while some slight iron depletions with a Munsell color of 10YR 5/2 were observed throughout the soil matrix. This finding is consistent with the F3 Depleted Matrix hydric soil indicator.

**Photograph 12:** Wetland restoration soil sample taken at toe-of-slope displaying evidence of strong hydric indicators (e.g., redoximorphic features).
