Town of Sturbridge

Tree Removal Permit Application

Shrī Gaṇēsh Tree and Plant Health Care

Project Assignment:

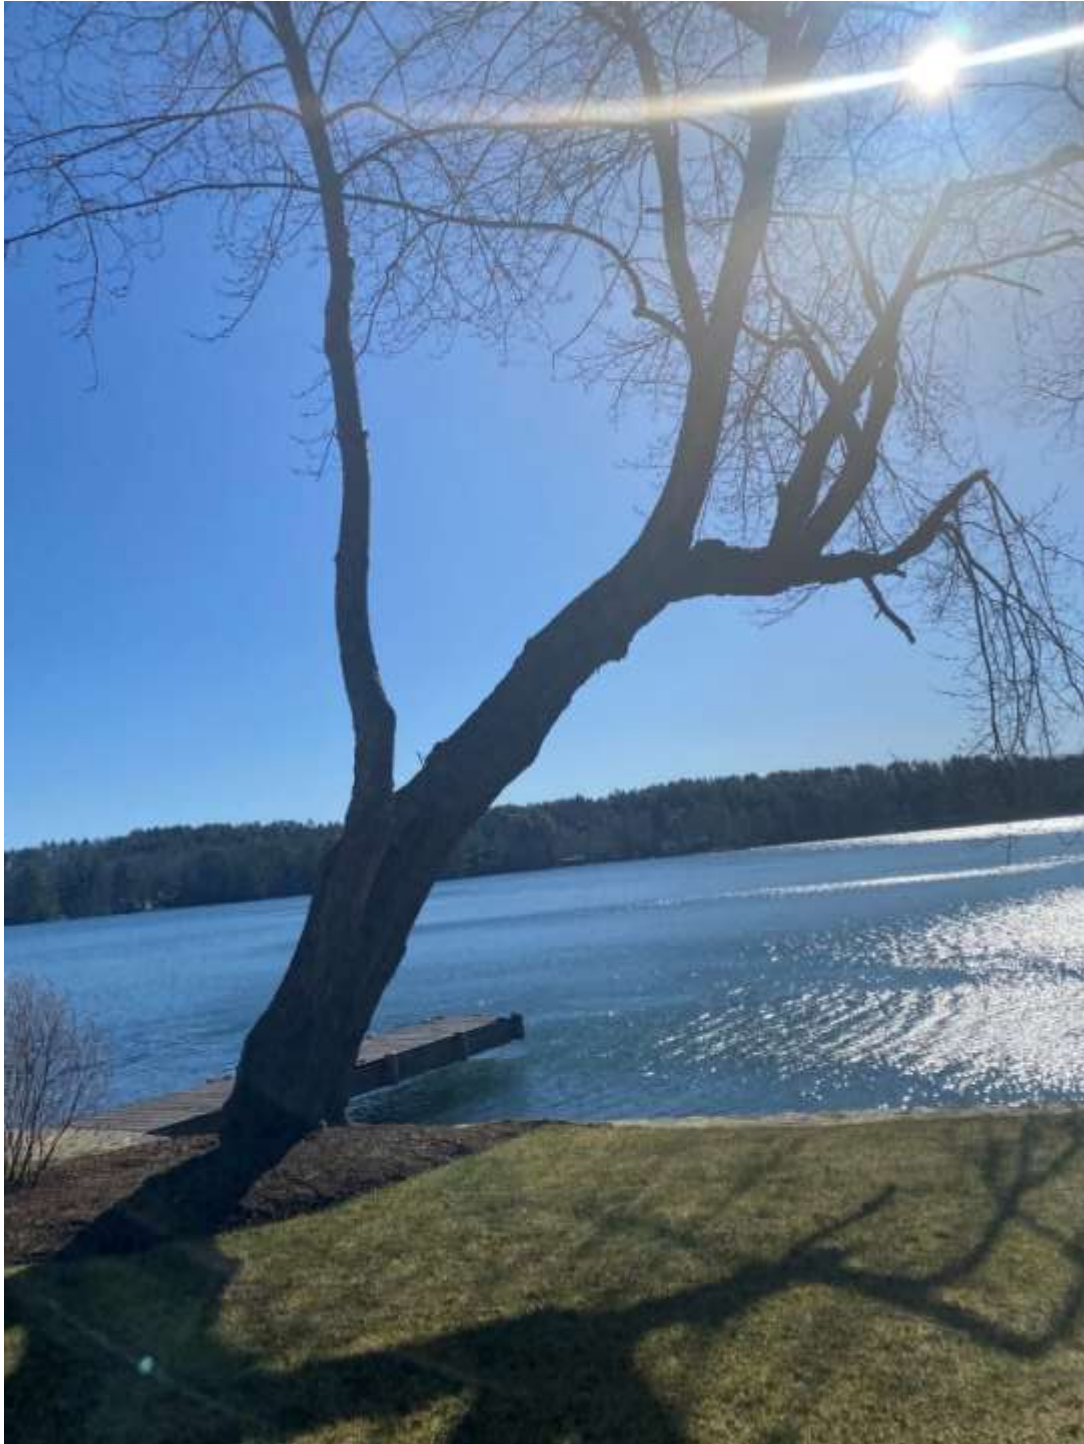
RED MAPLE – Tree #1 – from the South

The Stagais's have been living in the property since 2014 and have particular concern about the large red maple (*Acer rubrum*) located in their front yard and overhanging the lake. The tree **Tree #1 – (see map and attached 3 photos)** is a 30" diameter tree which lies about 5' from the water's edge. This tree was on the property previously to the Stagais purchasing it and constructing the new residence. The Stagais's had made efforts during construction to ensure its survival and continued good health. The Stagais's have treated the tree in the past with various plant health care prescriptions (bio-fertilizing) and in 2017 had the tree treated for the gypsy moth larvae control. They have always held the tree in high regard. The tree is in a high use area. The tree has noticeably declined to them dropping leaves earlier than it has in the past and dropping many small branches continually throughout the year. Of particular note is the tree is leaning heavily and appears to have recently moved more in that same direction. Noticeable is a root/ground disturbance which can be seen as there is a crack/hole in the ground next to the base of the tree. The tree has noticeable advanced decay within the entire lower trunk area. In addition, this tree should it fail, overtops or leans over the boat and recreational water vehicle storage area. It would also damage the stone wall most likely upon failure. The tree also overtops or would damage an existing hemlock tree beneath its crown in addition to some other understory plants present within its reach.

It is recommended that the tree be removed as it will continue to decline both in health and structural integrity. They would like the stump ground out also as the front yard is so minimal and it would also create a planting location for a smaller replacement tree.

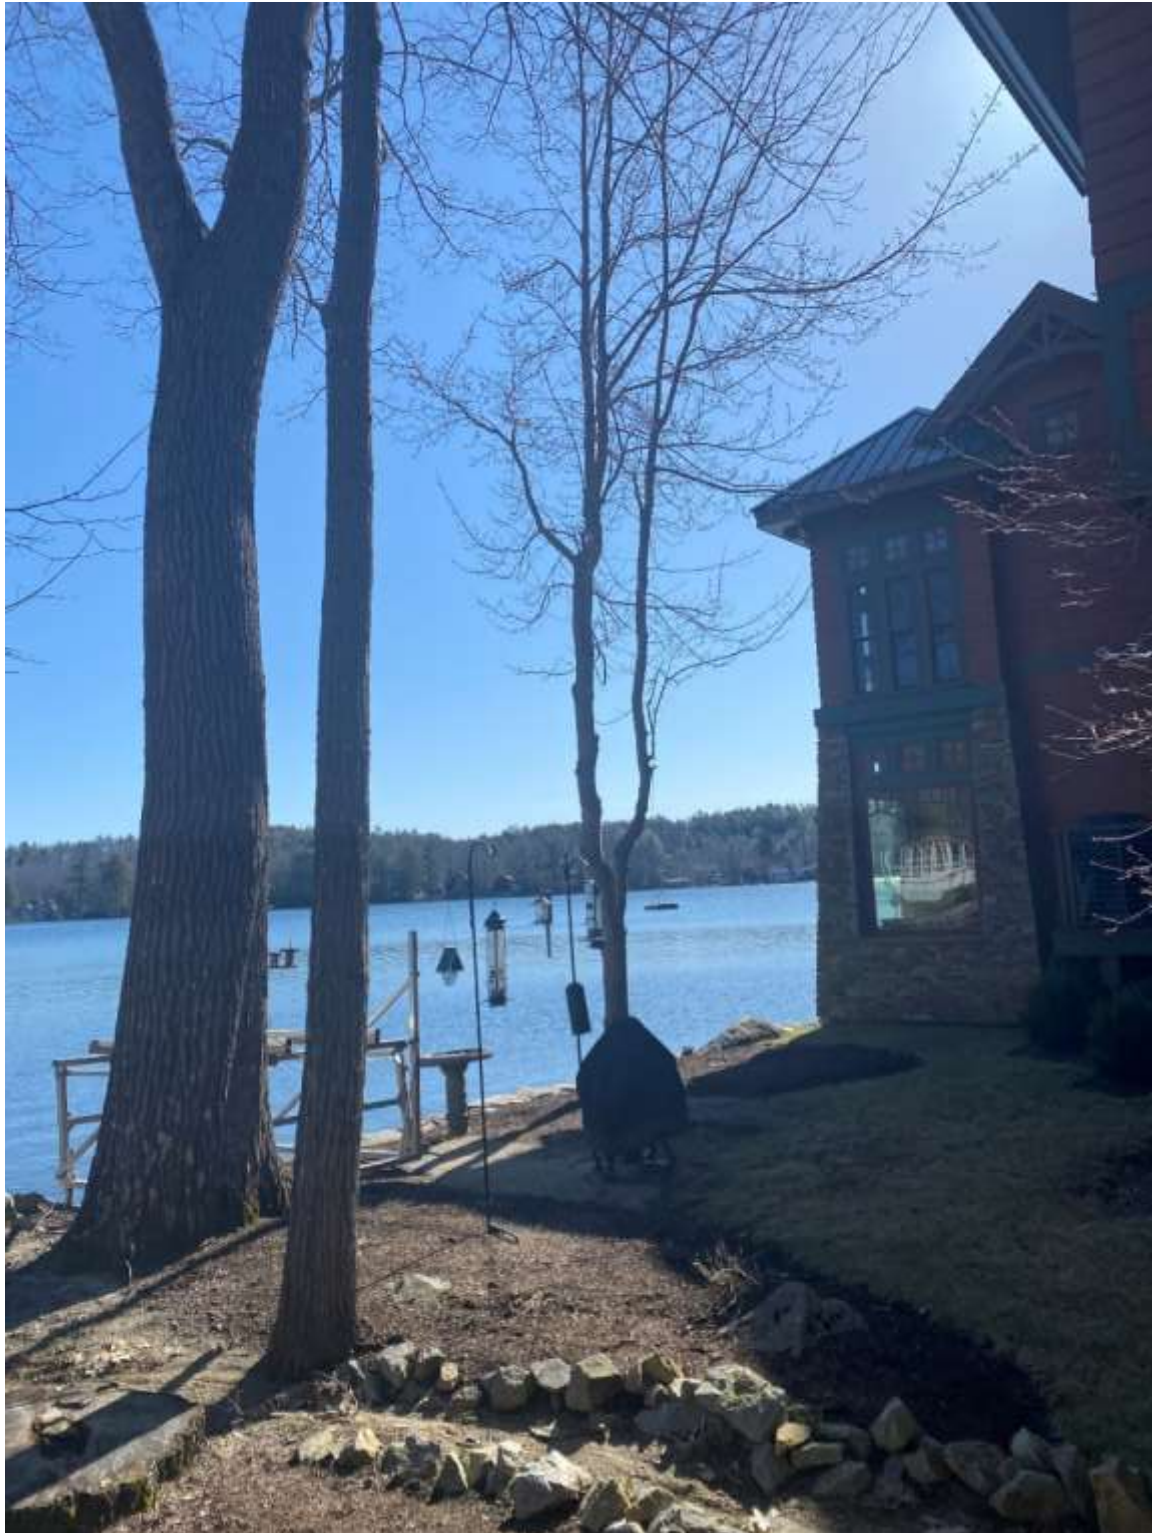
Tree # 2 – (see map and attached photo) – is a 10” diameter red oak (*Quercus rubra*) growing 15’ from the shoreline. It lies within a drainage “way” which flows water during exceptionally high rainfall events. The tree is an understory tree that was left when the house was constructed. It lies beneath a massive red oak. This tree can be defined as a suppressed understory tree. It also grows within the shade created by the house to the South. The tree has no hope of becoming an investable respected landscape tree. It will continue to grow slowly as it is suppressed and as it ages will continue its march and continually grow to the South and its interference with the residence will only increase over time.

Tree # 3 – (see map and attached photo) – is a 10” diameter red maple 5’ from the shoreline. It lies due East of the house within the very small rear yard area. It is within a mulched maintained highly used area. This tree was also left during the home construction process. It is a suppressed understory tree that will continue to grow towards the South and the house. Its branches and the tree itself should be removed because it will be problematic in the future. It is out of place and does not have the capacity or form to develop into a respectable landscape tree.

Trees # 2 an #3 – from the North
Red Oak and Red Maple understory trees

It is recommended that this tree be removed during these proposed removal operations. It does not have the capacity nor ability to develop into anything but problems to the homeowner in future years.

The tree is healthy. It’s location and ultimate size and what results from that size will eventually be problematic. The tree grows in a high use area within the very small Northeast back yard. The stump will ground out and replaced with suitable growing material. The tree will be replaced with a dwarf sized tree that is both ecological suitable for the site as well as in its eventual size.

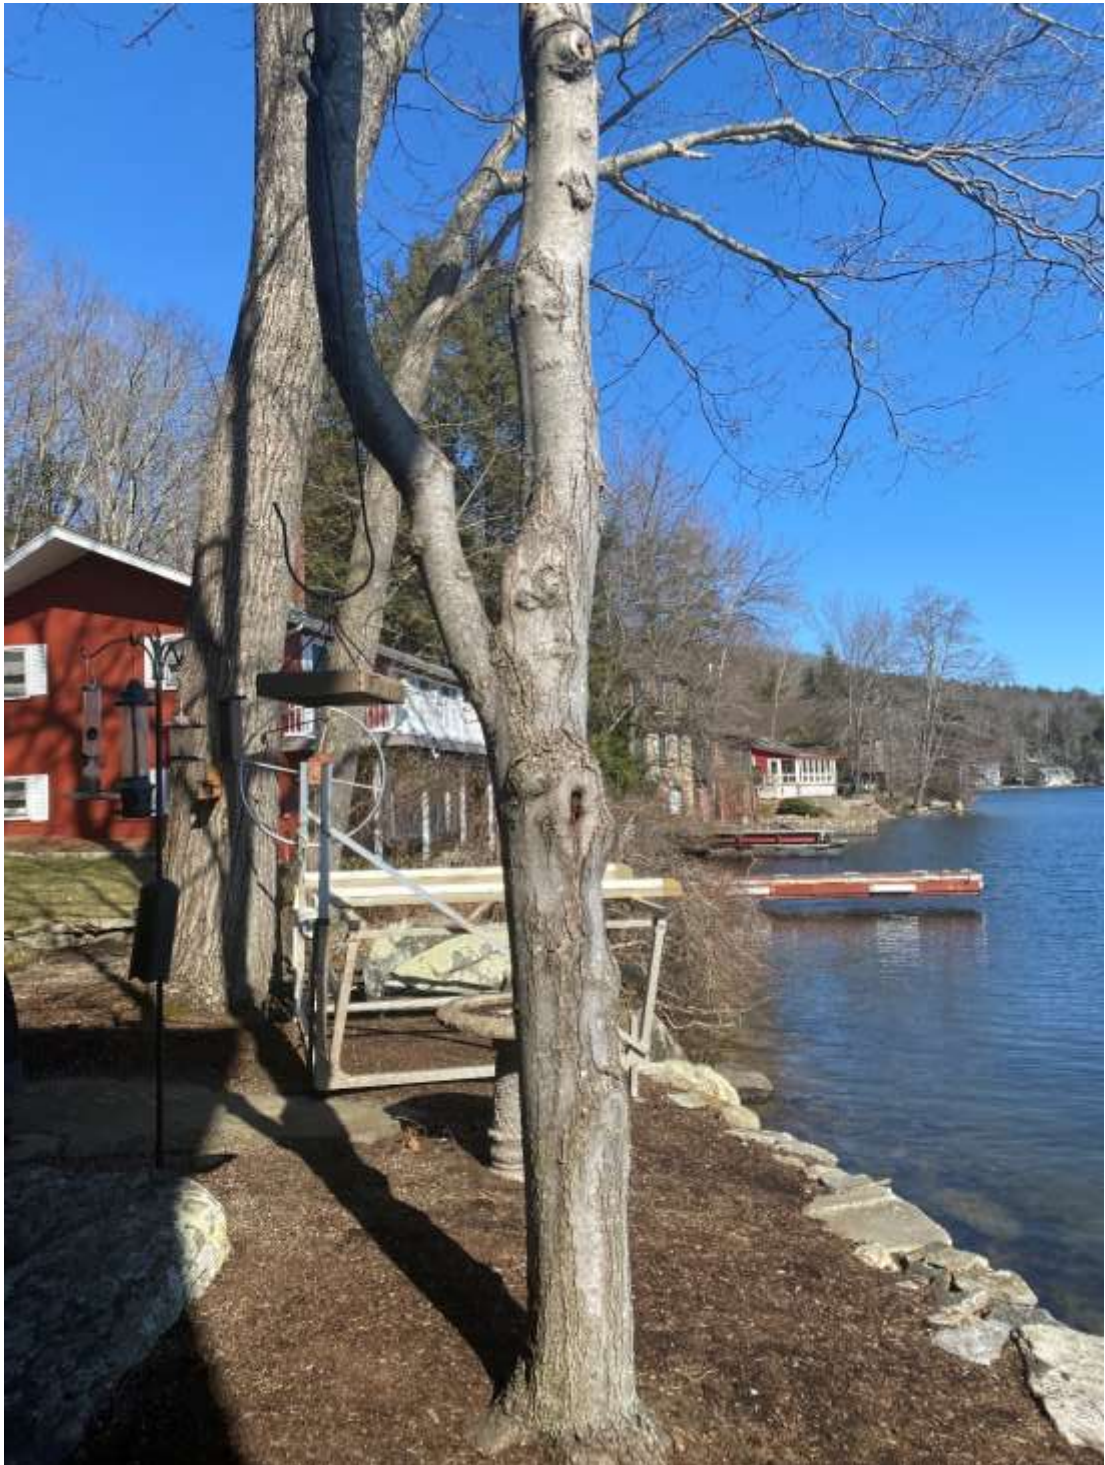
Tree # 3 – from the North

Red Maple
