FORM B – BUILDING

Town/City: Sturbridge

Address: 531 Route 15

Historic Name: Samuel Thompson House

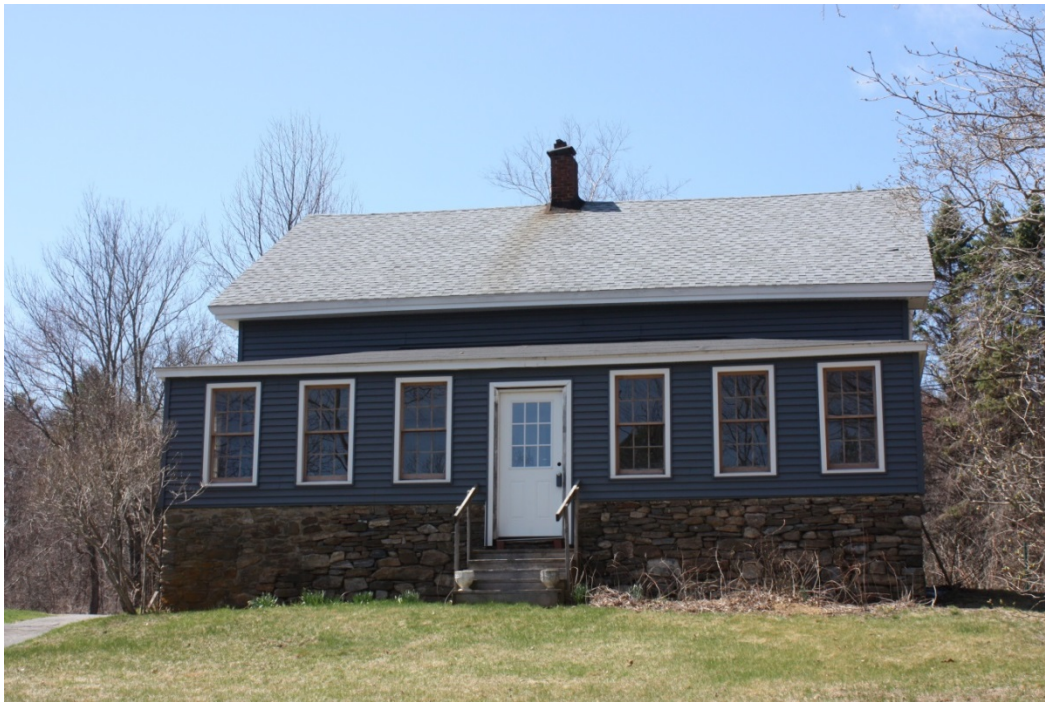
Photo 1: Eastern facing main façade

The main, eastern facing façade has stone on the lower half of a shed roof enclosed addition which runs the length of this elevation. There are steps which lead to a paneled door with nine upper lights and there are three, 6/6 windows on either side of the entry, for a total of six windows. A cross gable wing with an east/west aligned rectangular plan is off of the western rear elevation.

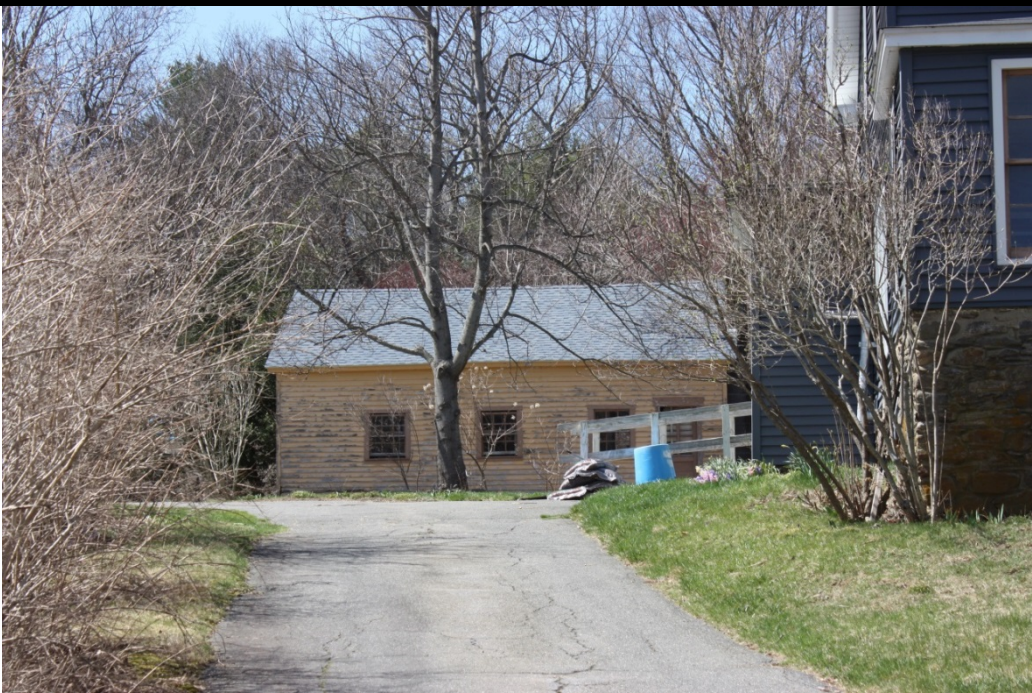
Photo 2: Eastern elevation of outbuilding

A north/south aligned rectangular plan outbuilding, identified as a garage, is four bays wide and has a side gable, asphalt shingle roof and is positioned to the southwest of the main residence. The exterior is clapboard with wood trim. Four windows on the eastern elevation are each 6/6.

The land was later divided into two tracts and in 1891, the "farm with buildings" was passed on to Sarah E. Thompson (1858-1933), wife of Samuel R. Thompson (1854-1919), (married in 1877), and then a second tract was added in 1892.⁵ Samuel R. was the son of Daniel C. Thompson (1814-1888) and Amanda E. Thompson (1818-1891), and was Samuel and Dolly's grandson and Samuel L. and Ruth C.'s nephew.⁶ (Figure 2) The rear, east/west aligned ell may have been constructed by 1898. (Figure 3) Barn outbuildings are also shown on the 1898 map, which may be related to the current garage. (Photo 2, Figure 3)
