**TOWN OF STURBRIDGE  
COMMERCIAL TOURIST DISTRICT  
IMPROVEMENT PLAN**

SUBMITTED APRIL 2, 2014

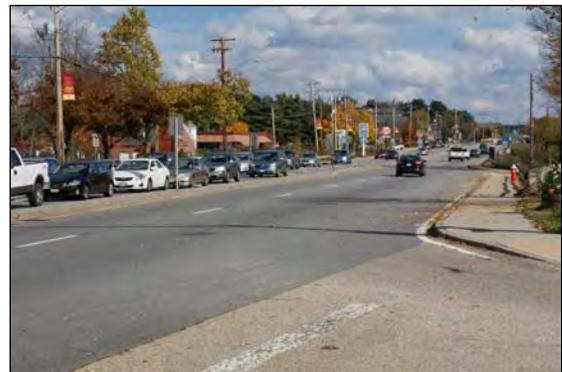
*Eastern Gateway: The heavy traffic volumes and width of Route 20 present challenges for crossing pedestrians.*

The roadway generally consists of four lanes (two lanes in each direction) with turning lanes at significant intersections. A raised concrete center median, approximately 6 feet wide, divides eastbound and westbound traffic. Sidewalks are located on both sides of the street from Route 131 to Cedar Street.

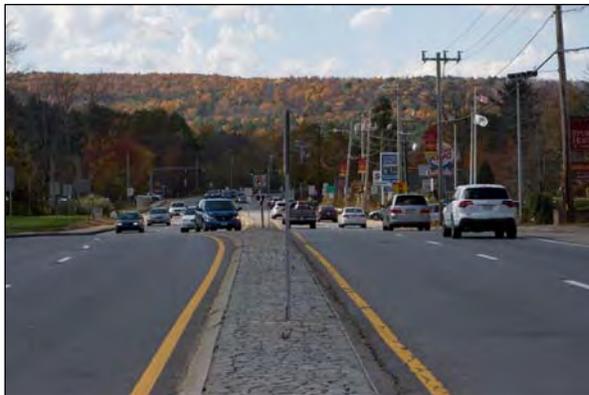
*Eastern Gateway: The existing center median presents opportunities for landscaping improvements.*

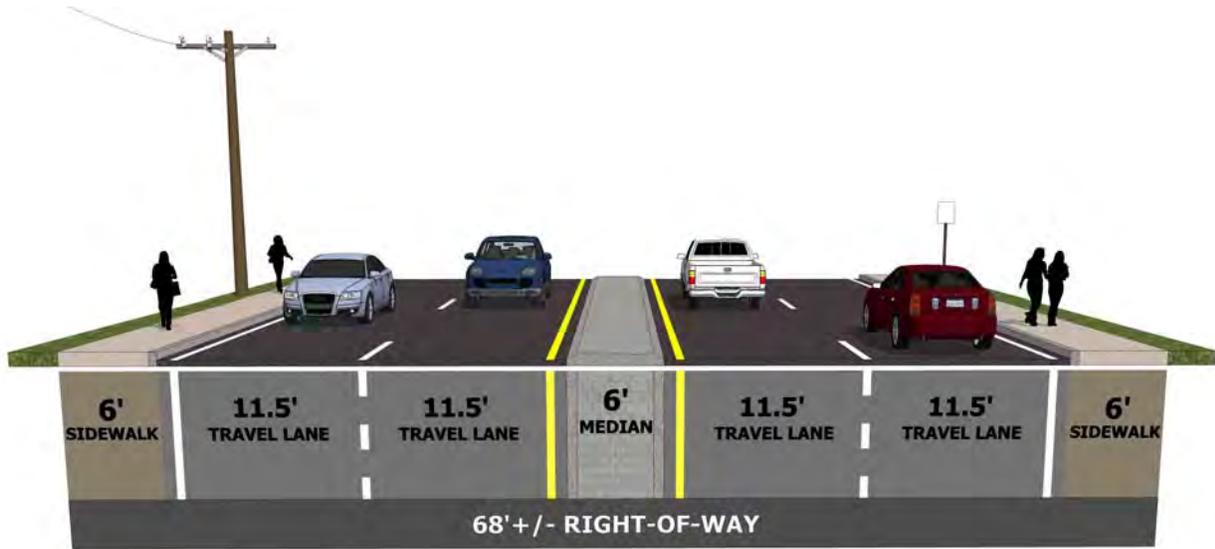
The existing cross-section of the Eastern Gateway is depicted in Figure 2.

*Figure 2: Eastern Gateway- Typical Cross Section*

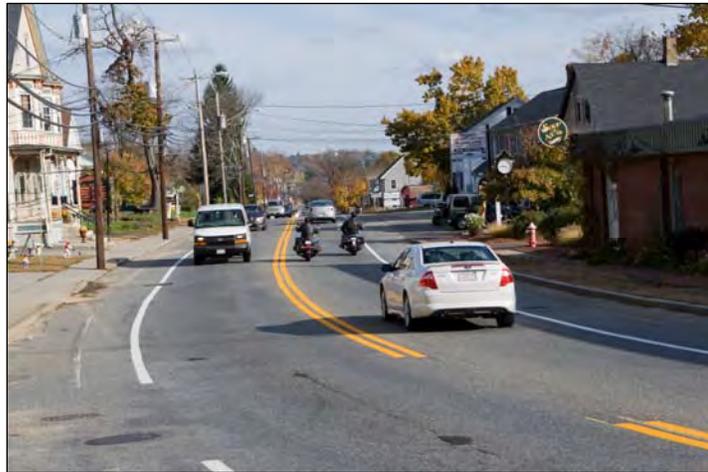
*Western Gateway: Wide shoulders along the Western Gateway present opportunities for on-street parking, bike lanes, and expanded sidewalks.*

Throughout the Western Gateway, Main Street (Route 20) is a two-lane roadway (one lane in each direction). Shoulders, approximately 6-feet wide, are located along each side of the roadway. Sidewalks are located along the north side of Main Street (Route 20) throughout the entire Western Gateway. On the south side of Main Street, sidewalks are located on approximately one third of the segment. The typical existing cross-section of the Western Gateway is shown in Figure 3 below.

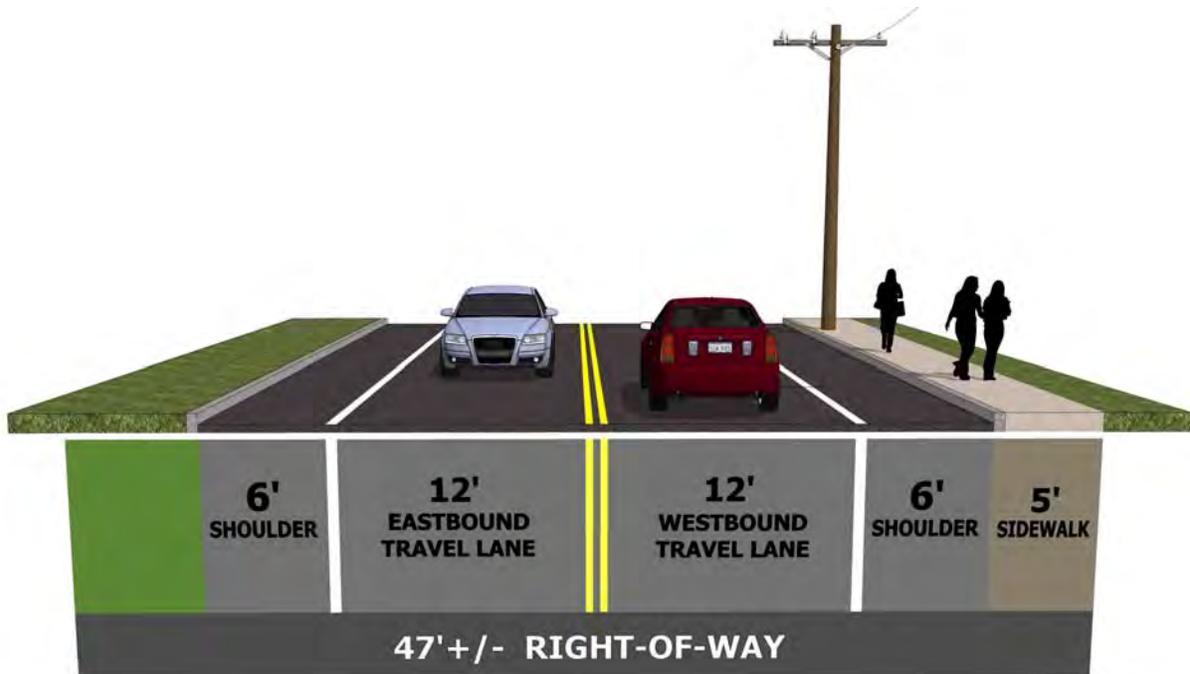
*Figure 3: Western Gateway- Typical Cross Section*

The existing cross-section of the Western Gateway consists of one 12-foot travel lane in each direction and with approximately 6-foot wide shoulders. Sidewalk is located along the northern side of Main Street (Route 20) throughout the Western Gateway and is typically five to six feet in width. Sidewalk is located on the south side of Main Street (Route 20) in two locations, from Snell Street to Cedar Street (approximately 850 feet) and from Bates Hill Road to Village Pizza (approximately 800 feet). There is also a small portion of brick sidewalk in poor condition in front of the Millyard Marketplace. Based on roadway plans received from MassDOT, the typical public right-of-way width within the Western Gateway is 50 feet.

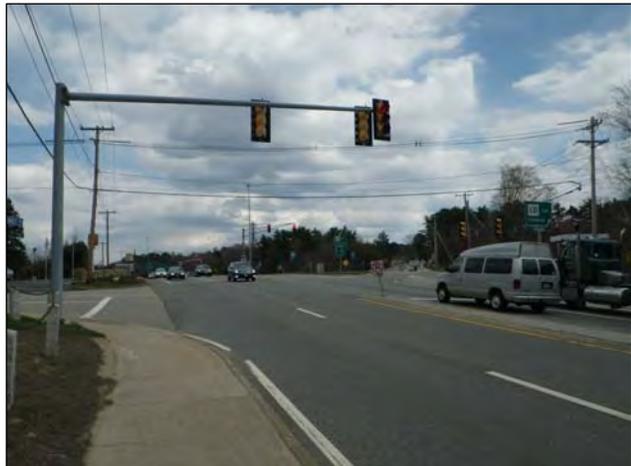
*Fairground Road Intersecting Route 20: Looking to the east.*

The intersection of Route 20, Route 131, and Fairground Road forms a four-legged signalized intersection. Route 20 forms the east and west legs, Route 131 forms the southeastern leg, and Fairground Road forms the northern leg. Route 131 approaches the intersection from the southeast, creating a skewed intersection. The northbound approach from Route 131 and the southbound approach from Fairground Road are offset by approximately 350 feet, creating a wide intersection footprint. Route 131 is also served by a set of right-turn channelized lanes. Two sets of traffic signals, one at Fairground Road and one at Route 131, are used to control the intersection.

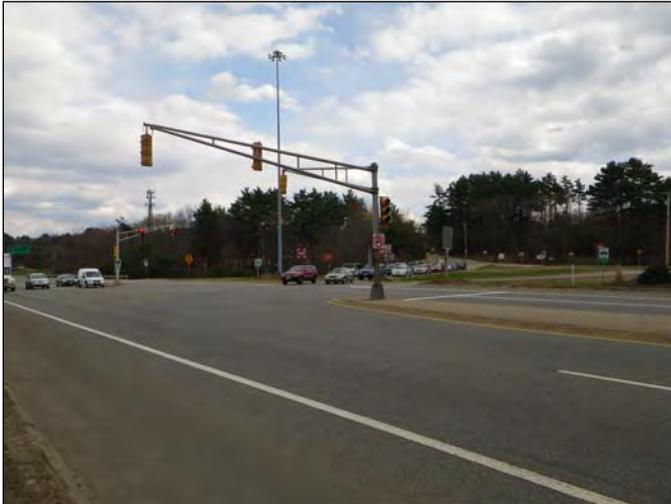
No pedestrian crosswalks or controls are provided at the intersection. Sidewalks are located along the southwestern corner of the intersections. The wide intersection design, coupled with the large radius of the Route 131 channelized lanes, create an auto-centric, unfriendly pedestrian environment at this intersection.

*Route 131 Intersecting Route 20: Looking to the southeast.*

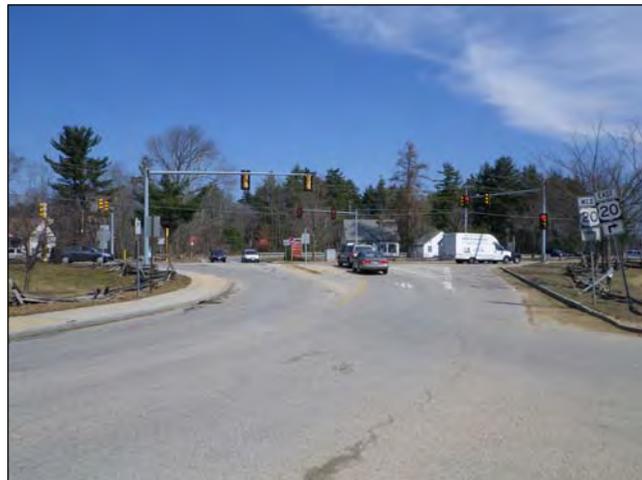
*Stallion Hill Road & Main Street (Route 20): Looking north.*

The intersection of Main Street (Route 20) and Stallion Hill Road forms a four-legged signalized intersection with Main Street (Route 20) forming the east and west legs of the intersection, Stallion Hill Road forming the south leg, and a jug-handle forming the north leg. The jug handle is located at the intersection to direct westbound traffic into Old Sturbridge Village and residences along Stallion Hill Road.

Old Sturbridge Village is located on Stallion Hill Road just south of the intersection and the Sturbridge Tourist Information building is located on the northeast corner of the intersection. Sidewalks are located at all corners of the intersection and crosswalks are located across the north, south, and west legs of the intersection. Pedestrian pushbuttons and signal heads are located across the west leg crosswalk, crossing Main Street (Route 20). No pedestrian pushbuttons or signal heads are provided for the north leg or south leg crossings.

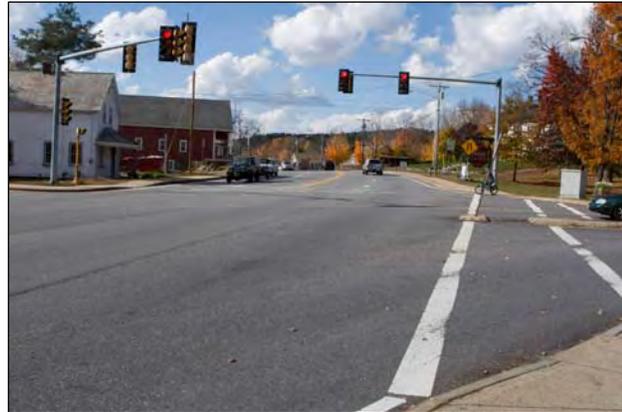
*Main Street (Route 20) & Cedar Street: Looking to the west.*

The intersection of Main Street (Route 20) and Cedar Street forms a three legged, signalized intersection. Main Street (Route 20) forms the east and west legs of the intersection while Cedar Street forms the north leg. A jug handle is provided on the south side of the intersection to allow for westbound U-turns.

Sidewalks are located at each corner of the intersection. Pedestrian crosswalks and signals are located across the north leg and west leg of the intersection. Main Street (Route 20) transitions from two lanes to one lane just west of the intersection. Centennial Park is located on the northeast corner of the intersection.

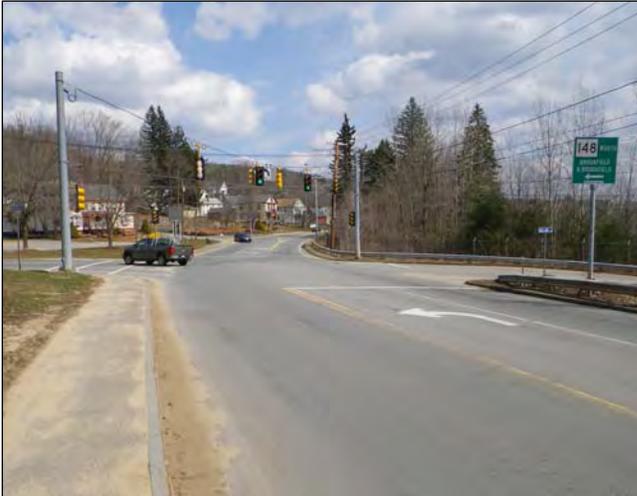
Sidewalks are located on the northeast and northwest corners of the intersection. No sidewalks are located on the southeastern or southwestern portions of the intersection as guardrail protects the Main Street (Route 20) from the steep embankment to the south. A marked crosswalk is located across the north leg of the intersection but is not accompanied by pushbuttons or pedestrian signals.

*Main Street (Route 20), Brookfield Road (Route 148) & Holland Road: Looking to the east into the CTD.*

The intersection of Main Street (Route 20), Brookfield Road (Route 148), and Holland Road forms a four-legged signalized intersection. Main Street (Route 20) forms the east and west legs of the intersection while Brookfield Road (Route 148) forms the north leg and Holland Road forms the south leg. This intersection establishes the western limit of the CTD.

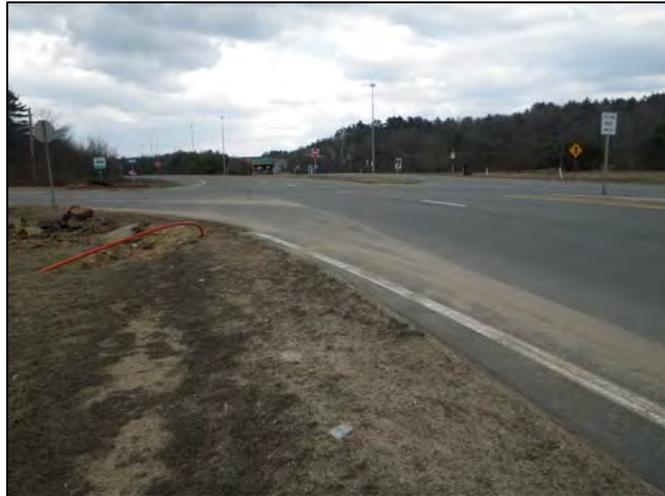
*Route 20 & New Boston Road: Drivers have difficulty entering Route 20 safely from New Boston Road due to the long crossing width and vehicle speeds on Route 20.*

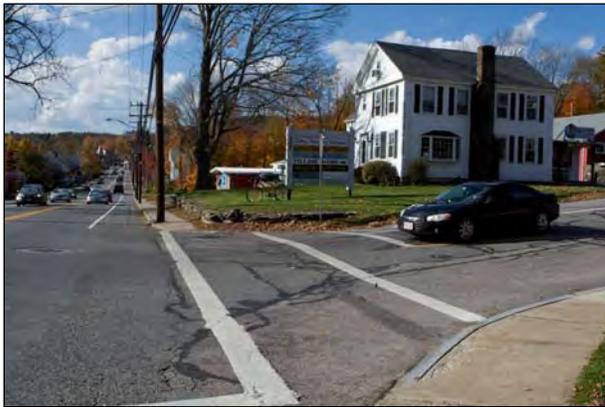
*Main Street (Route 20) & Arnold Road: Vehicles typically have difficulty entering Main Street (Route 20) from Arnold Road during peak traffic periods.*

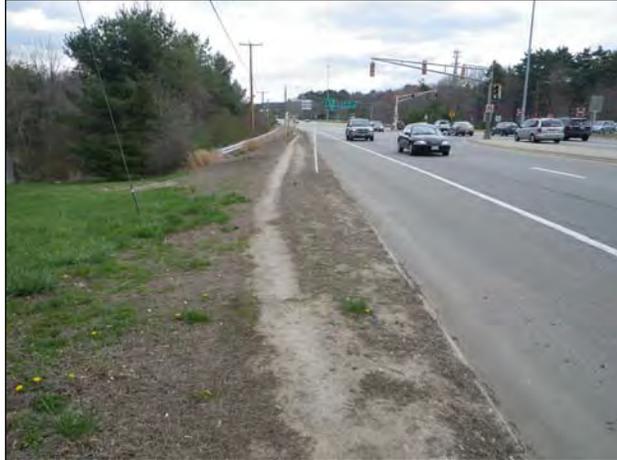
*Eastern Gateway: Desire paths along the north side of the eastern gateway show pedestrian use in the area without sidewalks.*

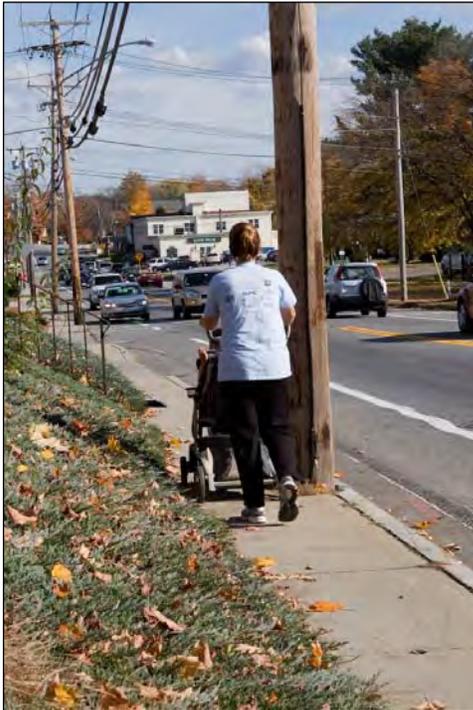
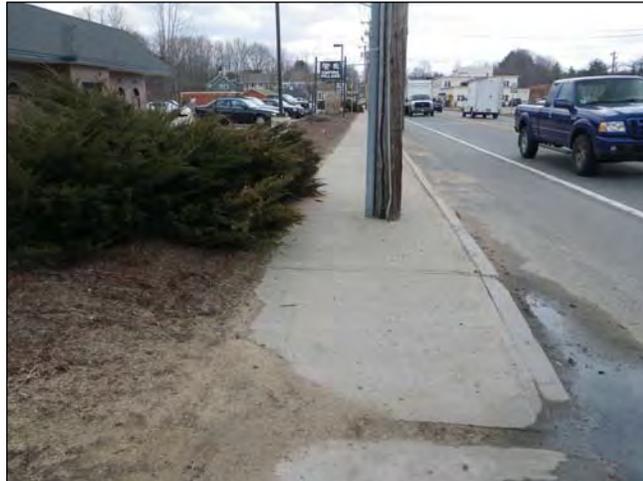
Along the Western Gateway, sidewalks are located throughout the segment on the north side of the Main Street (Route 20). Sidewalks along the north side of Main Street (Route 20) generally vary from 4-6 feet. At several side streets and driveways, sidewalk ramps lead right into catch basins. Utility poles run along the northern side of the Western Gateway, limiting the sidewalk clearance to 3 feet in some locations.

*Western Gateway: Utility poles in the middle of the sidewalk create difficult pedestrian travel.*

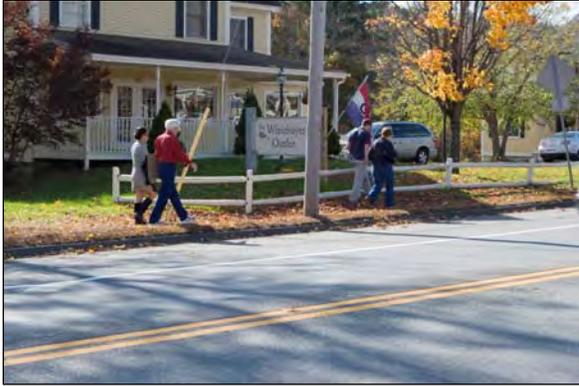
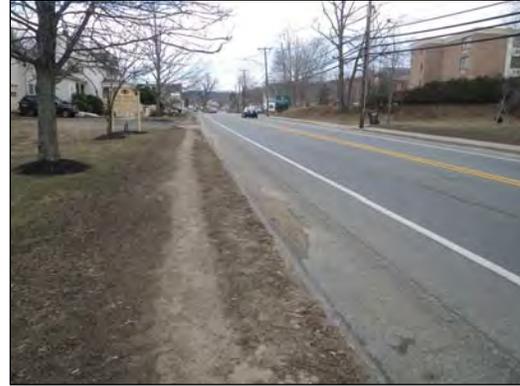
**Western Gateway:** Sidewalks are not provided through much of the southern side of the Western Gateway although pedestrians frequently travel through the area.

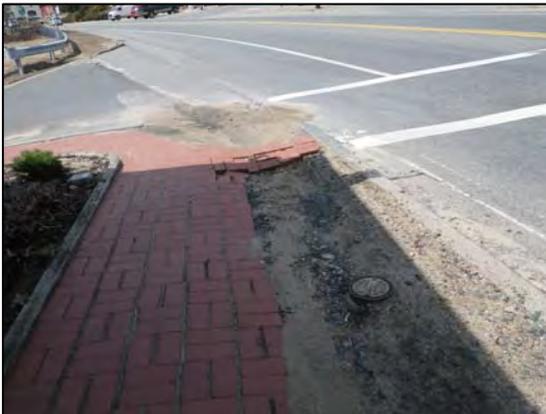
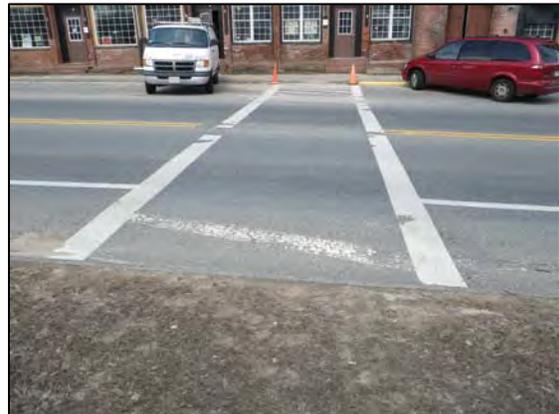
**Western Gateway:** Crosswalks leading to locations with no sidewalk or accessible ramps.

A total of eight crosswalks cross Main Street (Route 20) in the CTD. Of these eight crosswalks, two are located at signalized intersections, Stallion Hill Road and Cedar Street. The remaining crosswalks are midblock crosswalks within the Western Gateway. Many of these crosswalks are not ADA compliant as accessibility ramps and detectable warning pads are not installed. Additionally many of these crosswalks lead to areas without sidewalks.

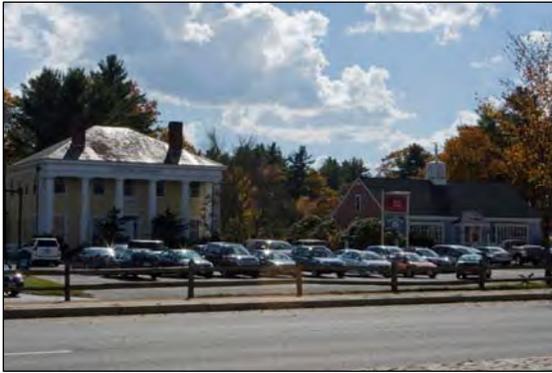
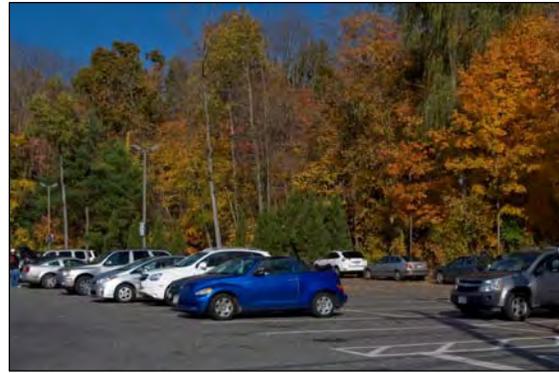
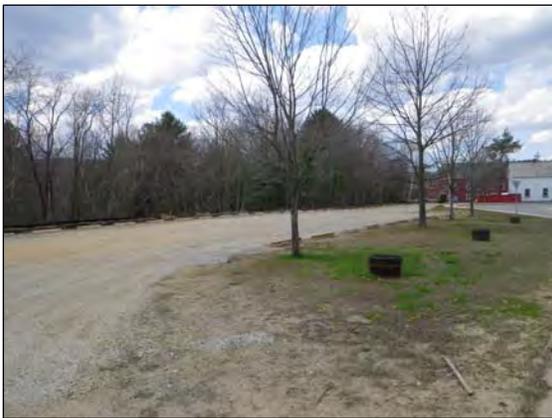
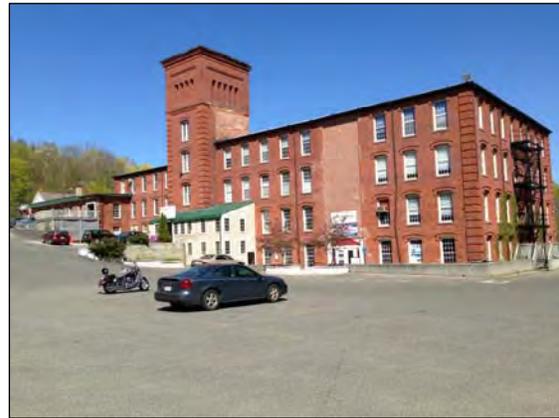
***Parking:*** *Parking through the CTD is primarily restricted to private business lots. Introducing shared business parking lots and on-street parking are options for various areas along the corridor.*

Parking along the corridor consists mostly of private business lots. No on-street parking is currently allowed along Main Street (Route 20) within the study area. Many businesses have parking lots located in front of their building while others have parking located on the side or behind their buildings. Parking in front of businesses generally creates wide curb cuts, affecting pedestrian safety. Some lots are over capacity while others are underutilized. In some situations, adjacent businesses may benefit from shared parking facilities. Transitioning parking to the rear of business lots will help create a pedestrian friendly environment within the CTD. There is potential for on-street parallel parking in the Western Gateway with the modification of the existing travel lane striping.

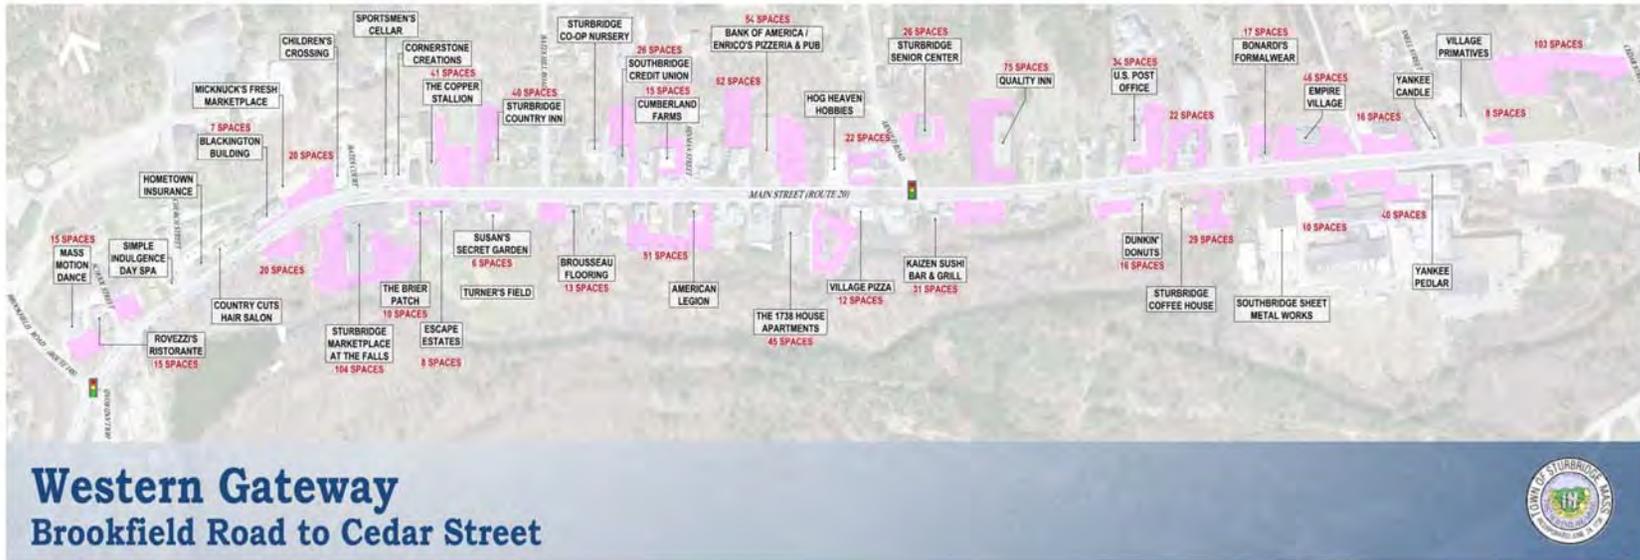
**Sturbridge Commercial Tourist District**  
**Parking Inventory**  
**Figure 4**

**Western Gateway**  
**Brookfield Road to Cedar Street**

A parking inventory has been completed for all major parking facilities within the CTD. Figures 4 and 5 show the location of each major parking lot and the number of the spaces in each lot. Larger parking facilities are concentrated in the Eastern Gateway while many smaller, single business lots are located within the Western Gateway.

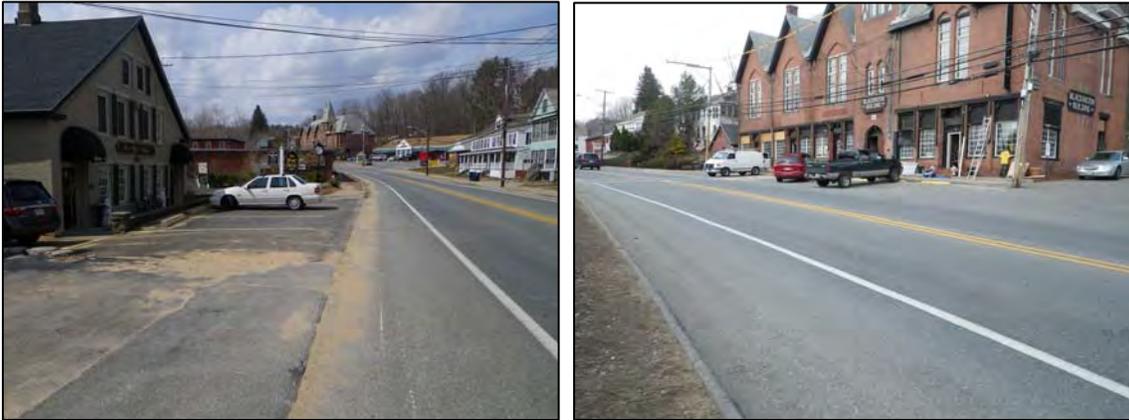
***Access Management:** Some properties, such as the Briar Patch and the Blackington Building, have roadside parking requiring vehicles to back onto Main Street (Route 20), presenting dangerous situations for not only passing drivers, but pedestrians and bicyclists.*

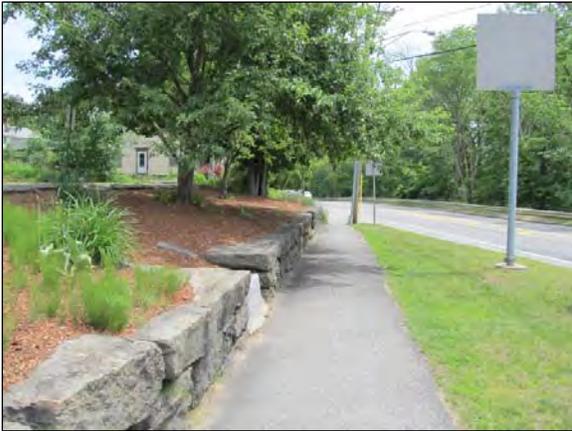
***Northeast Corner of Main Street and School Street:*** Lawn buffer strip between the road and sidewalk.

Since the existing sidewalk along Main Street is primarily located immediately at the edge of the road, there are very few buffer areas separating pedestrians from the vehicular way. Where they do exist – on the north side of Main Street just east of School Street and the south side of Main Street adjacent to the Sturbridge Marketplace – they are merely small wedge-shaped lawns or thin lawn strips just a few feet wide.

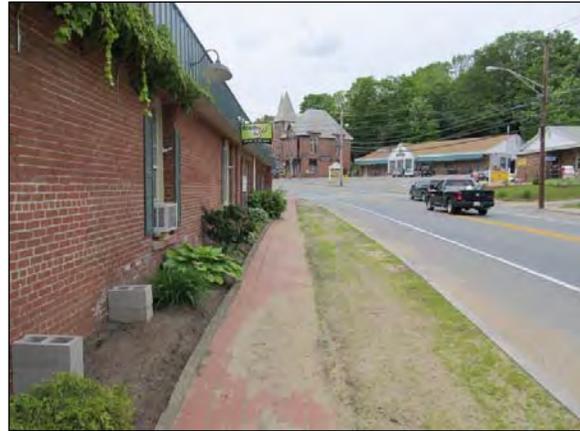
***Sturbridge Marketplace:*** Thin lawn buffer strip between the road and sidewalk.

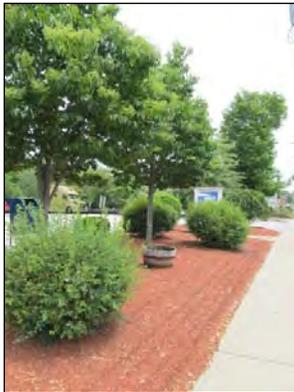
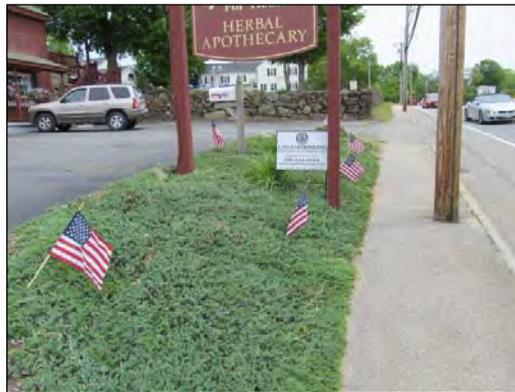
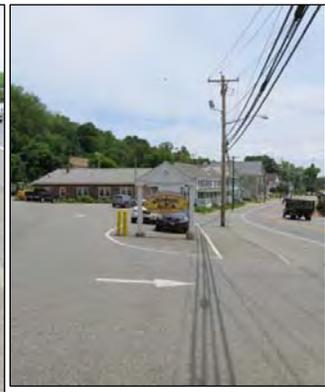
***Left to Right:*** Buffer planting with Japanese tree lilacs, shrubs, and mulch in front of the Post Office; Buffer planting with low juniper groundcover; no buffer strip between the sidewalk and parking except for paint markings at Micknuck's Market.

Although there are minimal buffer areas between the existing sidewalk and Main Street, there are buffer areas on the back side of the sidewalk where several parking areas are located. Some of these are planted with deciduous shade trees such as red maple and ash as well as ornamental trees such as crabapples and Japanese tree lilacs, and underplanted with shrubs, perennials, and groundcover. Others are completely devoid of vegetation and are simply mulched. These buffer areas are the primary source of shade for pedestrians traversing the sidewalks, with the exception of shade cover from trees located on private property just behind the sidewalk. In a few locations, there is no vegetative separation between the sidewalk and adjacent parking areas.

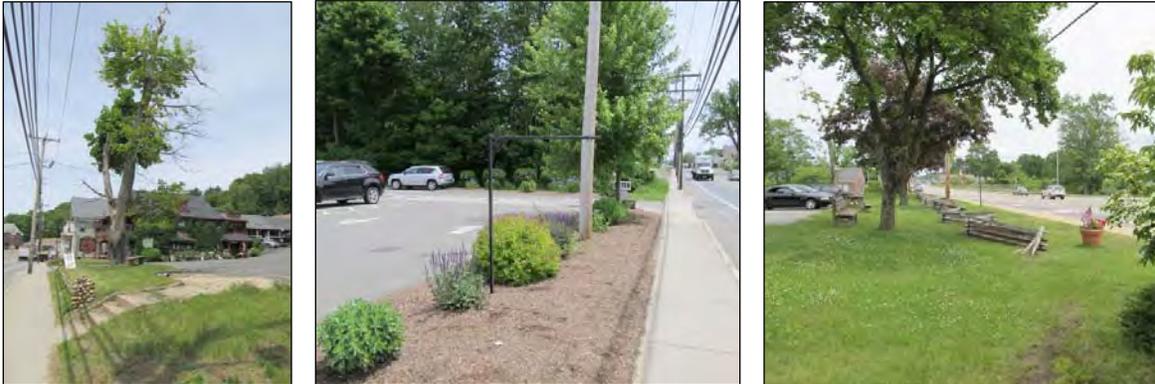
*Left to Right: Lawn buffer with low stone retaining wall and dying maple; Sparse buffer with trees, shrubs, perennials, and mulch; wide lawn buffer with shade trees, stacked rail fence and benches in front of the Tourist Center*

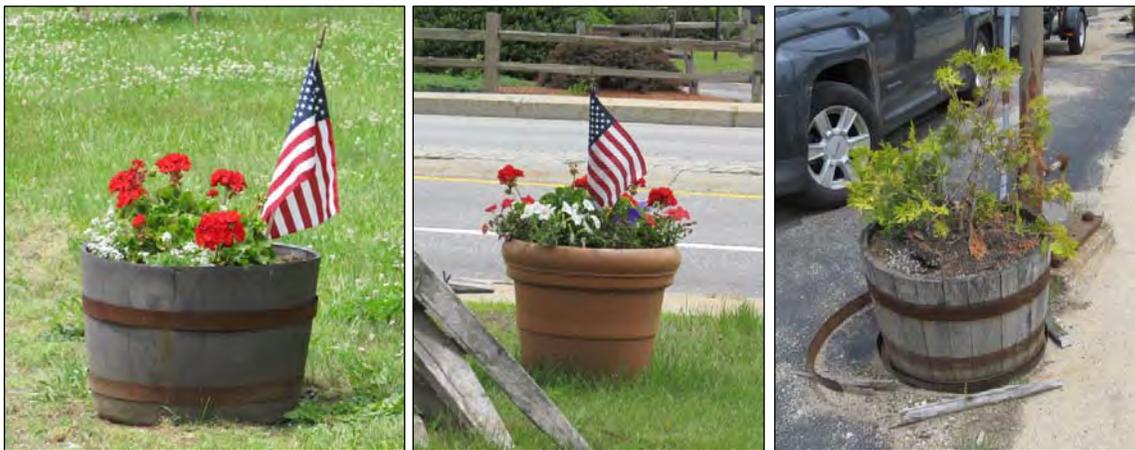
*Left to Right: Planted wood barrel with flowers at the corner of Main Street and Brookfield Road; Planted terra cotta pot with flowers in front of Centennial Park; Planted wood barrel in front of Georges Plaza in disrepair.*

In addition to planted buffers, wood barrels and occasional terra cotta pots planted with seasonal flowers are interspersed, albeit sparsely, throughout the District streetscape, particularly on public lands. These planters are seen at the northeast corner of the Main Street and Brookfield Road intersection, in front of the Senior Center, at Centennial Park, and in front of the Tourist Center at the corner of Burgess School Road. In front of Georges Plaza on the north side of Main Street in the eastern portion of the District are a few planted wood barrels that are in a state of disrepair.

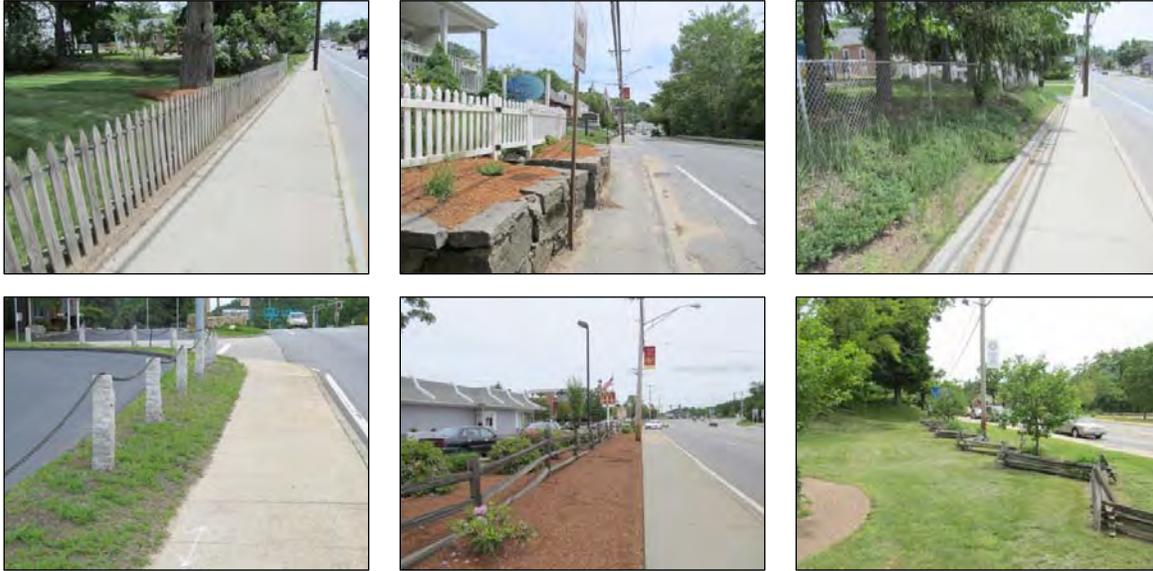
*Clockwise: Wood picket fence in front of the residence at 520 Main Street; White picket fence in front of Simple Indulgence Day Spa; Chain link fence and timber edge in front of Sturbridge Nursery School; Granite piers and chain in front of the Fairgrounds Antique Center; Split rail fence in front of McDonald's; and Stacked rail fence in front of Centennial Park.*

Additionally, there are a number of existing edge conditions used as either buffer treatments delineating between existing sidewalk and parking areas, as a separation between public sidewalk and private property, and as a retaining mechanism allowing for sidewalk space against the road. These edge conditions are diverse and prevalent, ranging from stone retaining walls, wood picket fences, stacked rail fences (also known as Battlefield, Snake, or Zig-Zag fences), split rail fences, granite piers with chain, and chain link fences.

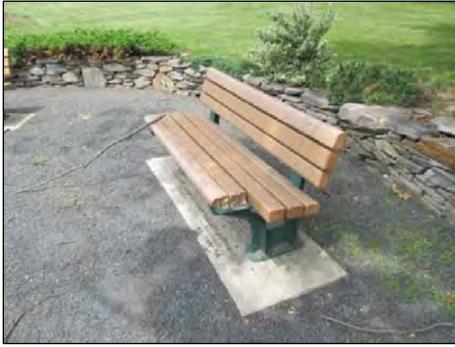
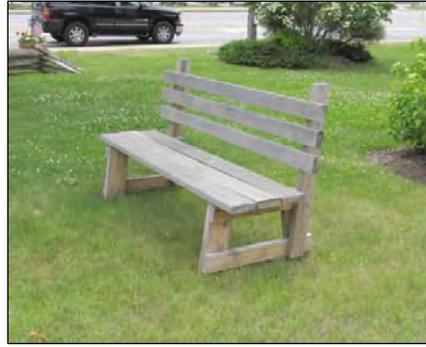
*Left to Right: Recycled plastic bench (damaged) in front of the Senior Center (similar to Centennial Park); Wood bench at the Tourist Center; Cobra-head roadway light on a utility pole with banner.*

Site amenities are scarce in the Commercial Tourist District. There are no benches or trash receptacles located within the immediate streetscape. In the adjacent parks are some small seating areas. Three recycled plastic benches are located in the small seating area at the Senior Center and two recycled plastic and metal benches are located at Centennial Park on the northeast corner of the Main Street and Cedar Street intersection. At the Tourist Center at the corner of Main Street and Burgess School Road are a few wood picnic tables and benches and granite block seats are located in the small park on the east side of the Sturbridge Marketplace. There are also no provisions for bicycle parking offered within the Commercial Tourist District. Without these amenities, the streetscape is geared more towards vehicular travel rather than pedestrian and cyclist access and experience. Furthermore, the site lighting within the District consists of typical roadway cobra-head fixtures attached to utility poles, thereby serving primarily the roadway with illumination of the sidewalk as a secondary benefit.

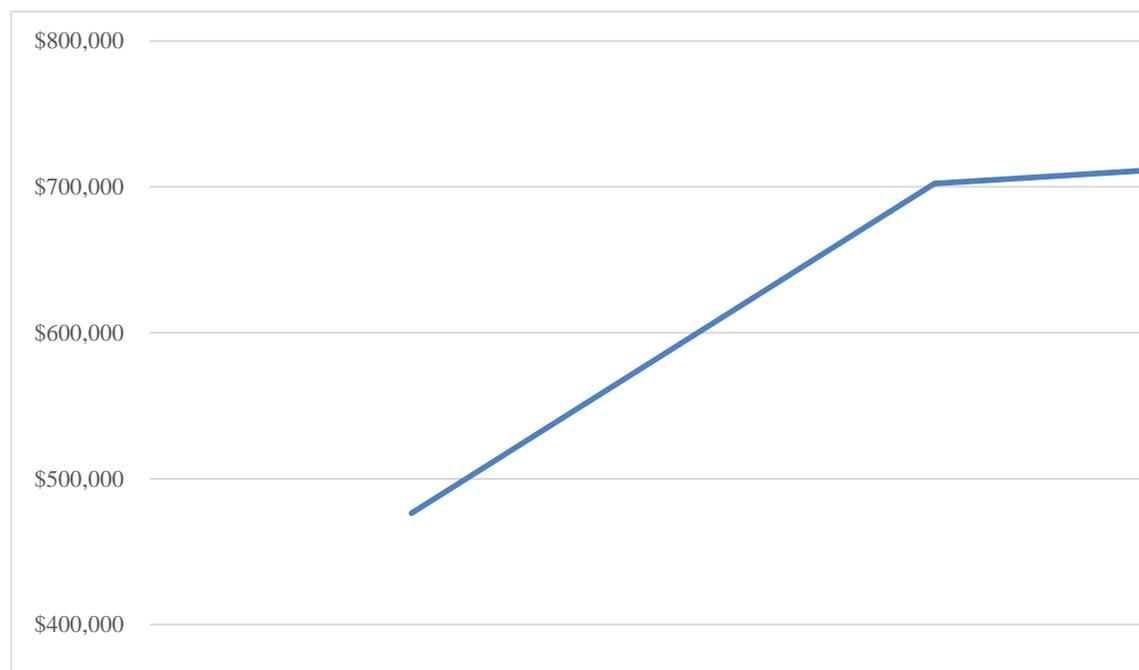
**Figure 19: Sturbridge Local Room & Meals Tax Revenue, 2010-2013**

Visitors also generate taxes paid to the Town of Sturbridge in the form of rooms and meals taxes. Sturbridge in 2010 adopted the local option meals tax, which now contributes to the Town's general fund. In FY2010, room taxes generated \$746,431 for Sturbridge and meals taxes generated \$112,181 (for the first six month period). In FY2013, revenues from rooms and meals taxes contributed over \$1 million to the Town. Figure x illustrates room and meals tax revenue generated in Sturbridge. It appears that these hospitality-related taxes are leveling in Sturbridge, however they are growing statewide. In a highly competitive market place for visitors discretionary time and dollars, Sturbridge appears to be a plateau, and in need of refreshment to be more competitive.

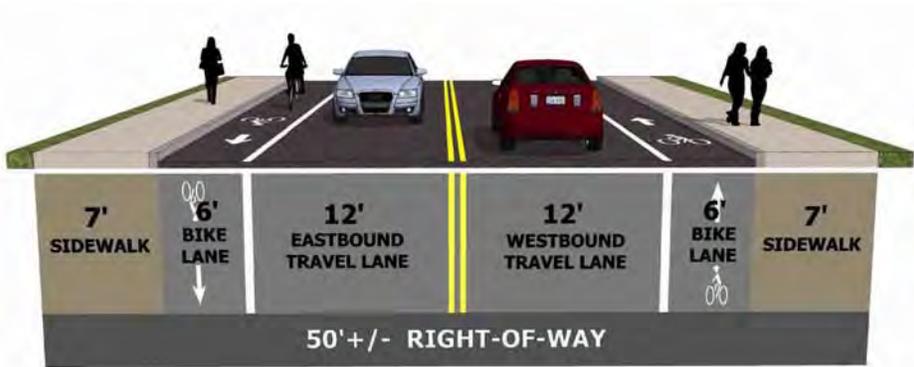
Alternative I would primarily consist of adding sidewalk to the southern side of Main Street (Route 20) and slightly widening the sidewalk on the northern side of the roadway. Six foot shoulders would remain, and could be striped as dedicated bike lanes. Pedestrian facilities throughout the Western Gateway would be improved with the addition of the sidewalk along the southern side of Main Street (Route 20) additionally; the widening of the sidewalk along the northern side of the roadway would minimize the existing ADA conflicts with the existing utility pole locations.

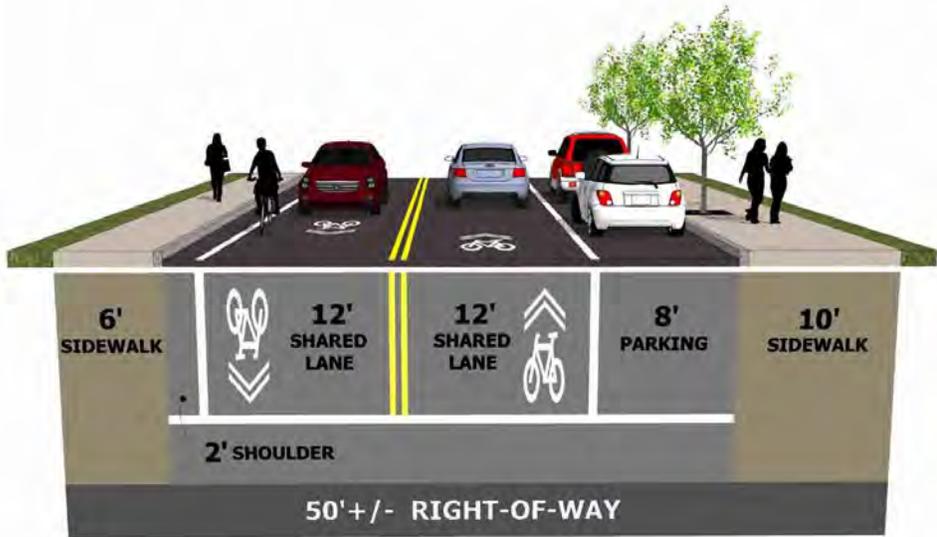
Under Alternative II, sidewalk would be added to the southern side of Main Street (Route 20), the existing sidewalk along the north side of Main Street (Route 20) would be widened to 10 feet, and an 8-foot wide parking lane would be added in the westbound direction. This alternative would provide a more inviting pedestrian environment with the addition and widening of sidewalks. The introduction of street parking may also reduce travel speeds, improving vehicle and pedestrian safety. Consequently bicyclists would not have a separated facility and would be encouraged to share the road with vehicles as “sharrows” would be placed in each travel lane.

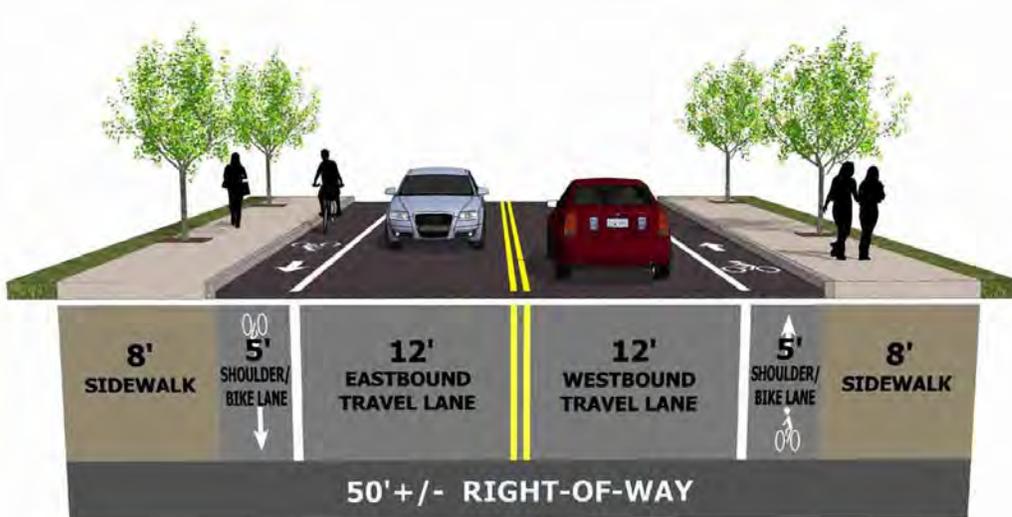
Under Alternative II, an 8-foot wide sidewalk would be added to the southern side of Main Street (Route 20), the existing sidewalk along the north side of Main Street (Route 20) would be widened to 8 feet. Each direction of travel would have a 12-foot wide travel lane and 5-foot wide bike lane. The 8-foot wide sidewalk on each side of the roadway would be accompanied by street trees placed on the outside of the sidewalk where appropriate. The placement of trees on the outside of the sidewalk allows the tree’s root systems to expand into the pervious material away from the roadway.

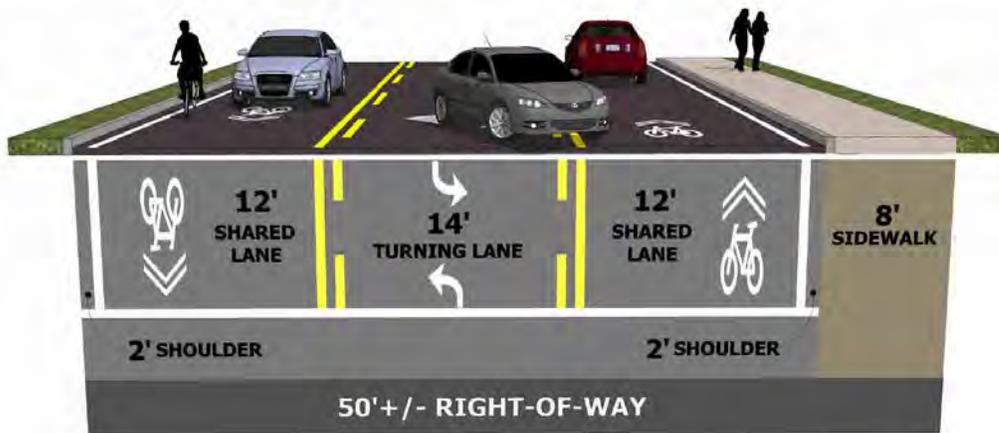
A Two-way-left-turn-lane (TWLTL) would be included in the Western Gateway under Alternative IV. The TWLTL would allow left turning vehicles on Main Street (Route 20) to queue within the TWLTL, minimizing the impact to through moving traffic. This would provide an advantage to vehicular traffic through the corridor. However, limited right-of-way would not allow for dedicated bicycle facilities and sidewalk along the southern side of the roadway.

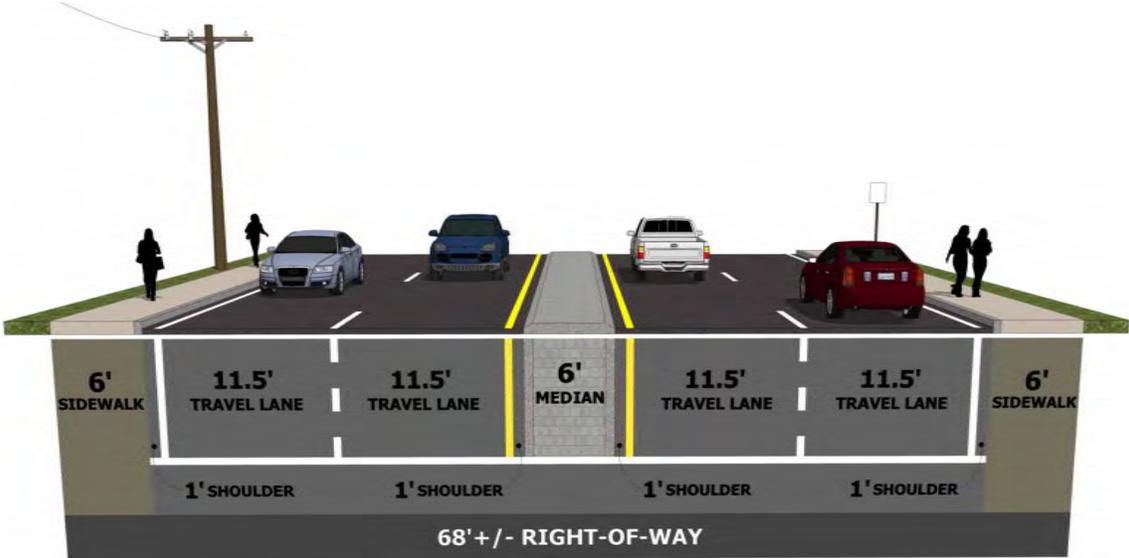
The existing cross-section of the Eastern Gateway fluctuates significantly throughout the approximately 0.75 mile long stretch of roadway. The existing cross-section shown in the above figure represents the minimal width of the cross-section extending from Cedar Street to Stallion Hill Road. East of Stallion Hill Road, the cross-section tends to widen as necessary to accommodate widening of the roadway for turning lanes and signalized intersections.

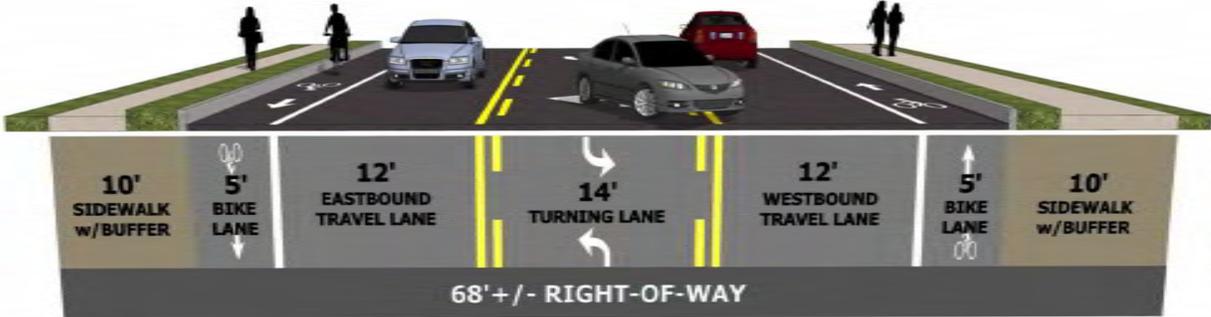
The first alternative that was considered was removal of the raised center median and center travel lanes and placement of a two-way-left-turn-lane (TWLTL). Implementation of this alternative would also allow for 5-foot wide bike lanes in each direction and wider sidewalks. This alternative would have the greatest benefit for pedestrian and bicycle transportation but would likely be difficult to implement for several reasons. Studies have shown that the . However, multiple lane approaches to each signalized intersection would likely be required to maintain acceptable level of service and traffic flow through the corridor. This would results in only minor portions of Main Street

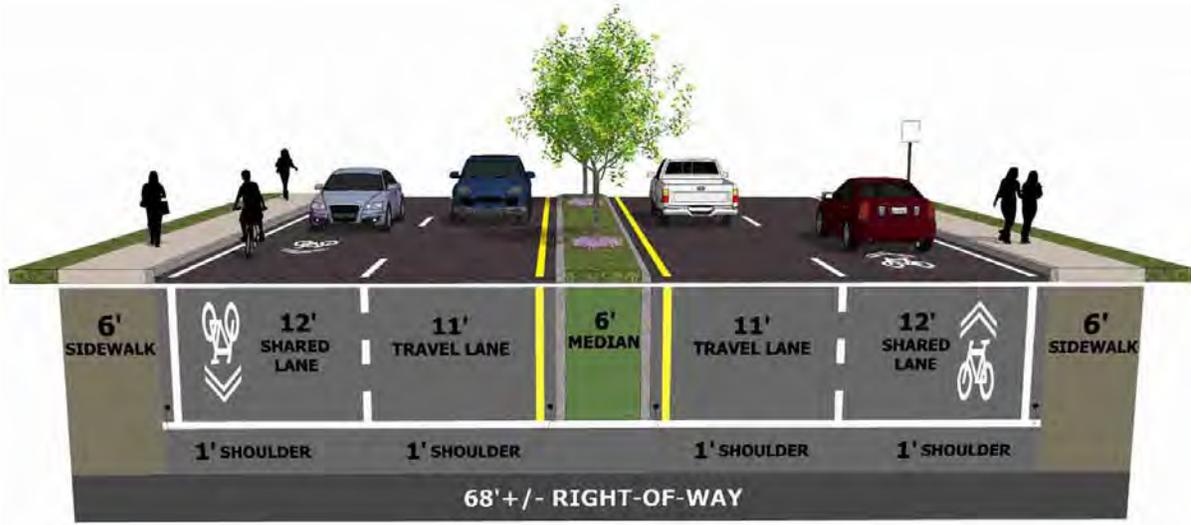
Alternative II would maintain the existing curb line of the Eastern Gateway and include primarily streetscape and striping improvements. The 6-foot wide sidewalks on both sides of the roadway would remain. The two 11.5-foot wide travel lanes in each direction would be reconfigured to an 11-foot wide inner travel lane and a 12-foot wide outer lane. The 12-foot wide outer lane would be accompanied by “sharrow” lane markings, providing a visual queue for drivers that bicycles are allowed full access of the travel lane. Alternative II would also include landscape improvements to the center median. The landscape improvements would consist of a combination of street trees and decorative pavers. Decorative lighting would also be included with the median with appropriate offsets between street trees and lamp posts.

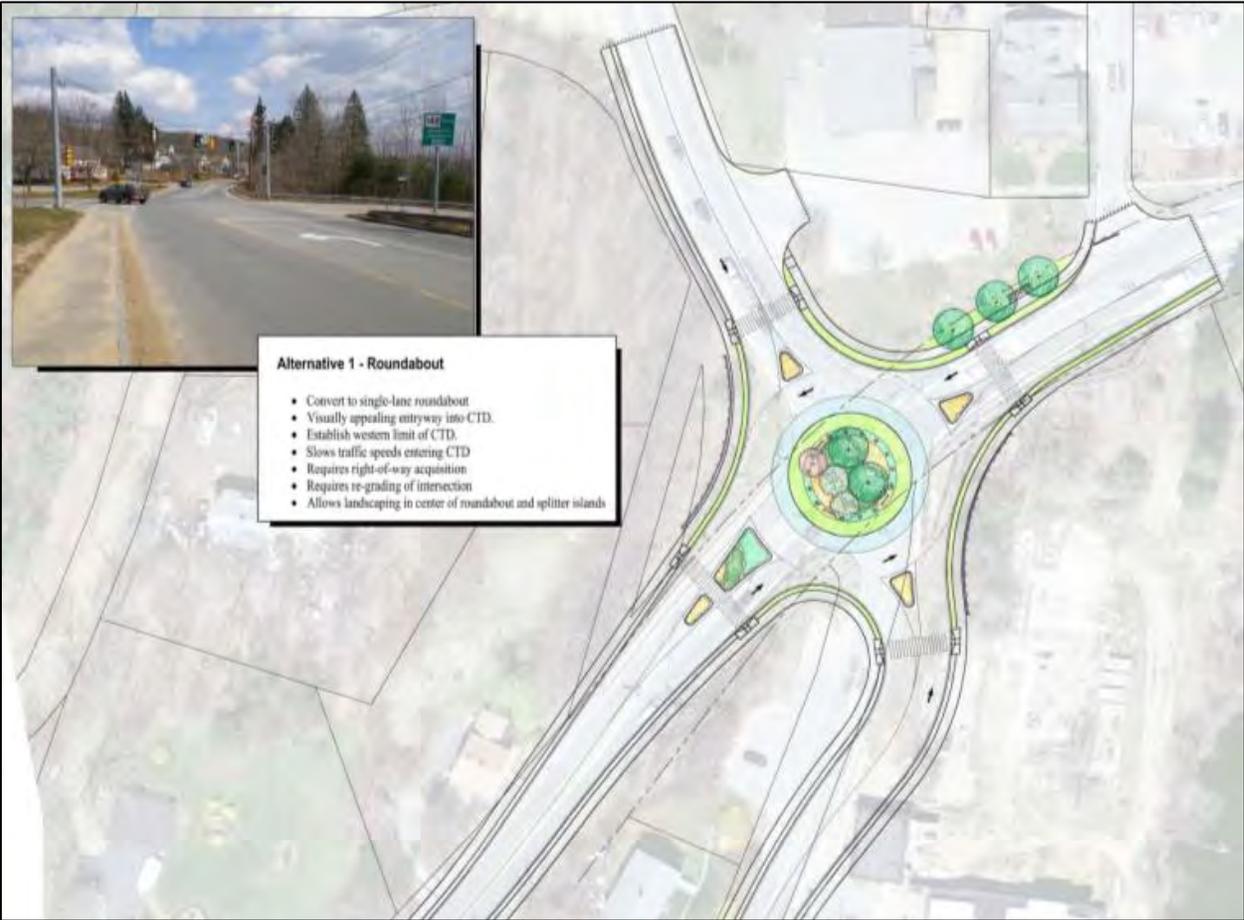
*Figure 28: Route 20 & Route 148 – Alternative 1 Roundabout*

Geometric improvements were considered at the intersection of Main Street (Route 20) and Brookfield road/Holland Road (Route 148) as part of the Sturbridge CTD study. Based on comments from the Working Group and feedback from Community Meeting I, the intersection was analyzed for conversion to a single lane roundabout. Conceptual plans for a roundabout at the intersection are shown in Figure XX.

The performance of the current intersection geometry and signal operation was compared to the performance under the roundabout alternative. The results are shown in Table 8.

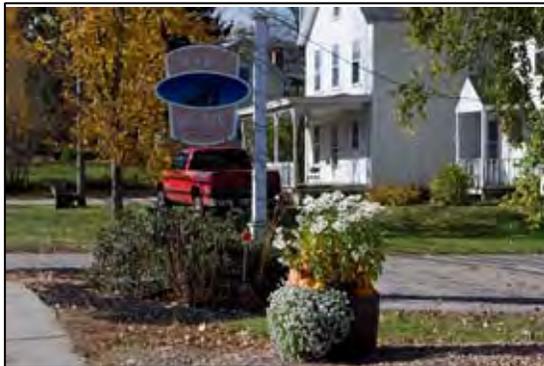
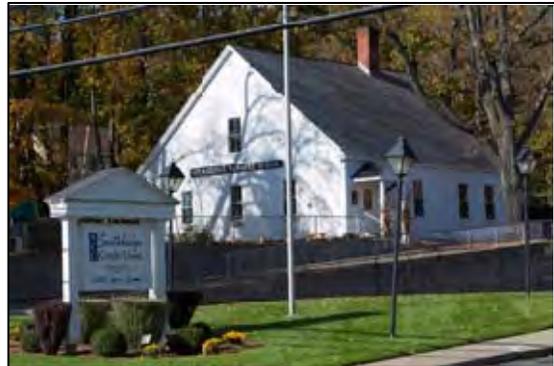
Some of the business signs are attractive and meet the traditional colonial style associated with Sturbridge as seen below in the photos. Other signs are unattractive, in poor condition, and not compliant with the latest Sturbridge Zoning Bylaws.

*Attractive signage within the Sturbridge CTD*
