**TOWN OF STURBRIDGE  
COMMERCIAL TOURIST DISTRICT  
IMPROVEMENT PLAN**

SUBMITTED APRIL 2, 2014

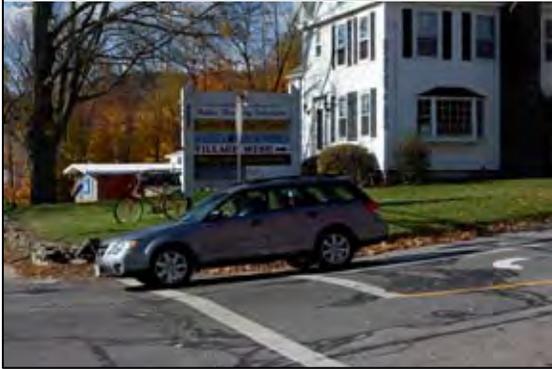
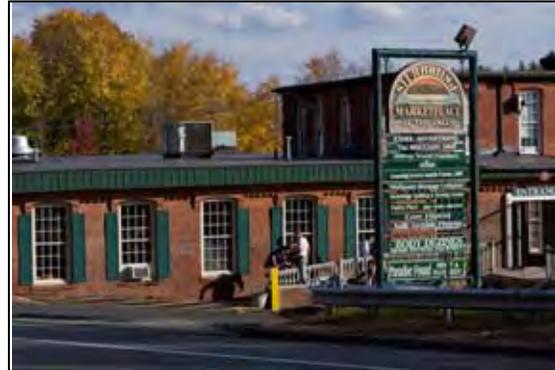
Many of the commercial properties within the CTD house multiple businesses. Multi-tenant commercial property signage generally consists of large signs with multiple placards, each with the name of a single business within the property. Some of the text on these signs is small and difficult to read. Others contain more information than can be grasped in a passing vehicle. Examples of multiple business signs are shown below.

*Signs with multiple businesses within the Sturbridge CTD*

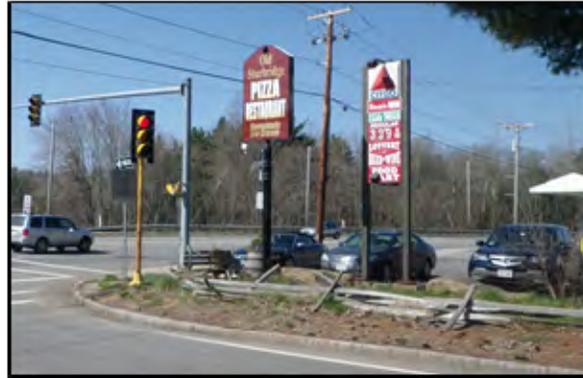
Several locations within the corridor experience sign clutter, in particular, the Eastern Gateway. Businesses along the northern side of the Eastern Gateway tend to have large scaled signage that dominates the landscape within the area. Some of the properties have multiple signs, adding to the clutter and confusion.

*Sign clutter in the Sturbridge CTD*

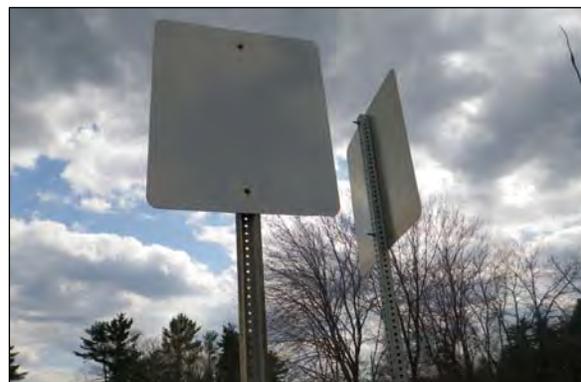
The photo to the right shows an image of a faded, illegible sign that should be removed or replaced. It is recommended that the Town coordinate with MassDOT to remove or replace traffic signs that are no longer legible or necessary.

*Illegible Signage within the Sturbridge CTD*

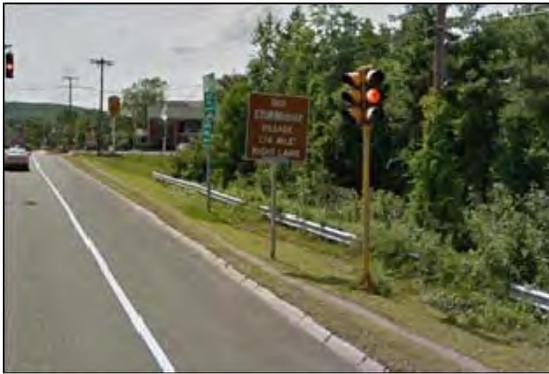
Westbound drivers are first met by a sign to OSV as they proceed through the intersection of Route 20 and Route 131. The sign is situated within the intersection and is lost among other guide and regulatory signs. Additionally, drivers traveling through this location are more likely to be viewing the traffic signal adjacent to the OSV sign rather than the OSV sign itself.

*OSV Signage at Route 131*

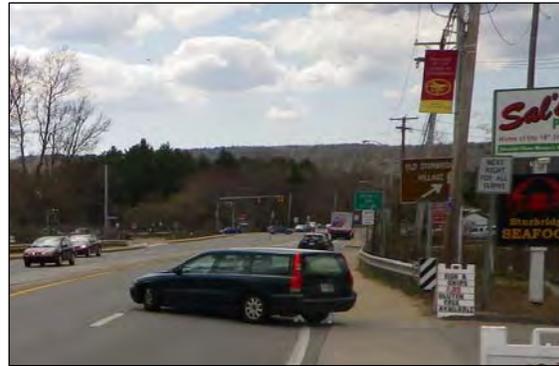
*OSV Signage approaching jug handle*

Westbound drivers are then directed to the right with an OSV sign approximately 200 feet east of the entrance to the jug handle at Stallion Hill Road. This sign gets lost in the adjacent business signage.

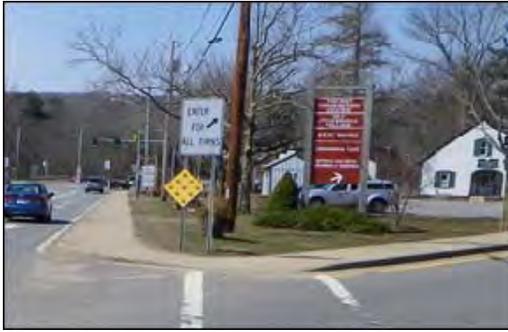
An informational sign is located at the entrance to the jug handle with placards reading “Tourist Information Center” and “Old Sturbridge Village”. The text on the sign is small and difficult to read. Additionally the sign is situated away from the roadway.

*Tourism signage at jug handle*

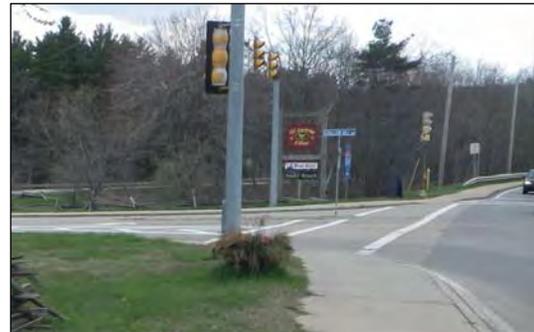
Finally, there is sign for OSV on the southwest corner of the Route 20/Stallion Hill Road intersection. This sign is noticeable for eastbound drivers approaching OSV, however, it serves no directional purpose for westbound drivers. Westbound drivers must enter OSV from the jug handle and do not see this sign until they are traveling through the intersection having already committed to entering Stallion Hill Road.

*OSV Signage at Stallion Hill Road*

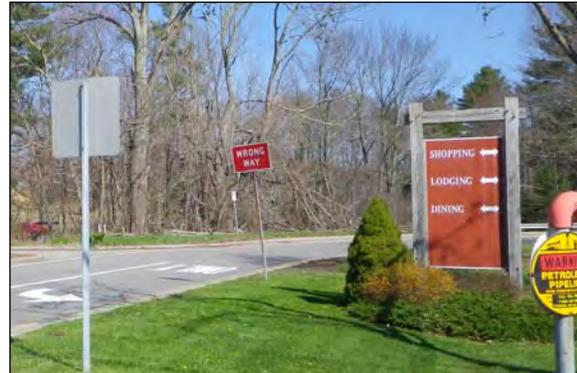
*Tourism signage at Visitor's Center*

Additional tourism related signage is limited throughout the corridor. An existing sign on the Visitor's Center property directs drivers exiting Stallion Hill Road to shopping, lodging, and dining. However, the sign is set back approximately 50 feet from the roadway and is difficult to see. Its location is also not viewable for the majority of traffic in the area travelling along Route 20.

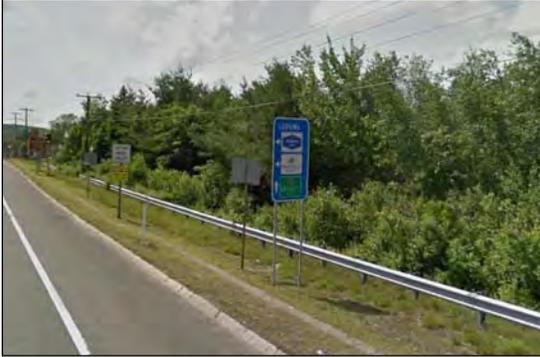
Other tourist and lodging directional information is located on the westbound approach to Route 131. The information is provided on standard service related highway signing with blue backgrounds. This signage is shown below.

*Lodging informational signage*

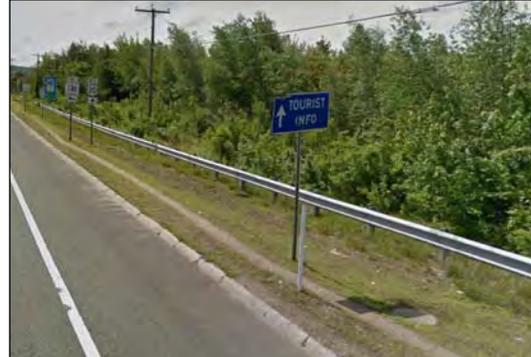
*Tourist informational signage*

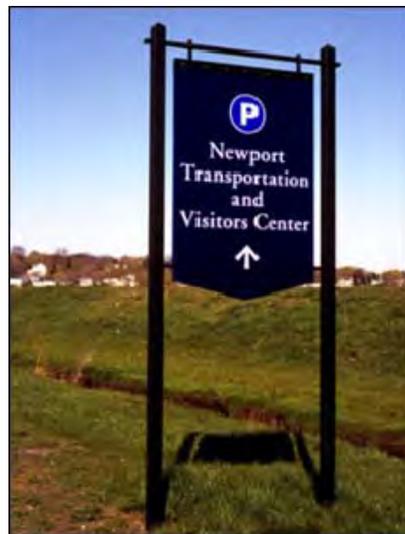
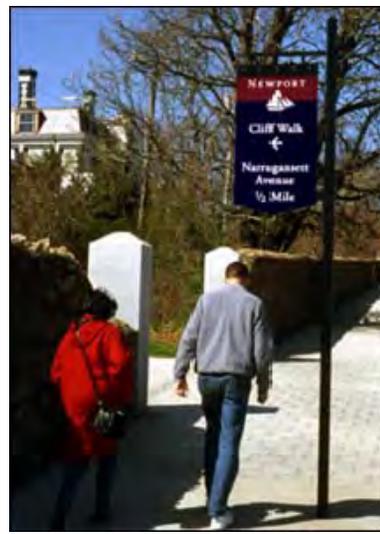
There are many examples of district specific wayfinding signage from other tourism oriented communities. Examples from Newport, Rhode Island, and Salem Massachusetts and shown below.

*Tourism oriented wayfinding, Newport, RI (Source: Roll Barresi & Associates)*

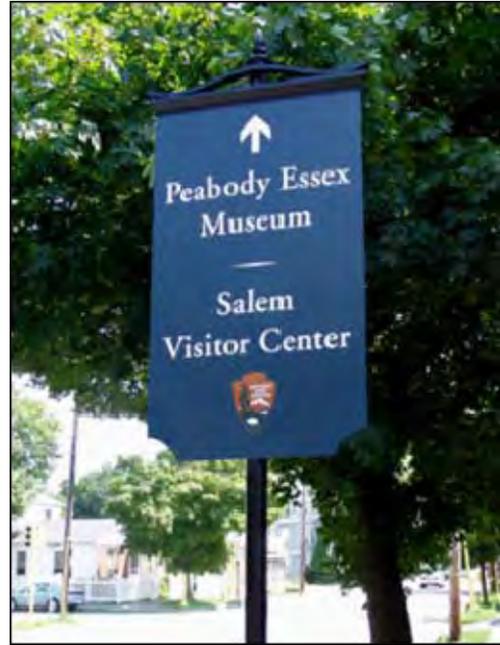
*Tourism oriented wayfinding, Salem, MA (Source: Roll Barresi & Associates)*

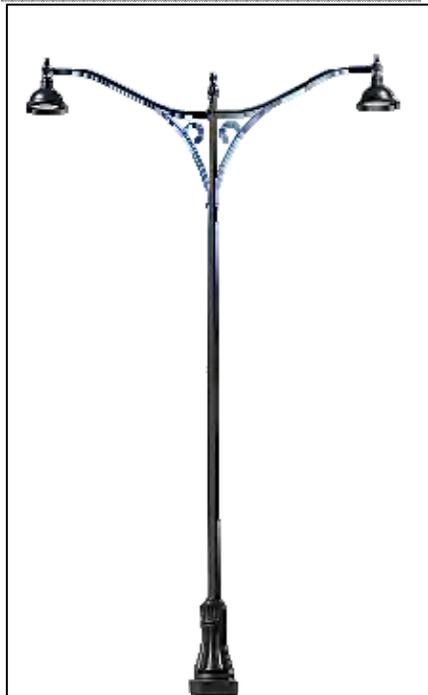
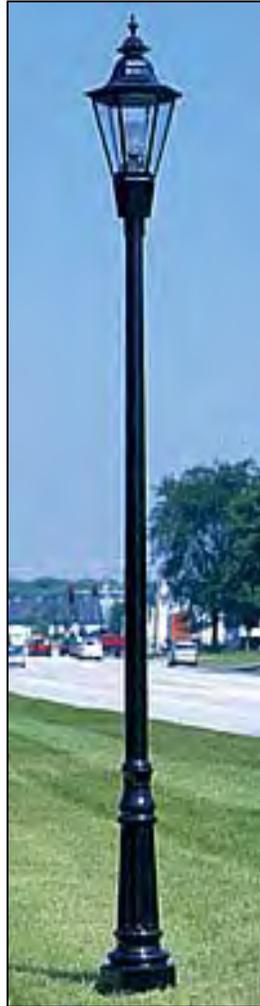
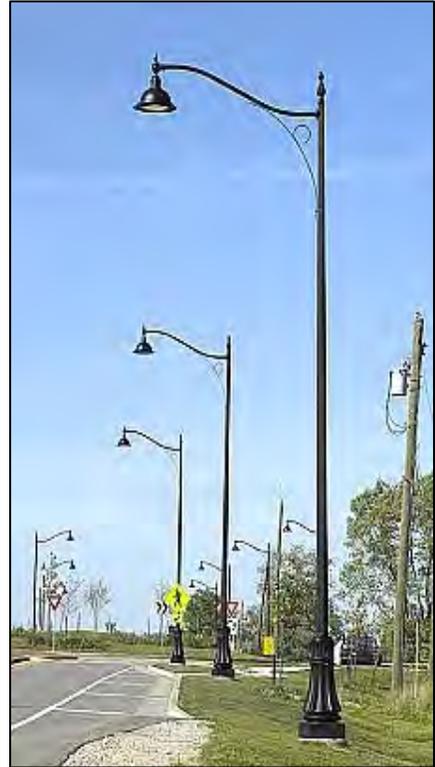
Because the overhead wires and utility poles have such a significant impact on one side of the street, we recommend installing ornamental roadway lights on the side of the street with no utility poles, and then supplementing with pedestrian scale lights on the opposite side of the street and where necessary for improved illumination. Images of the proposed lights are below.

*Proposed  
Ornamental Lights*

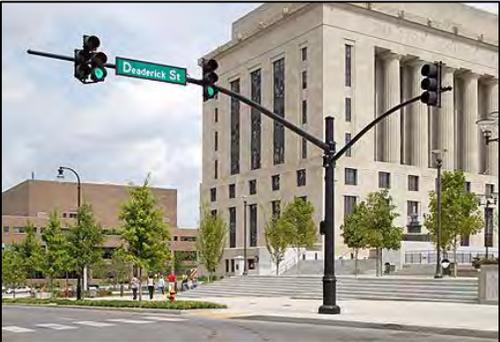
*Ornamental Traffic Signals,  
Pedestrian and Roadway  
Lights, and Landscaping*

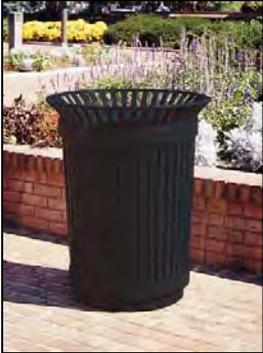
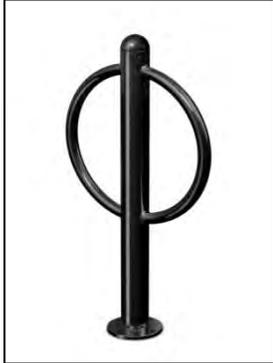
*Trash Receptacle  
And  
Bicycle Parking Post*
