# TOWN OF STURBRIDGE

## SENIOR CENTER PROGRAM

Issued: July 5, 2017

THE TOWN OF STURBRIDGE MASSACHUSETTS

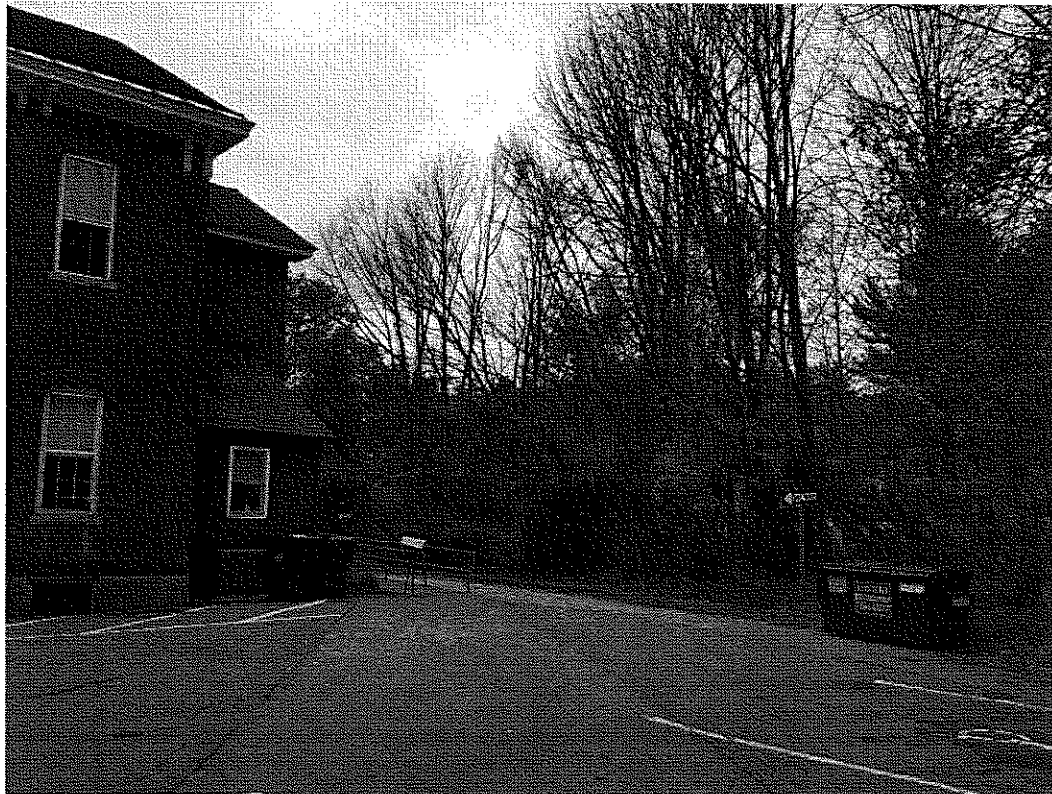
- Site circulation is challenging during winter conditions at the pitched driveway entrance to the Senior Center off of Arnold Road.
- The exit from Arnold Road onto busy state road Route 20 is also challenging especially when crossing traffic to make a left turn to east Route 20.
- The parking lot surface is sloped and the asphalt is deteriorated resulting in surfaces that are uneven and rutted creating a hazardous walking surface.
- Accessible parking spaces are not well oriented to the accessible building entrance. Striping and signage should be upgraded.
- Parking for larger delivery and passenger vans is not well accommodated.
- The number of present parking spaces is inadequate. Striping and signage should be upgraded.
- There is a lack of space for outdoor activities including walking paths.
- Sloping grades are not conducive to activities such as picnics and concerts.

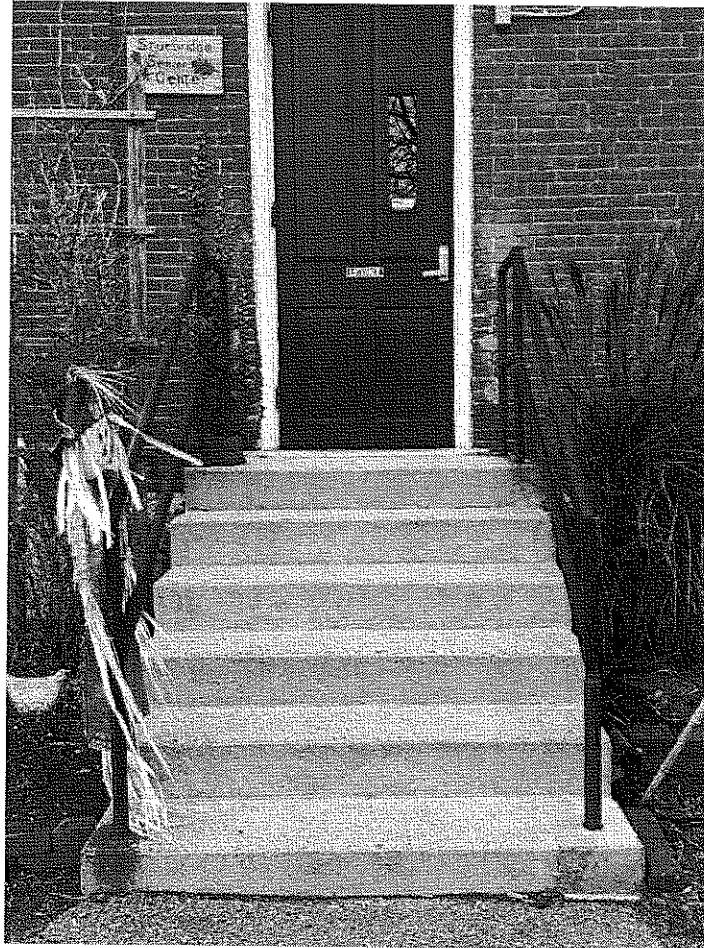
- The front entrance facing on Main Street has a short steep flight of concrete steps with a small landing which restricts the space for a person to stand on the landing and simultaneously open the out-swinging door safely. A person exiting the building in this location may not be aware of someone standing within the limited landing space on the opposite side of the door.
- There is no covered drop off/pick up entry point.
- Windows are single pane and in need of repair and energy efficiency measures.
- A new asphalt shingle roof was installed in 2016.

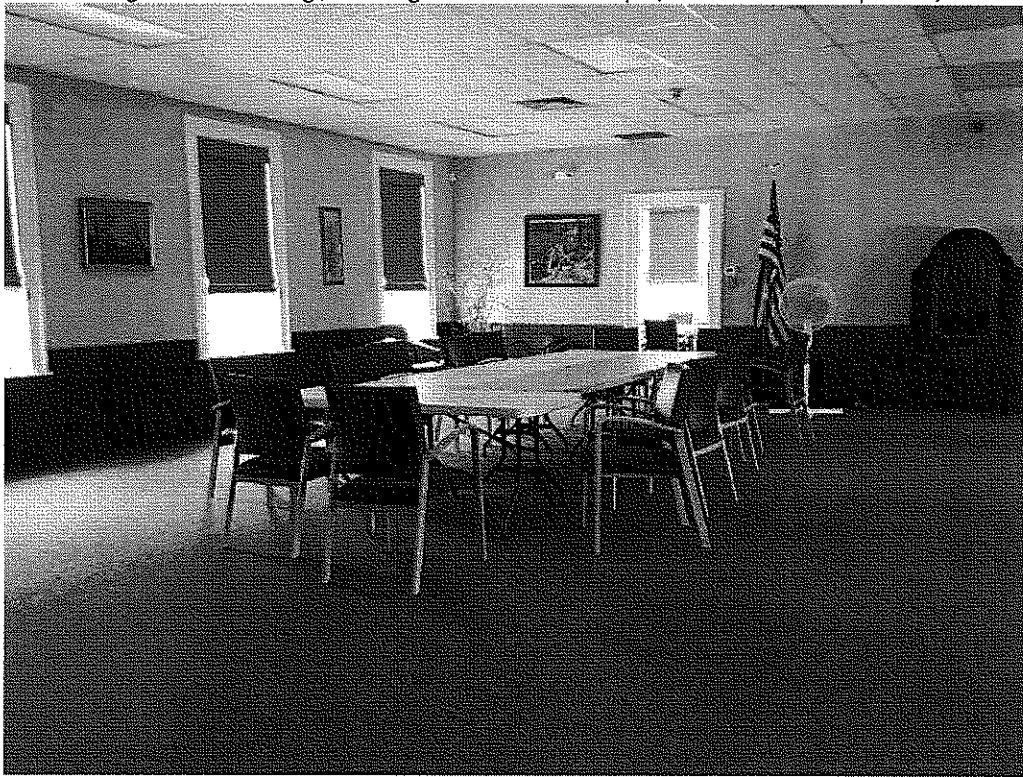
The main room on the second floor serves as a large meeting room and exercise room. Furniture must be moved to accommodate a variety of programs.

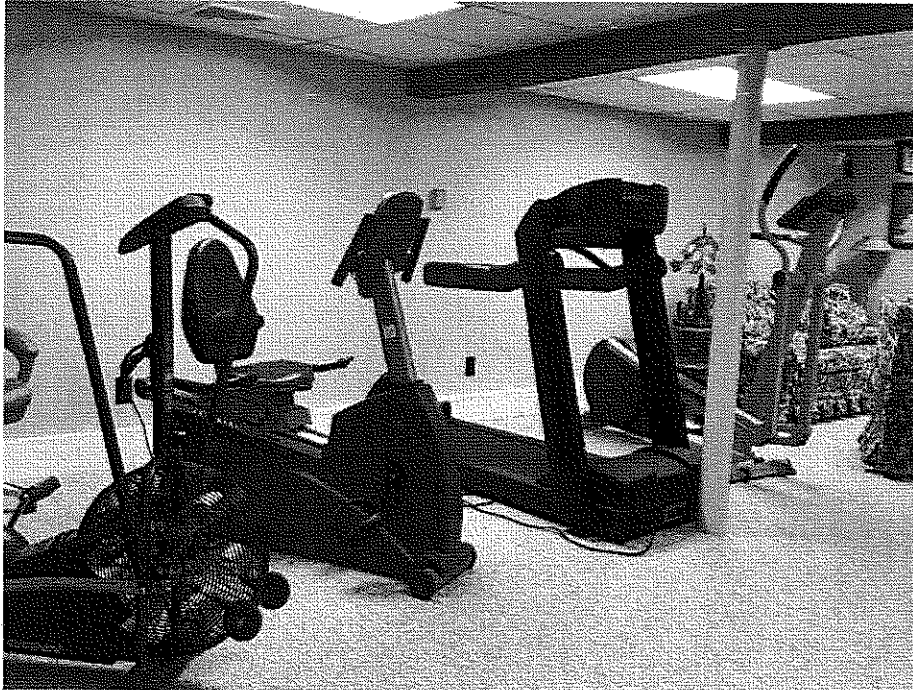
The Workout area in the basement shares space with the Library and Game area.

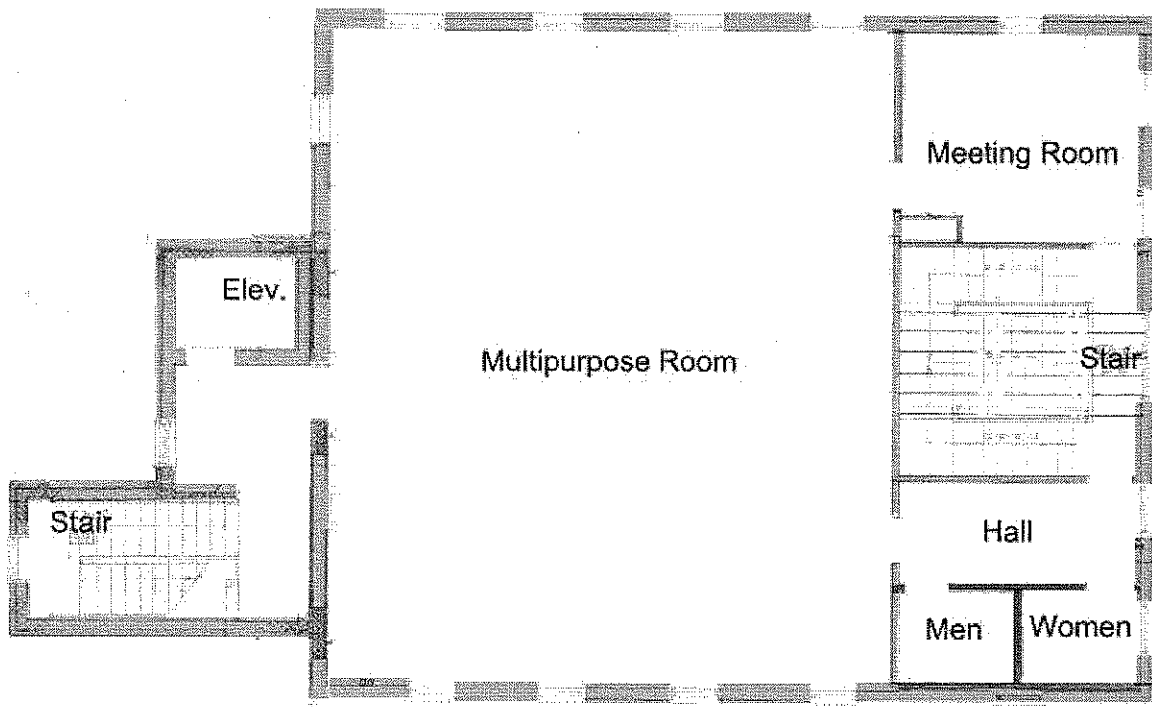
Existing Second Floor Plan

With a few exceptions, the main room of the second floor remains in its original configuration as a public meeting space. Second floor spaces are accessed by way of the 1998 elevator tower / stair addition and by the monumental central staircase at the front of the building. The historic monumental stair has been approved as a second means of egress although it is not fully compliant with current building code requirements. The Multipurpose room is reasonably sized to meet the space needs of most programs that utilize it. The room is reserved for a wide variety of exercise programs including Silver Sneakers, Yoga, and Tai Chi as well as for educational programs including lectures and films. There is no storage associated with the room which presents a challenge for staff to move furniture up and down the elevator in order to prepare for the next activity.

The Meeting Room fills an important role as it provides gathering space for small groups involved in language learning, skill development, small classes and committee use. It is a well-used room that would benefit users by being enlarged, incorporating storage, and being adjacent to other semi-private uses. Access through the Multi-purpose room is distracting and disruptive to users of that space and inconvenient for users of the Meeting Room. Single user toilet rooms are inadequate for the number of users of the second floor.

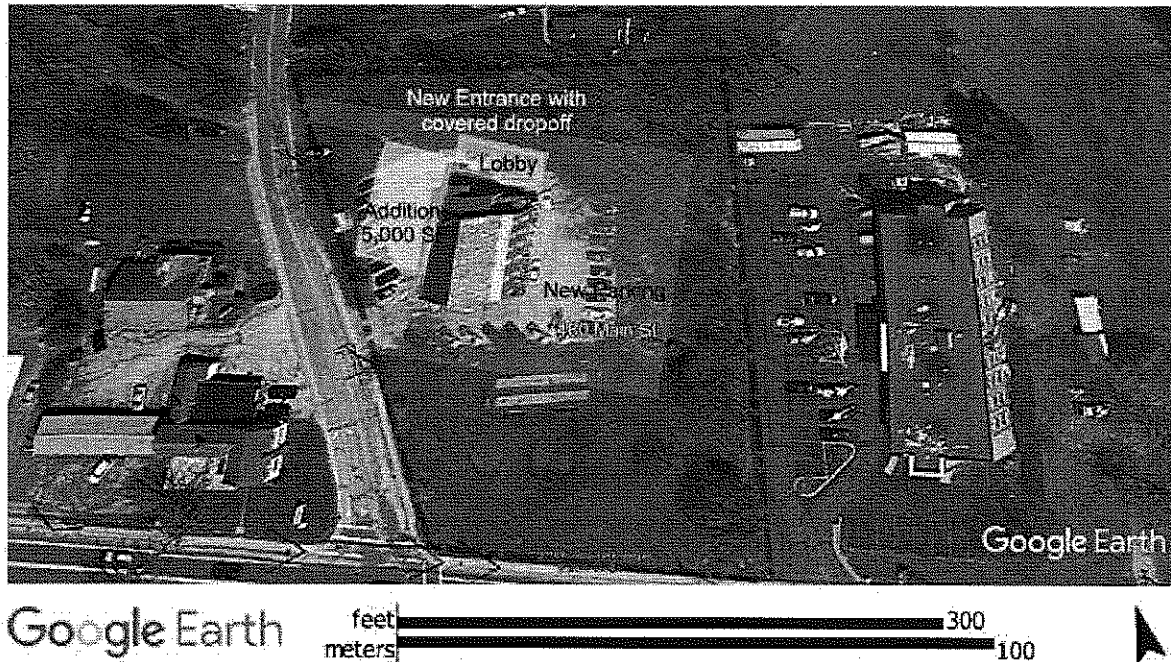
According to the Town of Sturbridge Assessor's records, the lot acreage at 480 Main Street is 0.78 acres. The site slopes gently from the high point at the Senior Center building to Route 20 to the south, and more gently to the adjacent hotel building to the east. Given the slope, the front yard is not usable for outdoor gatherings as are desired in the facility program. New site circulation and parking could be accommodated along with an addition that would address future space needs if the landscape is altered with terracing and other means of providing flat planes.
