# TOWN OF STURBRIDGE

## DEPARTMENT OF PUBLIC WORKS PROGRAM

Issued: August 29, 2017

## EXISTING CONDITIONS SURVEY

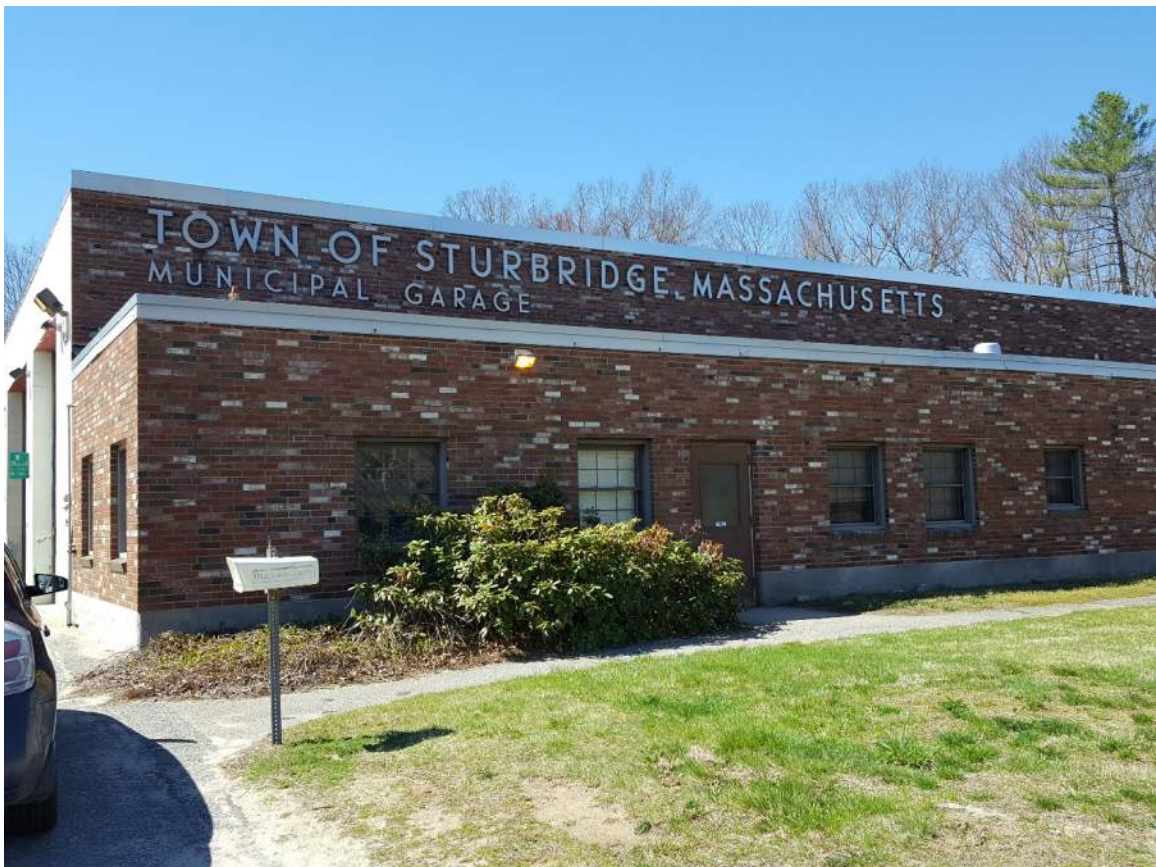
Figure 2: The main building on the site houses DPW administration, maintenance and storage bays. The public entrance is in the center of the photograph.

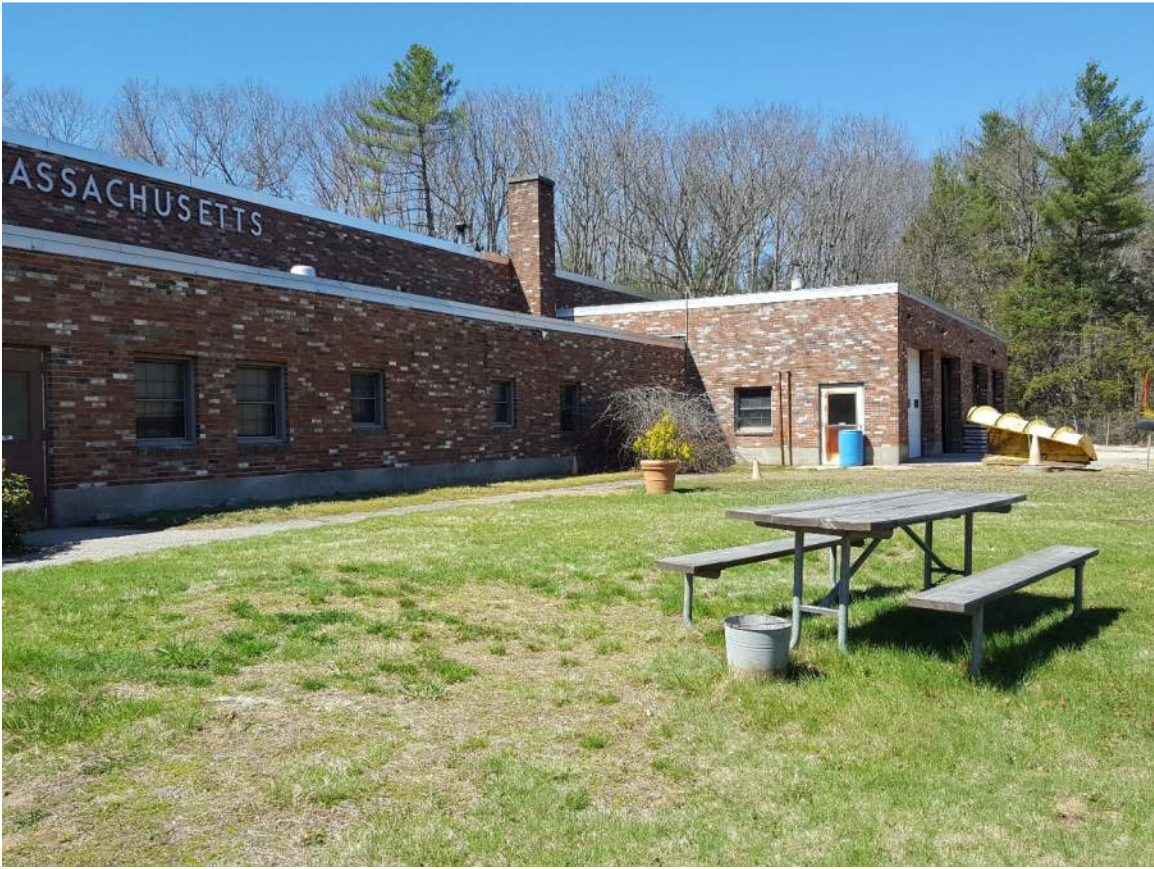
Figure 3: Equipment storage bays form the end of the administration wing.

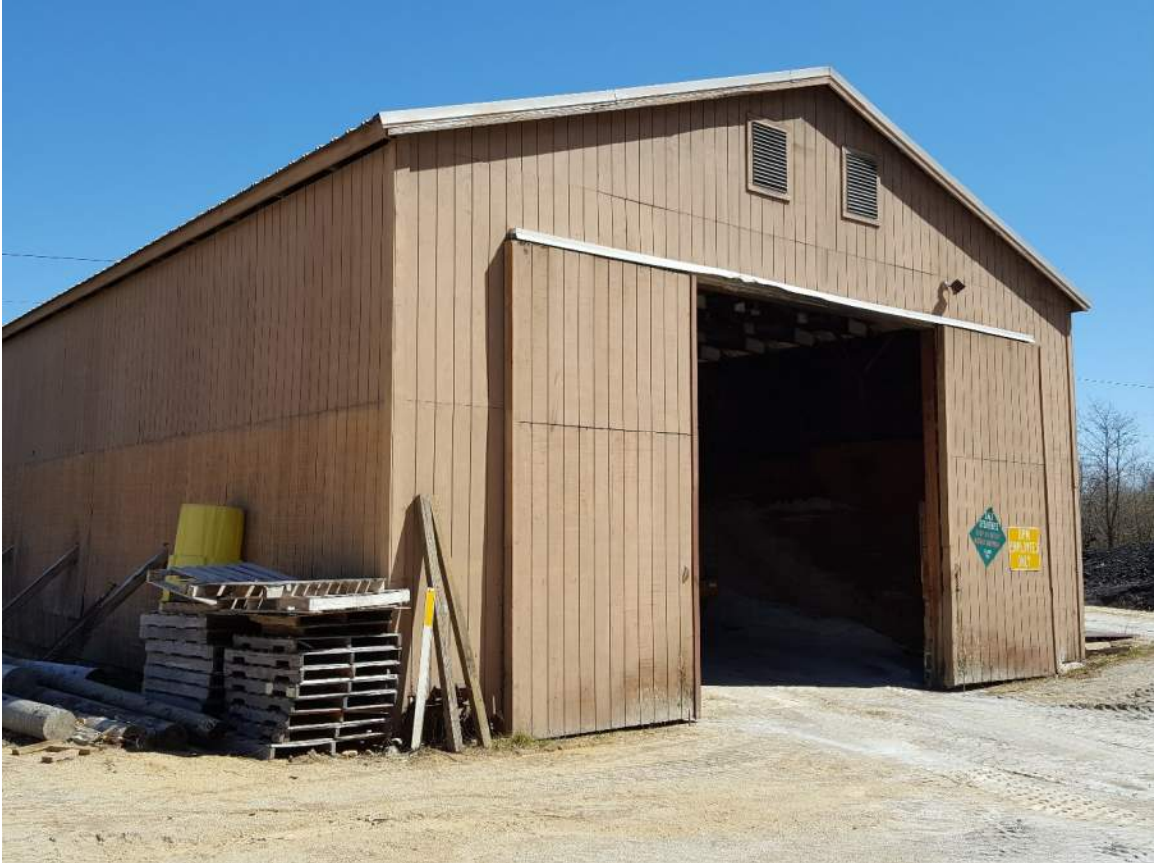
Figure 4: The Salt Shed houses salt and loading equipment. Sand is stockpiled adjacent to the shed.

- A dedicated paint room/spray booth should be provided including adequate ventilation.
- The forty year old Salt Shed does protect the material within. A new drive thru salt and sand (or mix) shed should be considered for future efficiency of loading operations under cover.

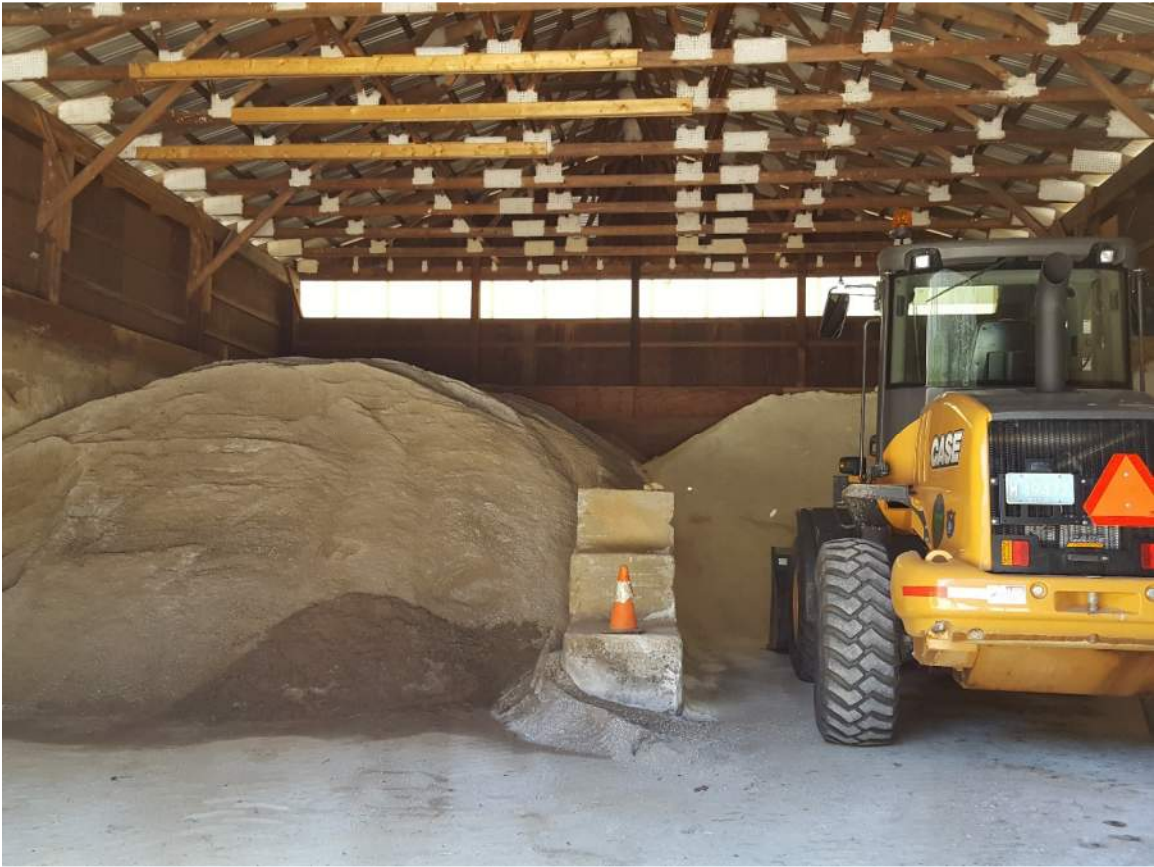
Figure 5: Forty year old Salt Shed interior bays house material and equipment.

Recommended square footages represent an increase of 36% for enclosed storage and administrative functions. The Salt Shed will need to be replaced in the next 10 years due to its age. A state-of-the-art shed that protects material and equipment would be warranted. Construction of shed-roof exterior storage areas is best practice to cover equipment stored outside.

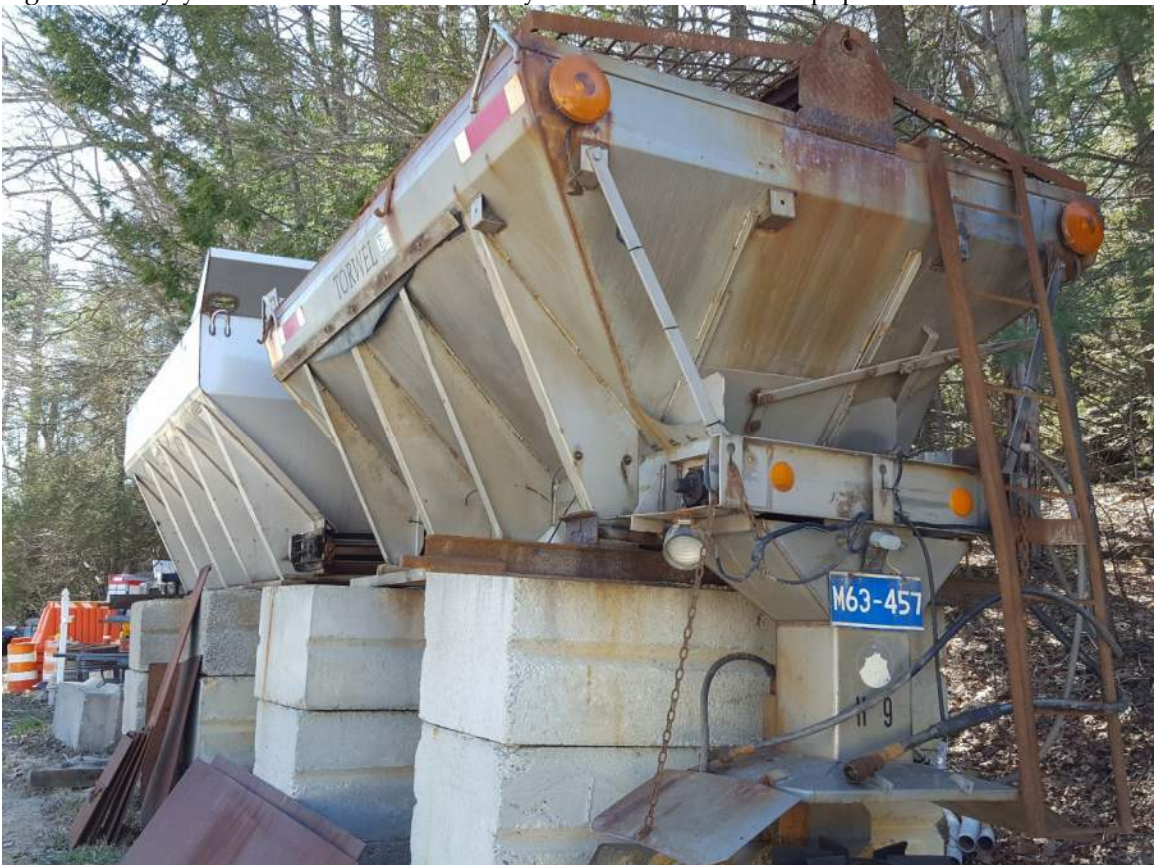
Figure 6: Sanding equipment is stored in the open near the Salt Shed and sand pile.

- There is no covered storage for equipment such as salt hoppers, plows, trailers and other items which would benefit from being protected from the elements.

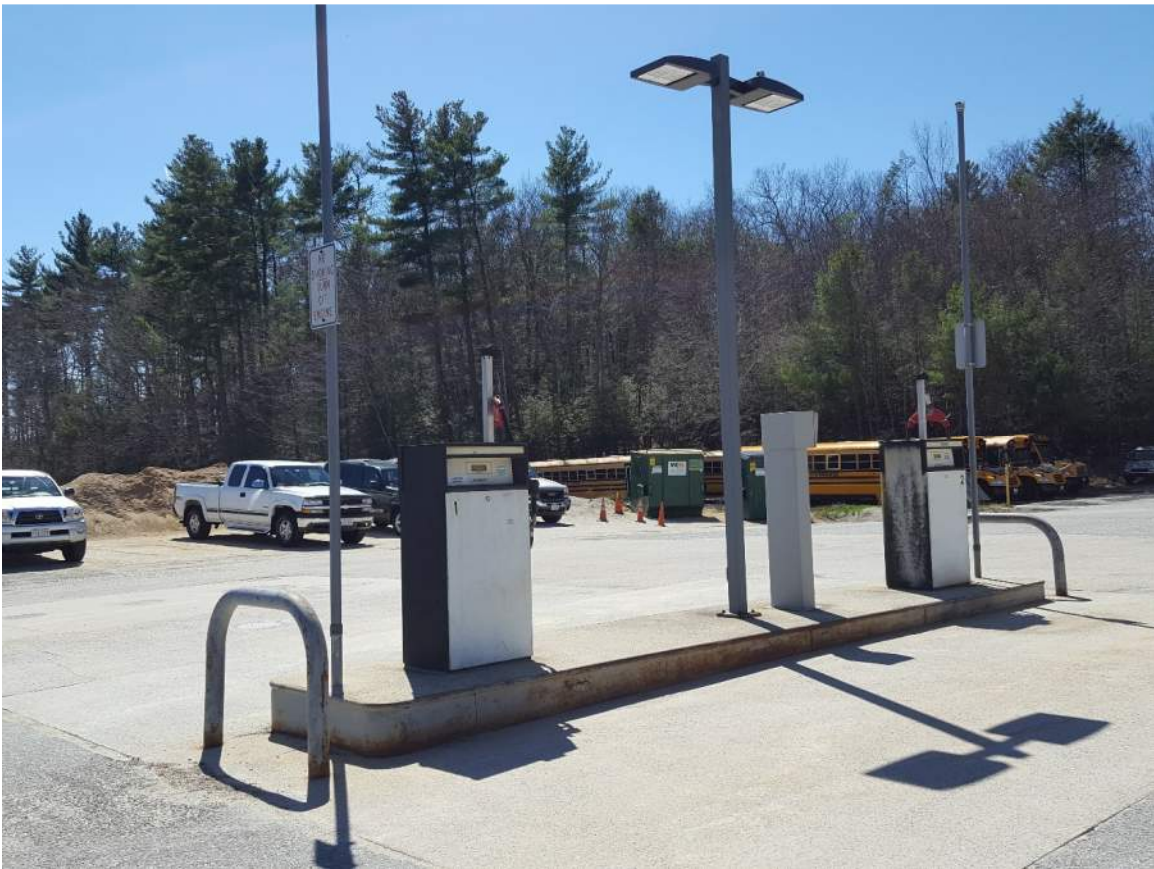
Strategically located in the geographic center of the Town of Sturbridge, the Department of Public Works facility is sited on just over 14 acres of land which it shares with the Water Pollution Control facility and the Dog Pound. The DPW portion of the site contains a wide variety of uses. The main building, constructed in 1970, incorporates administrative offices, vehicle maintenance, and vehicle and equipment storage uses. Additional equipment is stored, uncovered, around the property. Earthwork materials such as loam, sand and gravel are stored in designated areas. In addition, a salt shed provides cover for road salt and winter mix. While adequate to cover the material, sanding trucks must be loaded in the open. Another area of the site provides storage for concrete drainage structures and drainage pipe. In addition, there is a fueling facility consisting of underground fiberglass coated steel storage tanks, replaced in 1997, housing 8,000 gallons of gasoline and 10,000 gallons of diesel fuel. The tanks have a life span of 30 to 40 years,

but the pumps are now 20 years old and should be upgraded. The Sturbridge dog pound is also located in the northwest corner of the site.

Figure 7: The existing fueling island is in good repair although dispensers will need to be replaced.

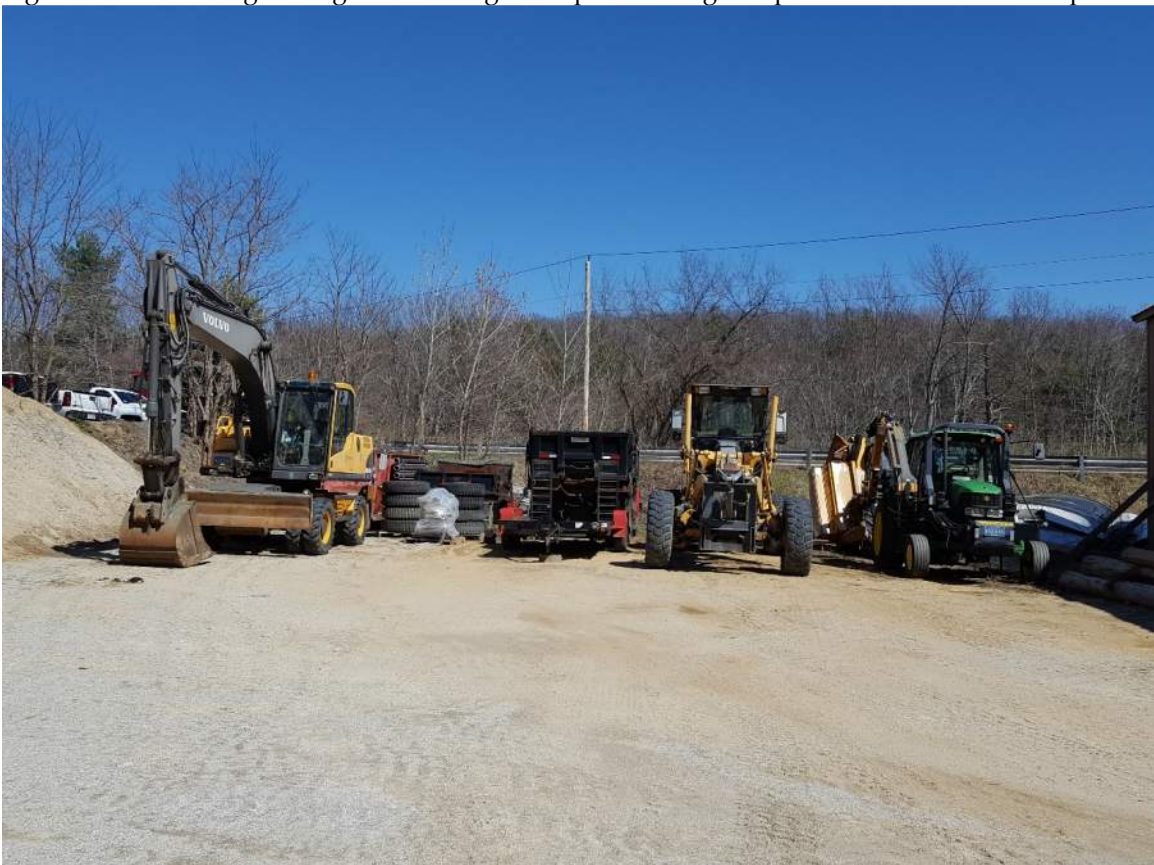
Figure 8: Seasonal equipment is stored in an open area adjacent to the Salt Shed.

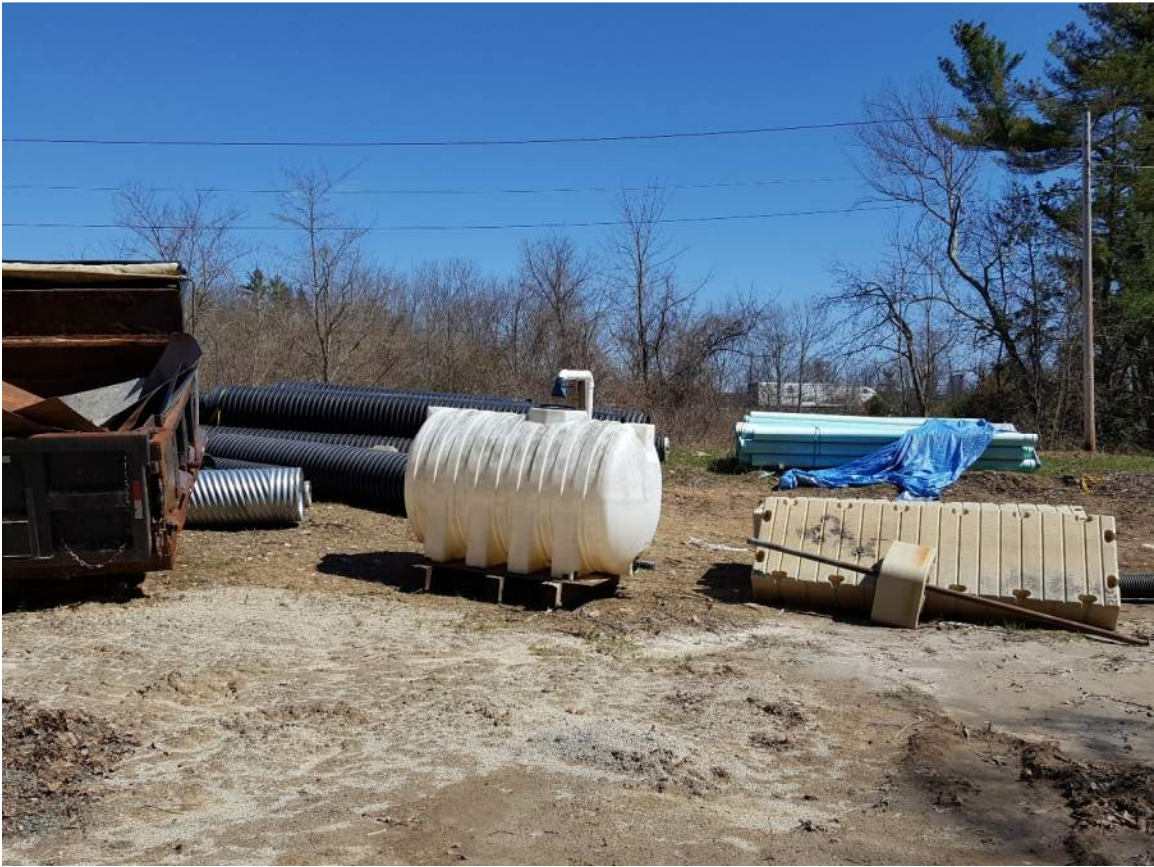
Figure 9: The area south of the Salt Shed is used for storage of drainage structures and conduit.

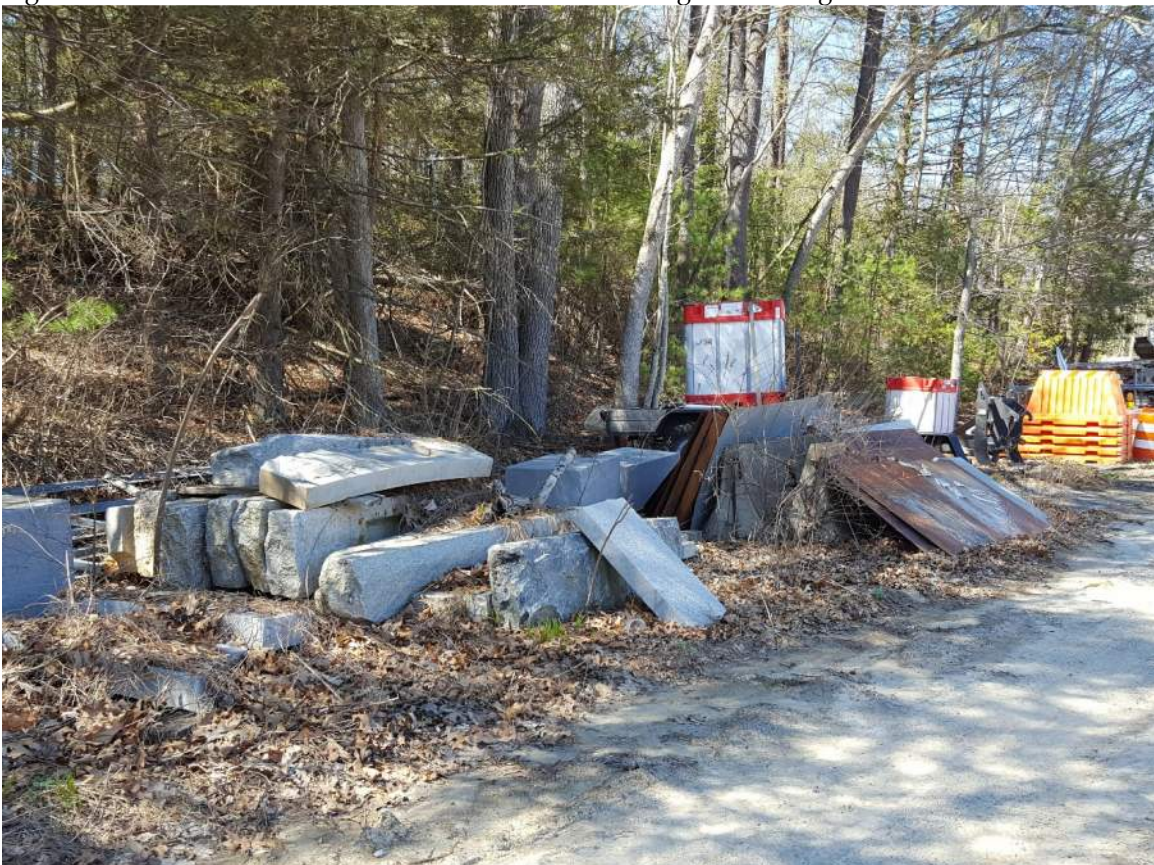
Figure 10: Areas for stockpiling of various roadway materials line the interior access roads.

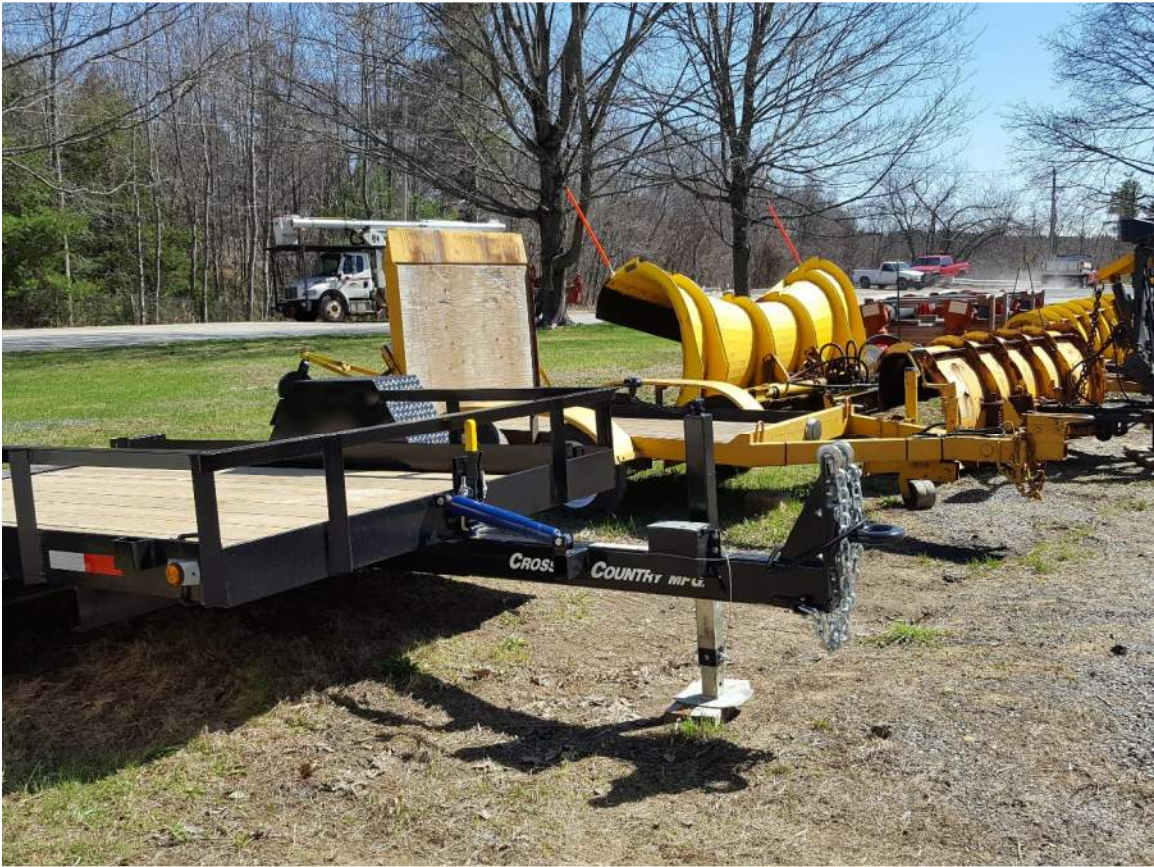
Figure 11: Plows, trailers and other equipment are stored around the perimeter of the building.

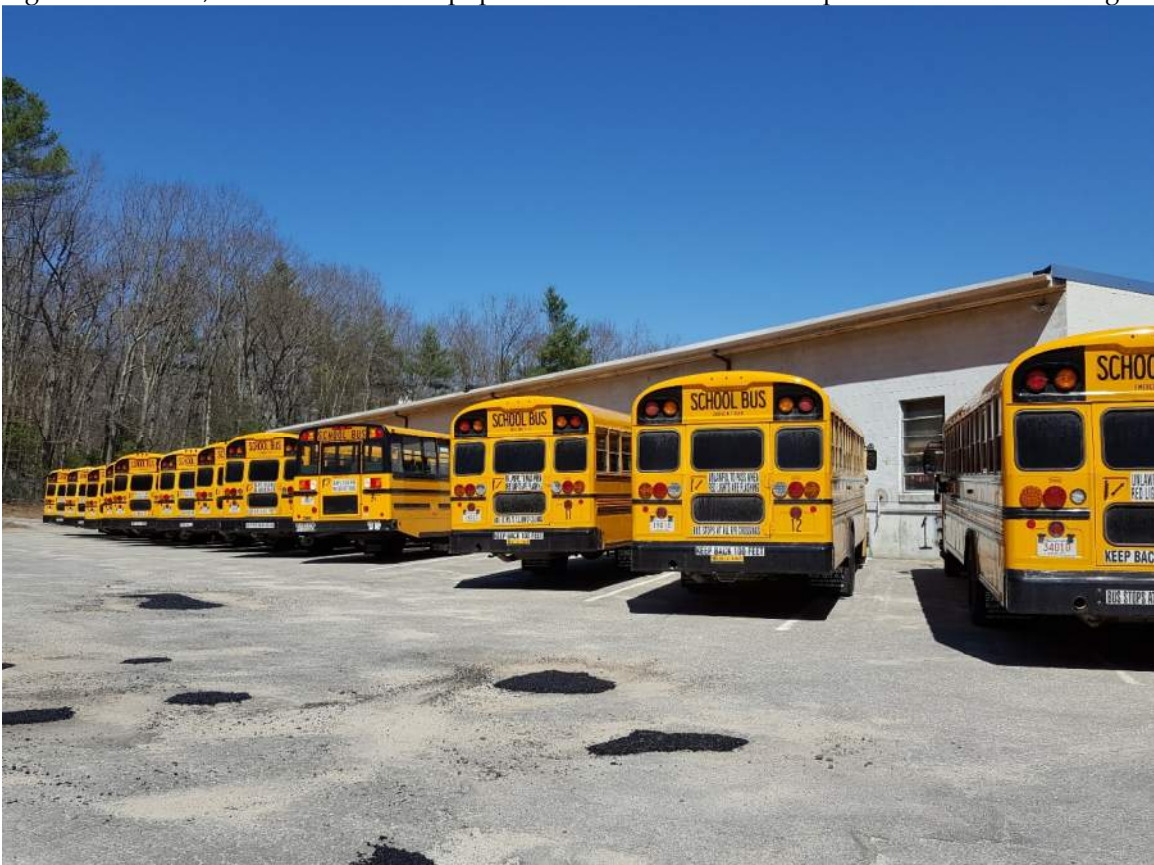
Figure 12: The Town owned school busses are stored and dispatched at the DPW site.

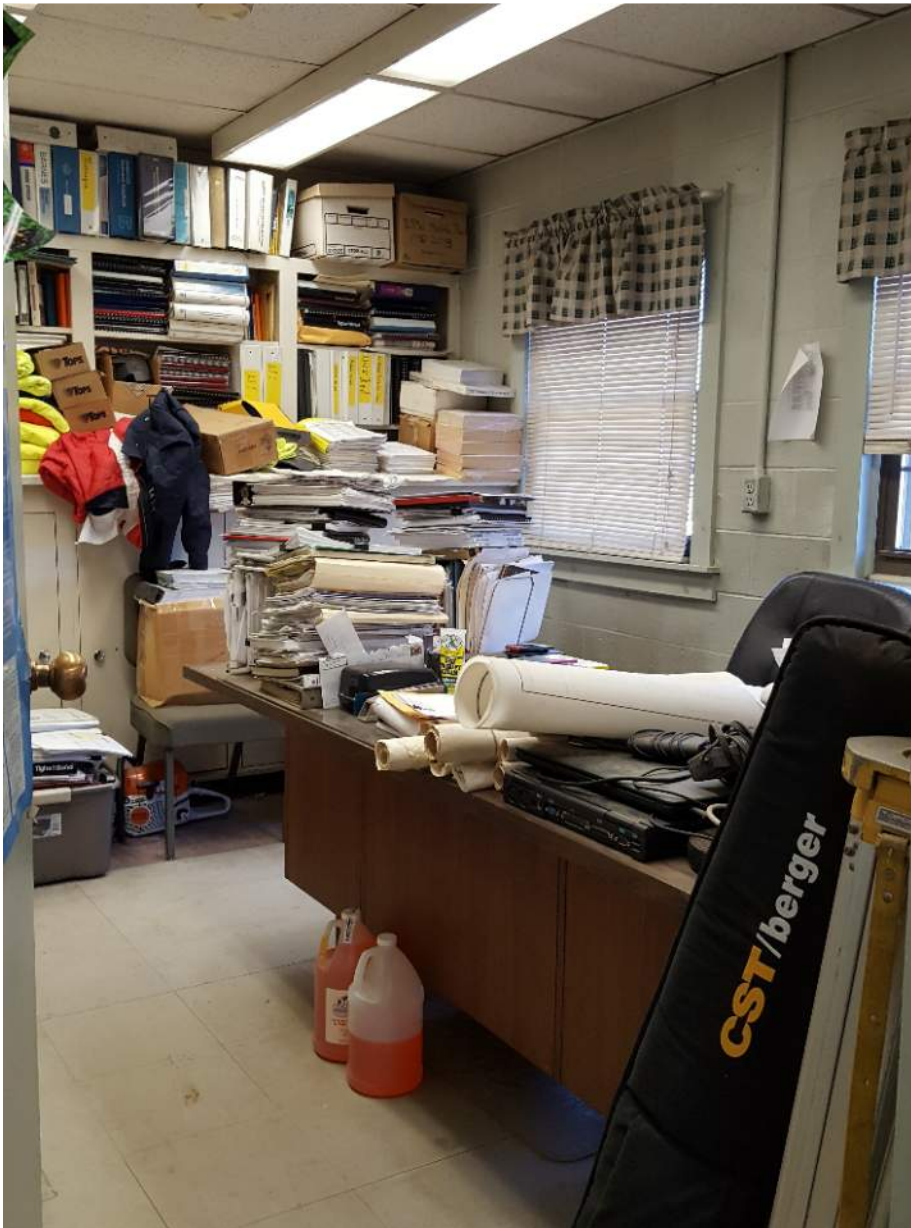
- The DPW Director's Office is overcrowded with items that should be moved to a dedicated storage room. There is no room for private conferencing regarding personnel issues.
- The Administrative Assistant shares the Reception/Waiting Room which is publically accessible. This arrangement provides no privacy or security for administrative personnel.
- Storage area for office supplies, equipment, manuals, records, drawings, etc. is inadequate. Some supplies are stored in the shower stall of the men's toilet room.
- Toilet rooms presently serve a single occupant. With a potential occupant load of 33 persons including DPW personnel and bus drivers, more toilet facilities are warranted.

Figure 11: The Director's Office is crowded with records for which there is no space elsewhere.

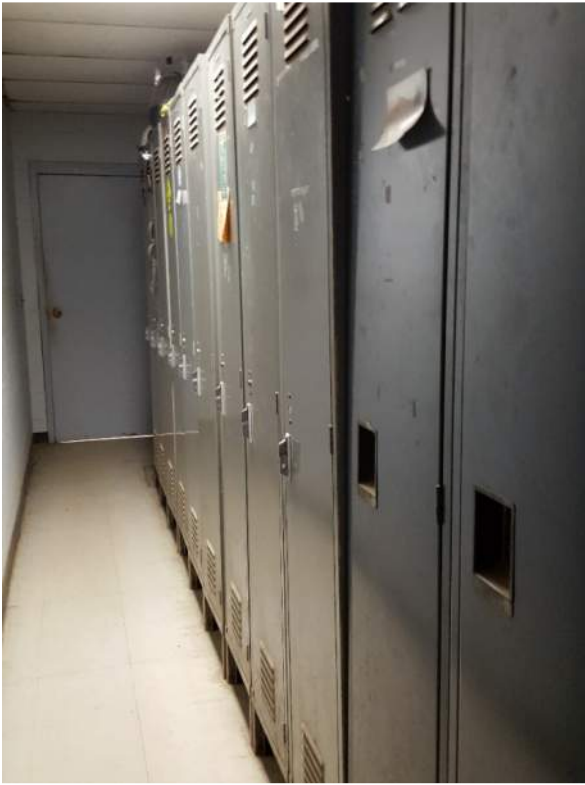
- There are no locker or changing rooms. Some lockers are currently housed in the main corridor of the administrative area while others line the wall in the women's toilet room further limiting access to this room.
- The Break Room is very small, accommodating 6 people at a table if it is pulled away from the wall, with minimal kitchen facilities and no day room area.
- There are no conference facilities. Conferencing takes place in the Break Room which is not private and provides limited seating or training tools.
- The Administration area is not ADA compliant. While the public may not utilize this area on a regular basis, employees requiring universal accessibility would not be accommodated.

Figure 13: The width of the main Corridor in the Administrative area is impeded by lockers creating building code and ADA compliance issues.

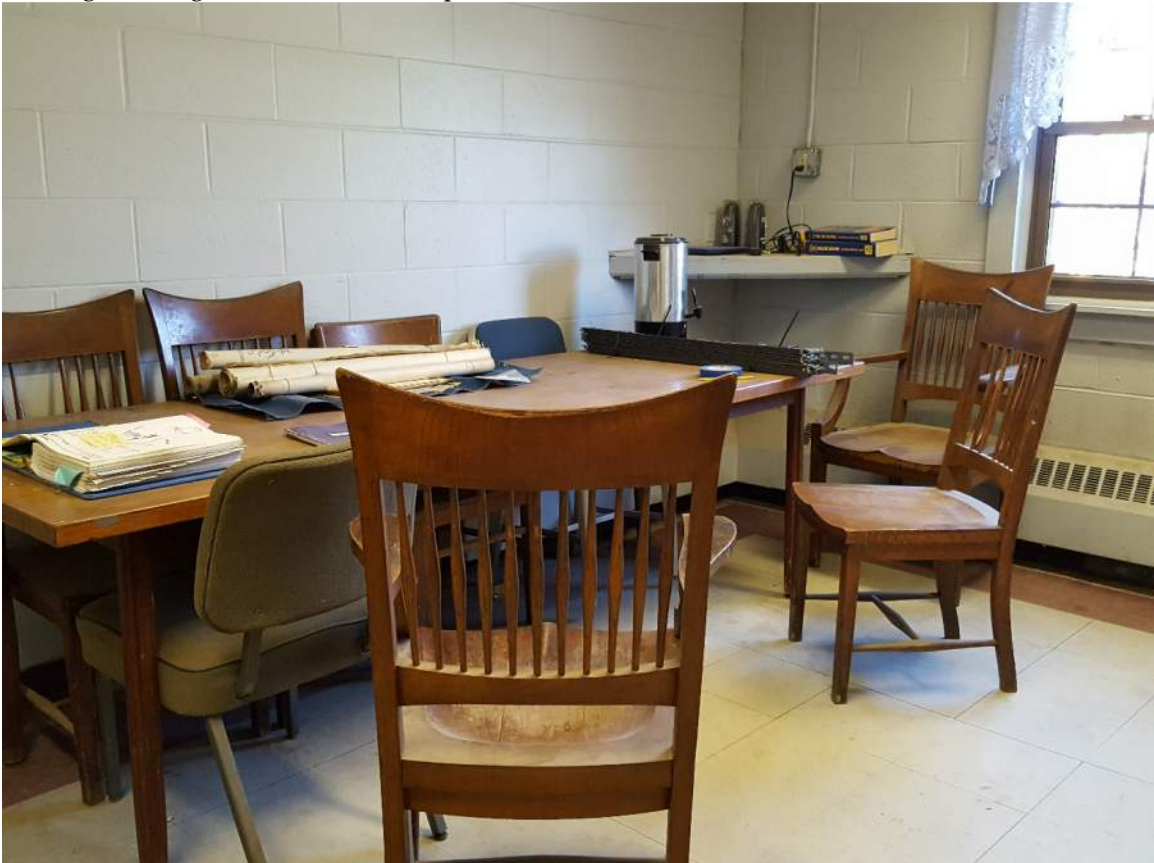
Figure 14: Limited Break Room facilities include seating at the plan layout table. The room is shared as a Conference space.

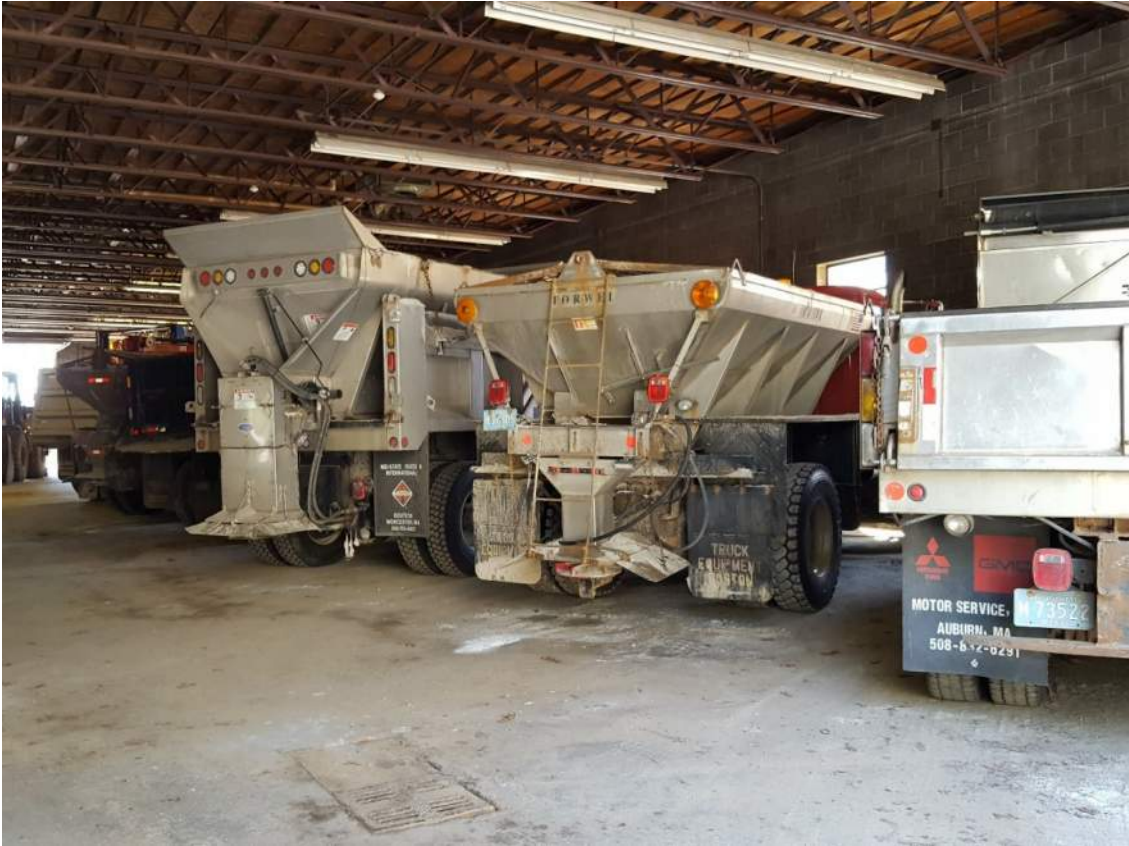
- The vehicle circulation path through the center aisle of the main garage means that during the winter it must be kept clear to allow plows to maneuver from diagonal parking into the center aisle to the exit. During the summer months, a portion of the center is used for vehicle storage. These vehicles must be parked outside, uncovered, during the winter months.

Figure 13: Diagonally parked, 6 plow trucks line the west wall of the main garage.

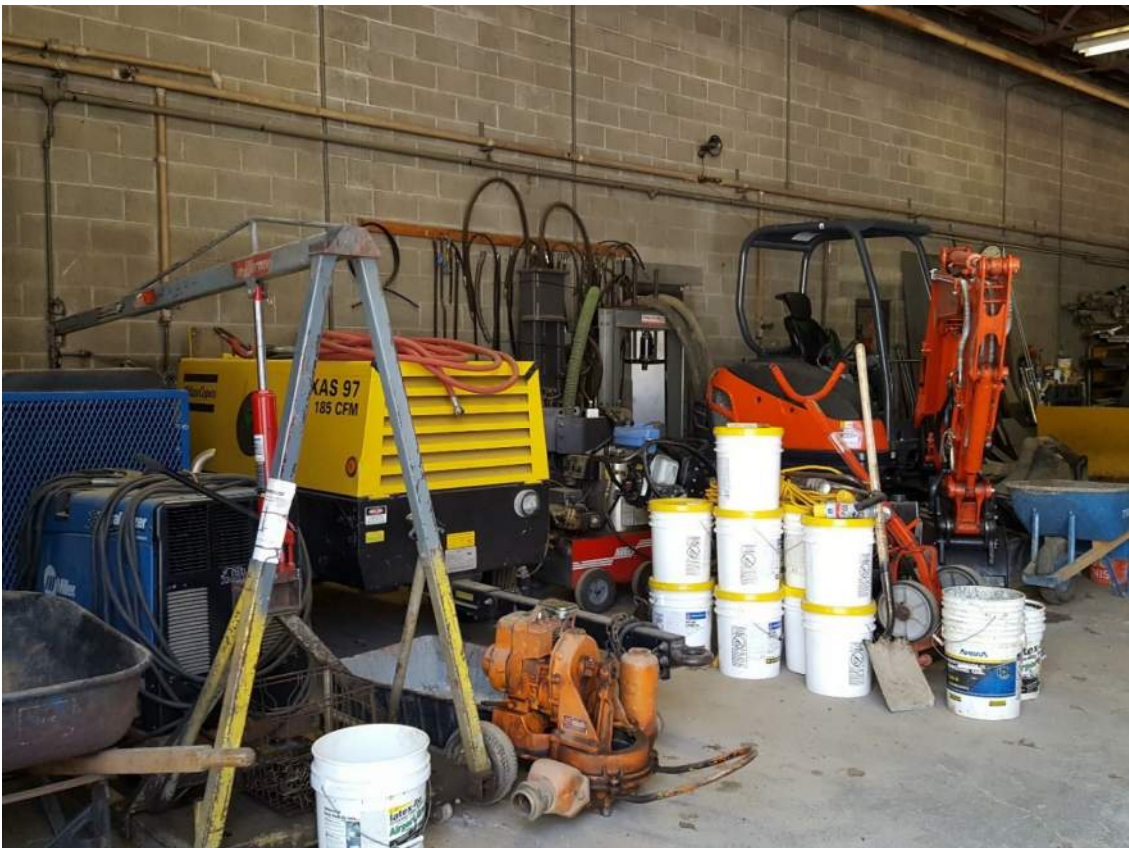
Figure 14: Equipment and supplies are organized along the east wall of the garage.

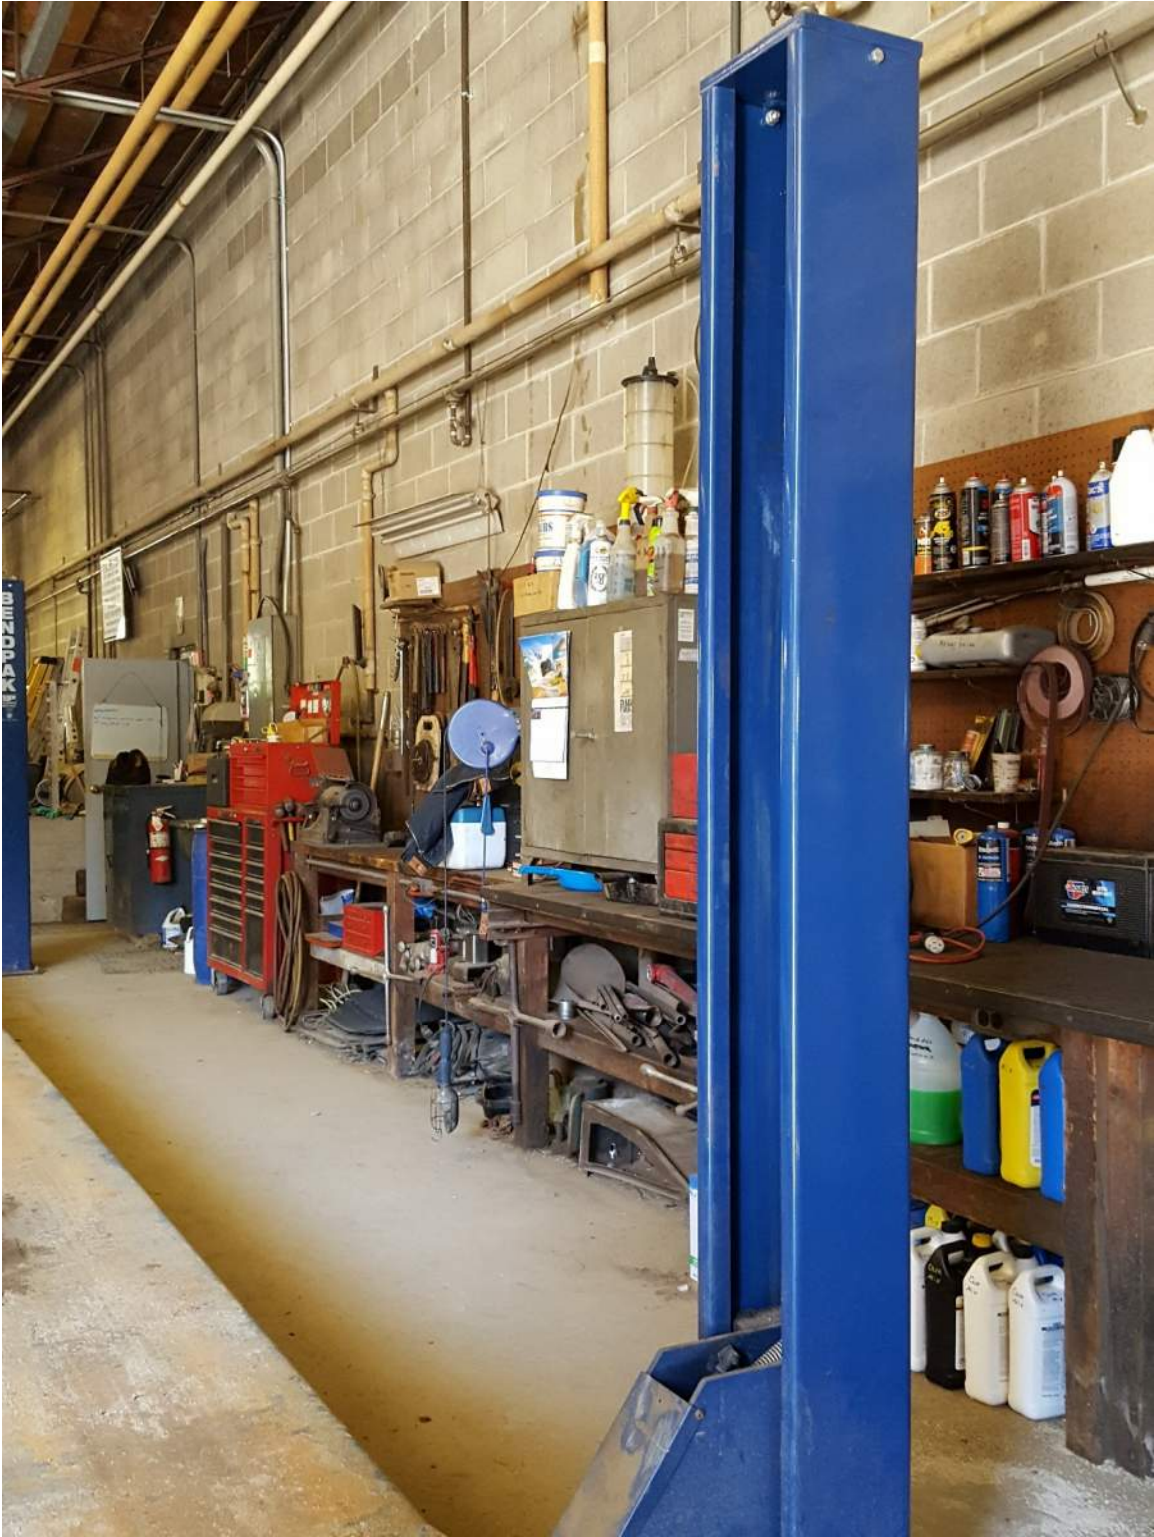
Figure 15: Mechanics tools are stored adjacent to the the vehicle lift.

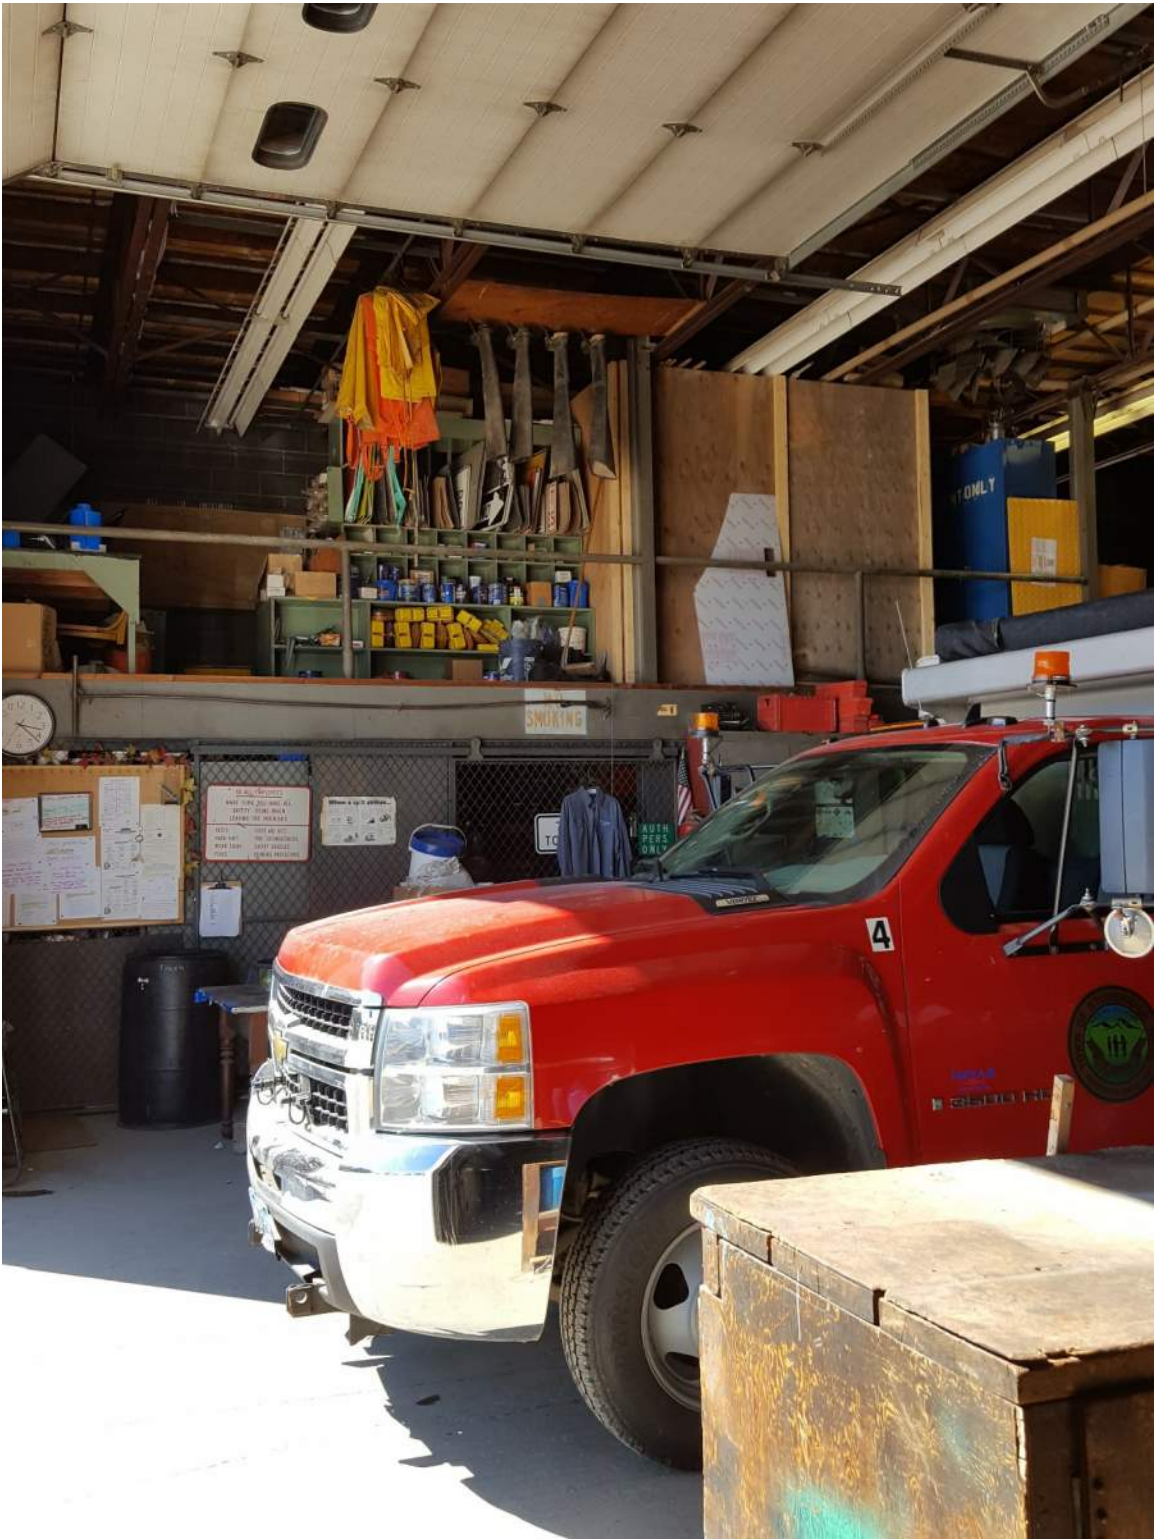
Figure 16: A secure two-story crib for specialized equipment and supplies lines a portion of the west wall.

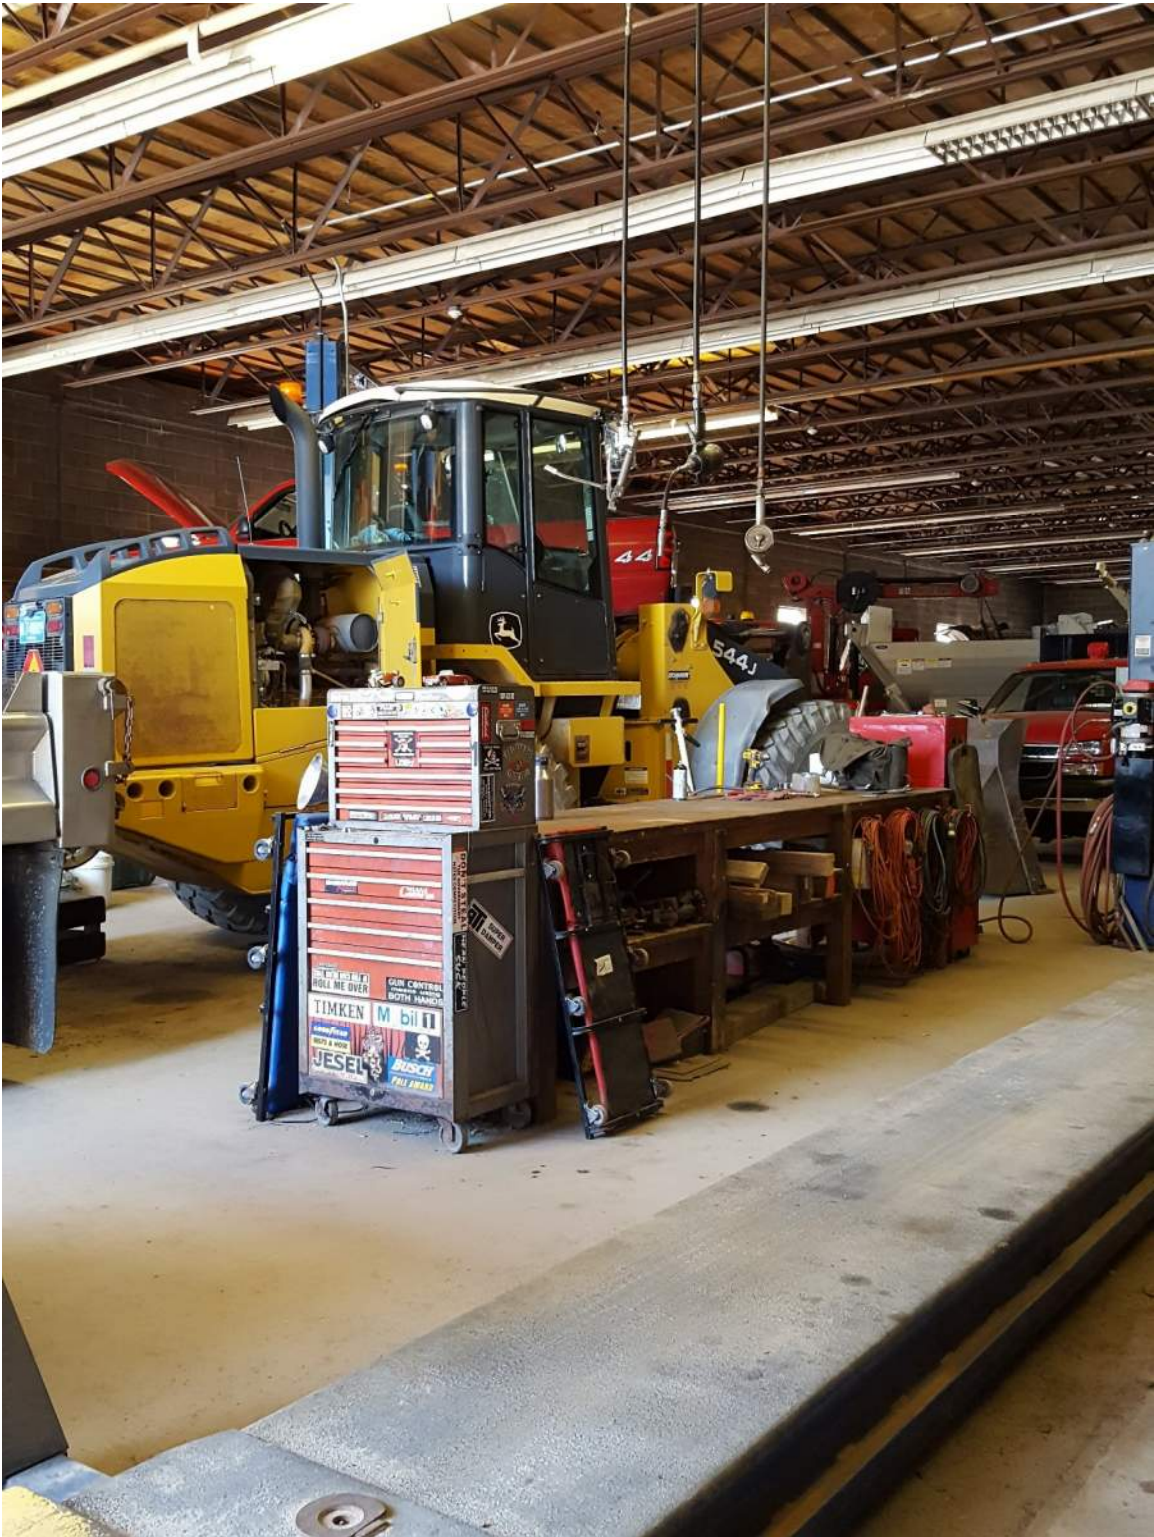
Figure 17: A jumble of equipment is temporarily stored in the center drive aisle. Note the vehicle lift in the foreground, an island with mechanics tools in the center, and vehicles stored or awaiting service in the center aisle. Dump trucks are stored beyond the center aisle.
