# TOWN OF STURBRIDGE

## PUBLIC SAFETY COMPLEX PROGRAM

The Town of Sturbridge Massachusetts

# EXISTING CONDITIONS SURVEY

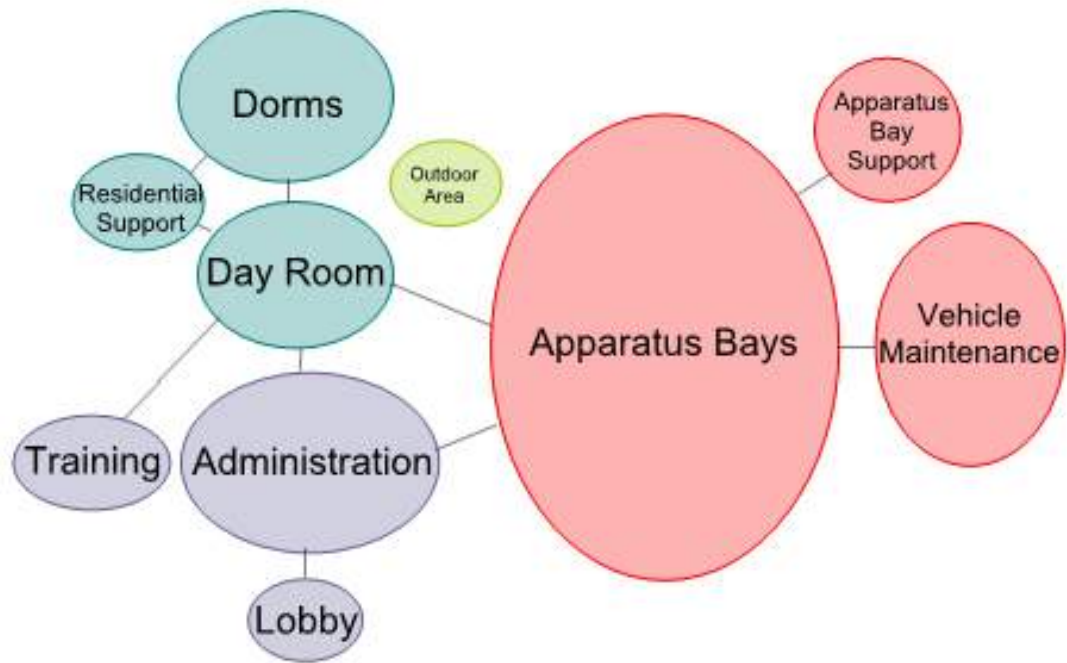
Figure 3: A simple bubble diagram shows the potential separation of activities and the connectivity of spaces for a typical Fire Department. The Sturbridge facility is arranged according to this illustration with the Apparatus facilities on the lowest level and the other spaces two floors above. It is possible to further separate the Administration functions by moving them to the currently unfinished second floor level in order to free up space for other uses.

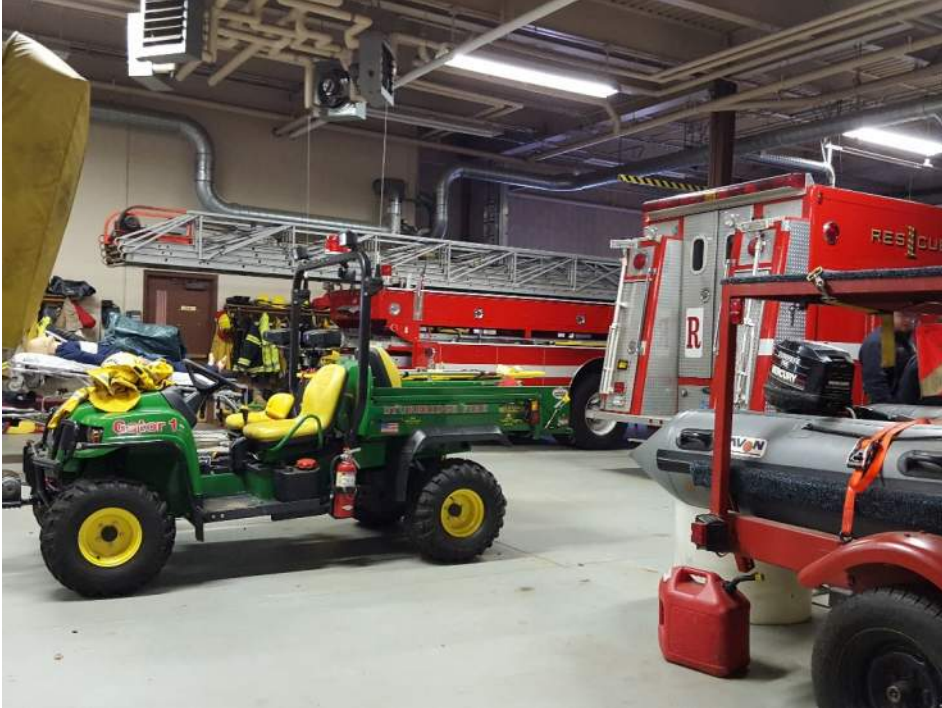
Figure 4: The Apparatus Bays hold heavy equipment as well as rescue boats and small vehicles. The amount and quality of existing space is adequate for the equipment needs into the foreseeable future. Drawbacks are that there is no wash/maintenance bay, no separate toilet and decontamination facilities for men and women, and access to the main road is uphill with a sharp turn onto the State Highway.

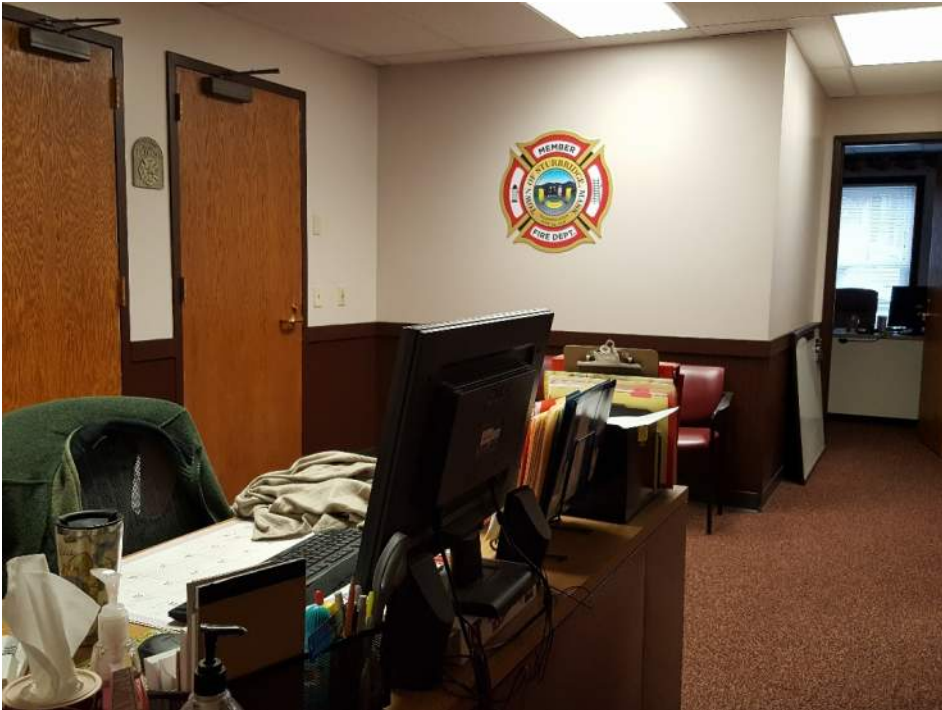
Figure 5: One of the toilet rooms off the Lobby has been removed to provide additional space in the Administrative Assistant's office for an internal waiting area. The Administrative area is compact without adequate storage spaces for supplies and dress uniforms.

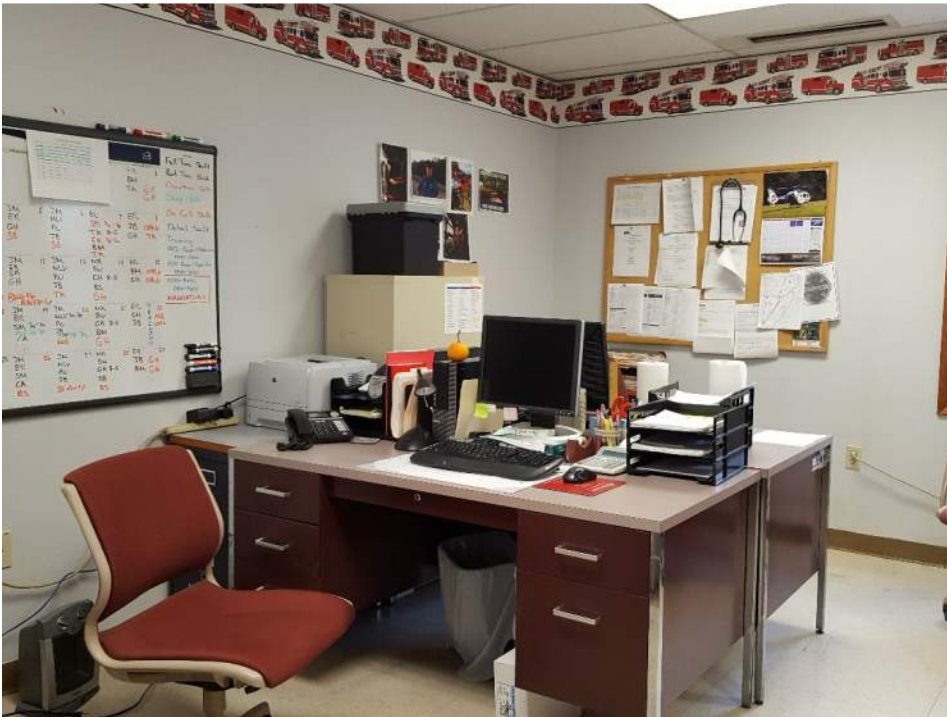
Figure 6: The Officer's Office holds four desks including the Billing Clerk. The Billing Clerk and associated records should have a separate, private and secure space. Officers require a desk and computer, along with file, printing and communications equipment in order to write and file reports. This area is currently used as video training space which might better be separated for noise and privacy for both the report writers and the trainees.

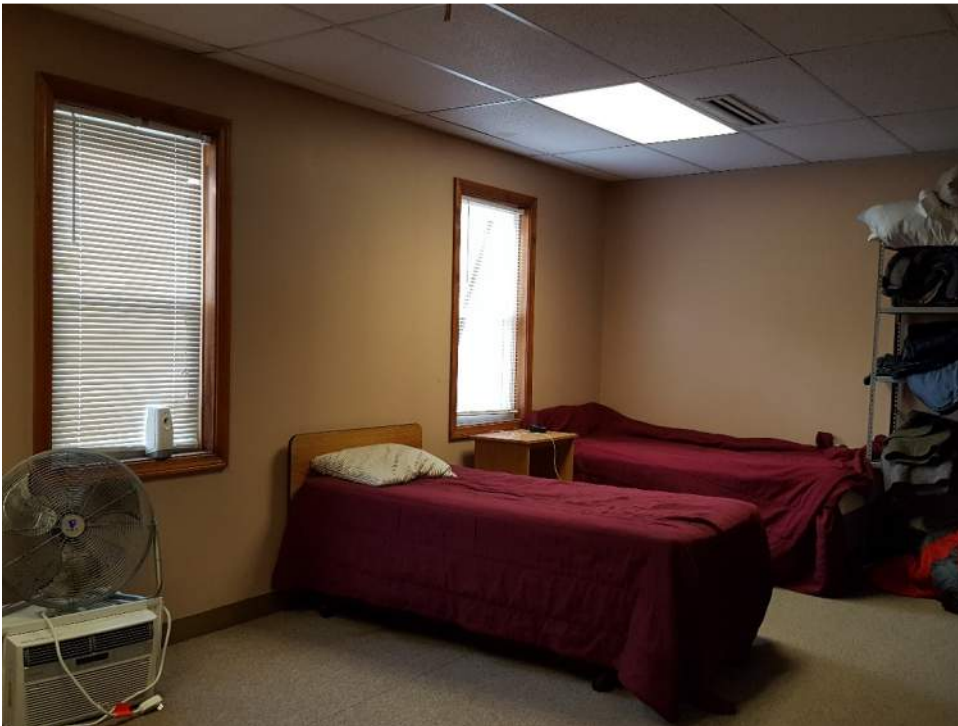
Figure 7: The Men's Dormitory features four twin beds, metal lockers and storage shelving. An optimal layout would include single unit sleeping quarters and dedicated furnishings for personal belongings.

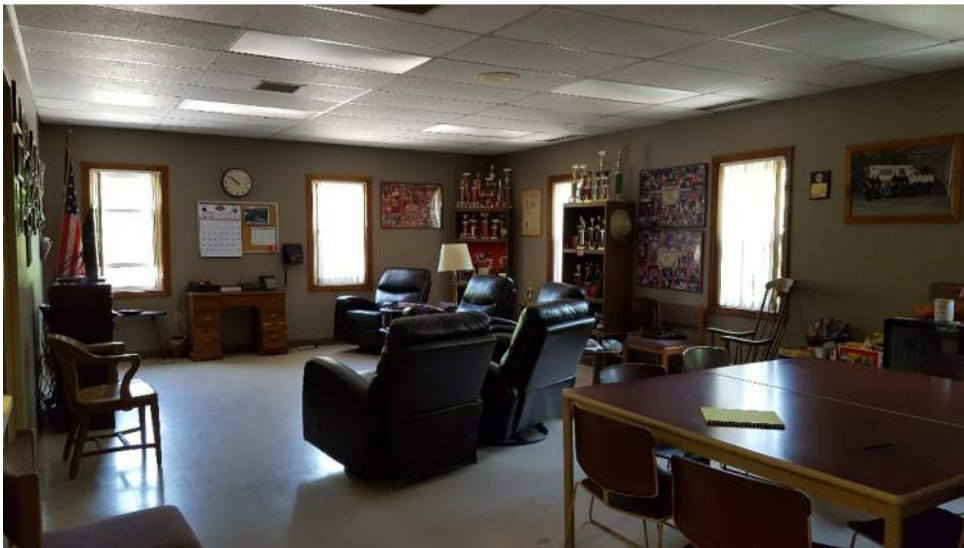
Figure 9: The Day Room/Training Room is adequate to the needs of the Department. Associated storage space includes the lockers for part time members. The adjacency of the lockers to toilet rooms and changing facilities could be improved upon. The training area of the Day Room also serves as the dining area.

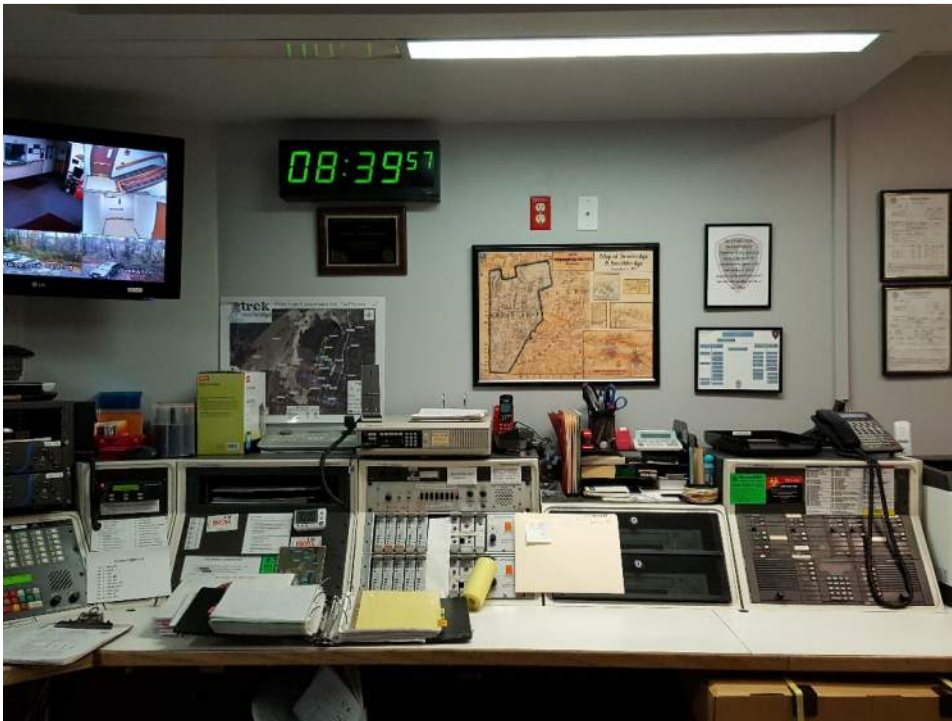
Figure 11: The current dispatch room is centrally located at the main lobby of the building. The dispatcher serves as the receptionist directing visitors. The space is crowded

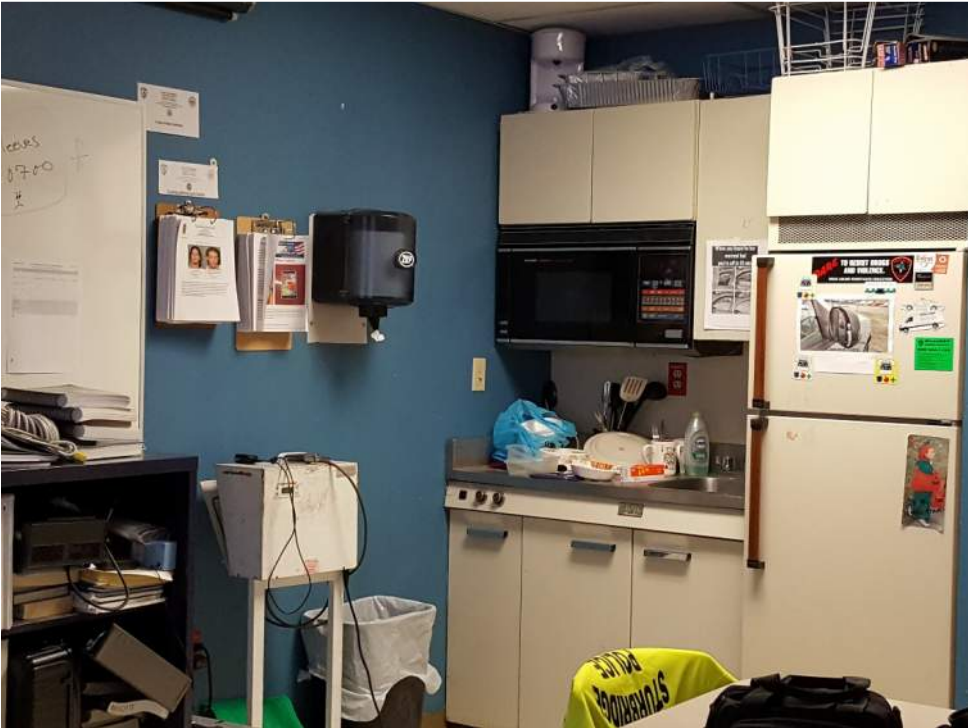
Figure 16: The Kitchen is a well-used area that could be expanded.

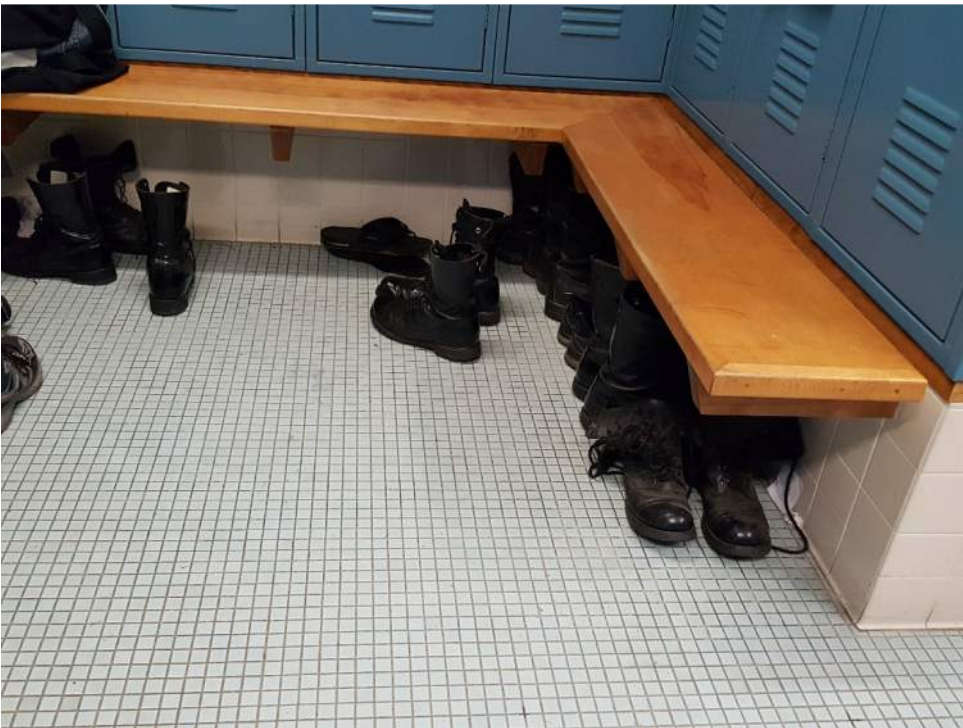
Figure 18: Toilet rooms and locker room facilities are extremely limited and small without adequate or ADA accessible facilities.

- Men's and Women's Locker Rooms and associated toilet facilities are inadequate in terms of space and accessibility.
- Enlarge Kitchen facilities.
- Administrative staff toilet rooms are not ADA accessible.

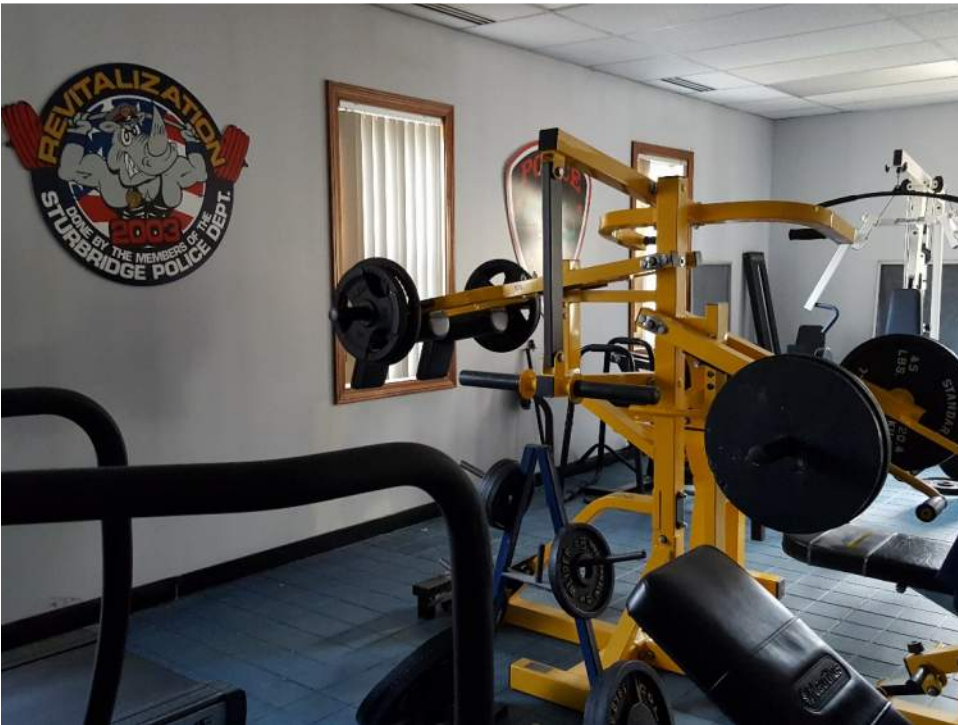
Figure 19: The Exercise Room is furnished with multiple types of exercise equipment. The room could be larger to increase safely around the equipment, and possibly shared with the Fire Department.

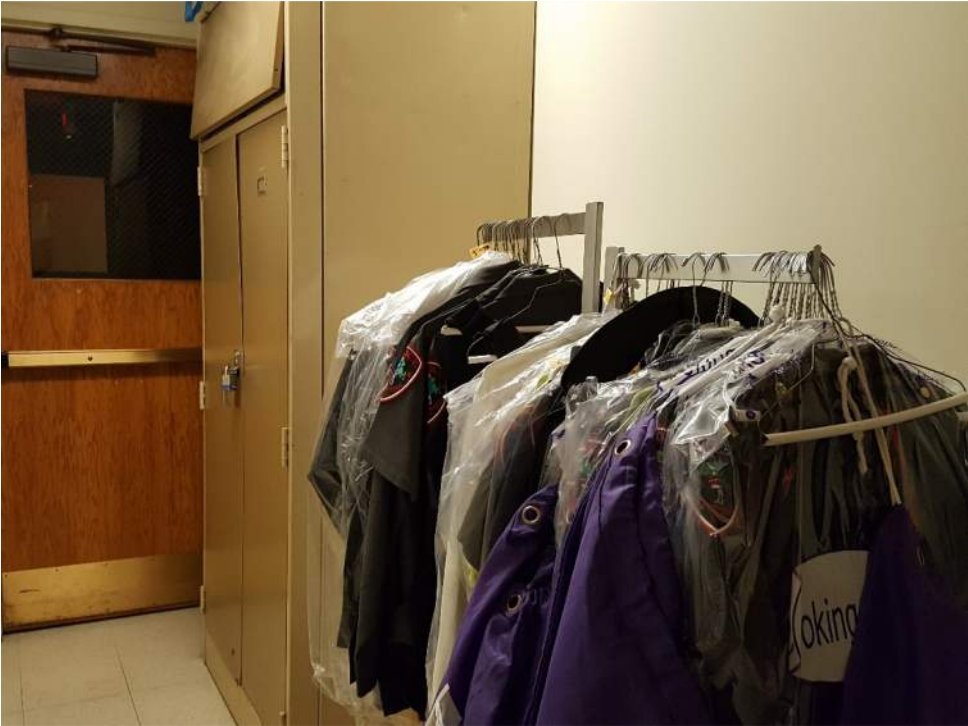
Figure 20: Lack of storage space has led to code violations where egress corridors are blocked by objects within the egress path.

- All facilities should be made ADA compliant.
- Storage areas should be found to eliminate storage within egress corridors.

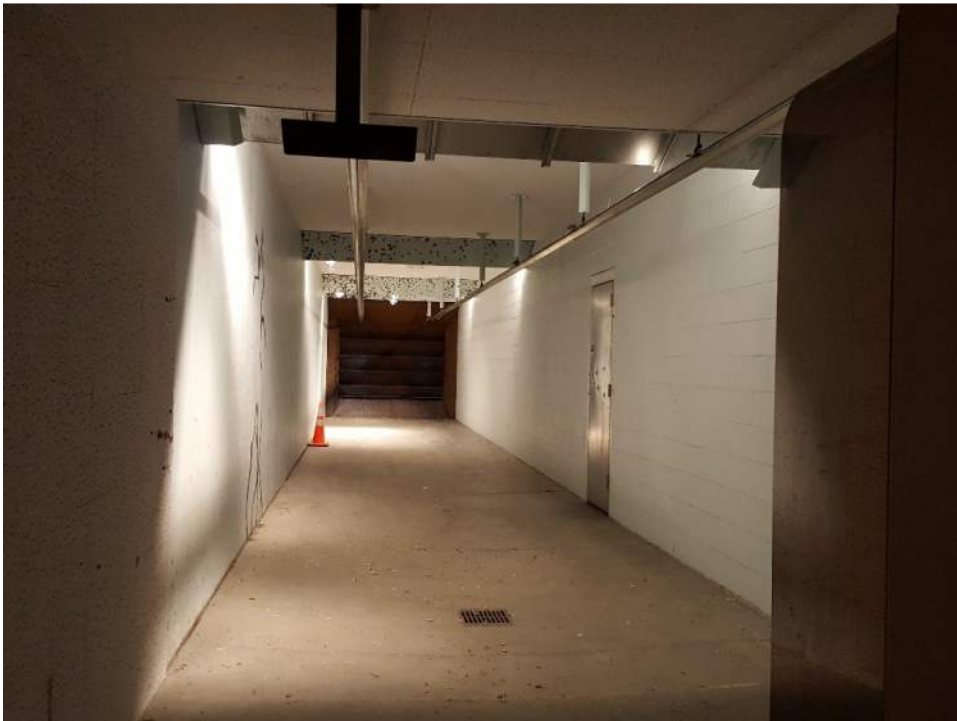
Figure 20: The Firing Range on the Intermediate Level is utilized but the working condition of the exhaust system remains an ongoing issue.

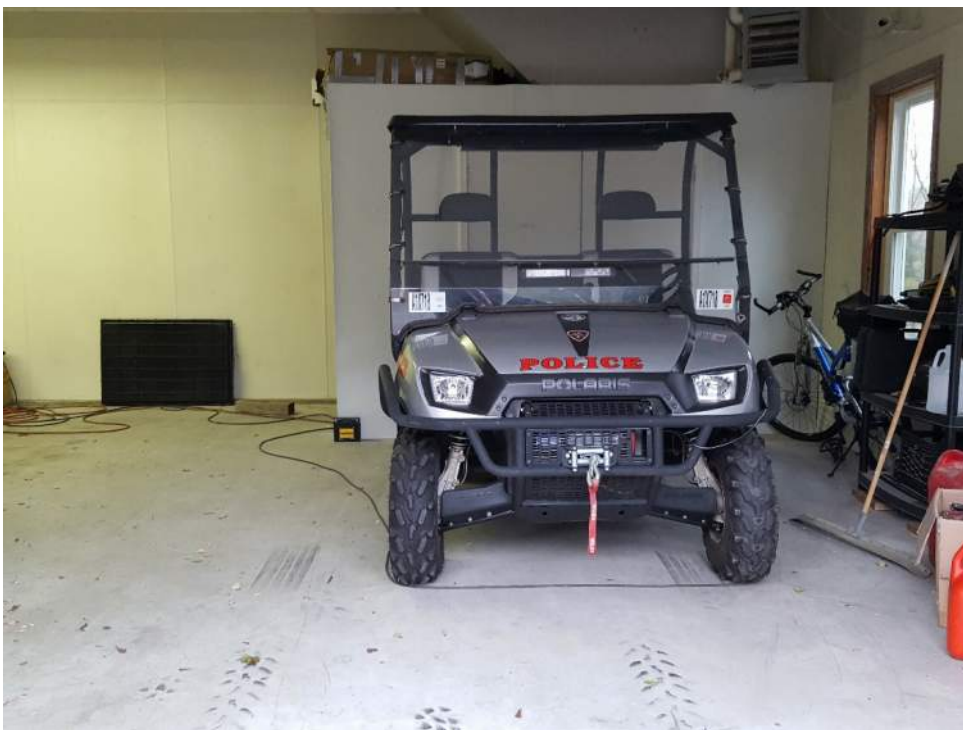
Figure 21: The Garage is composed of two bays which typically house the Chief's vehicle and smaller vehicles that need indoor protection. The Sally Port enters through the garage and down a corridor to the booking area. The route should be more secure and direct.

- Currently there are 2 garage bays. The majority of cruisers are housed in the parking lot, unprotected from the weather. The maximum number should be housed under cover.

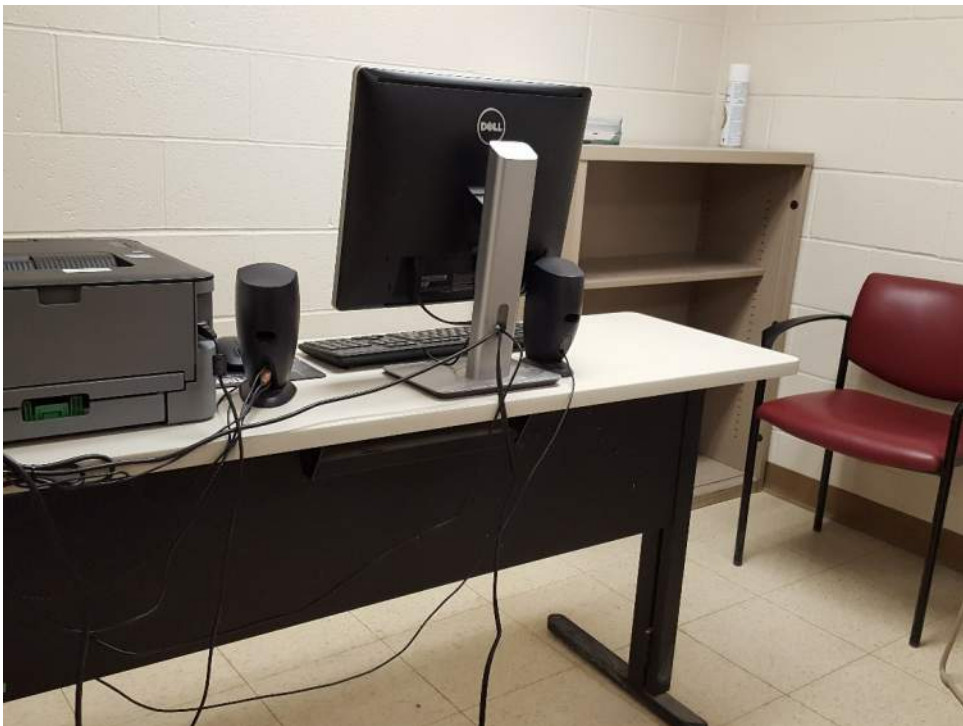
Figure 23: A former storage room has been converted to an interview room while other rooms associated with the former Civil Defense program are underutilized or serve as impromptu storage areas.

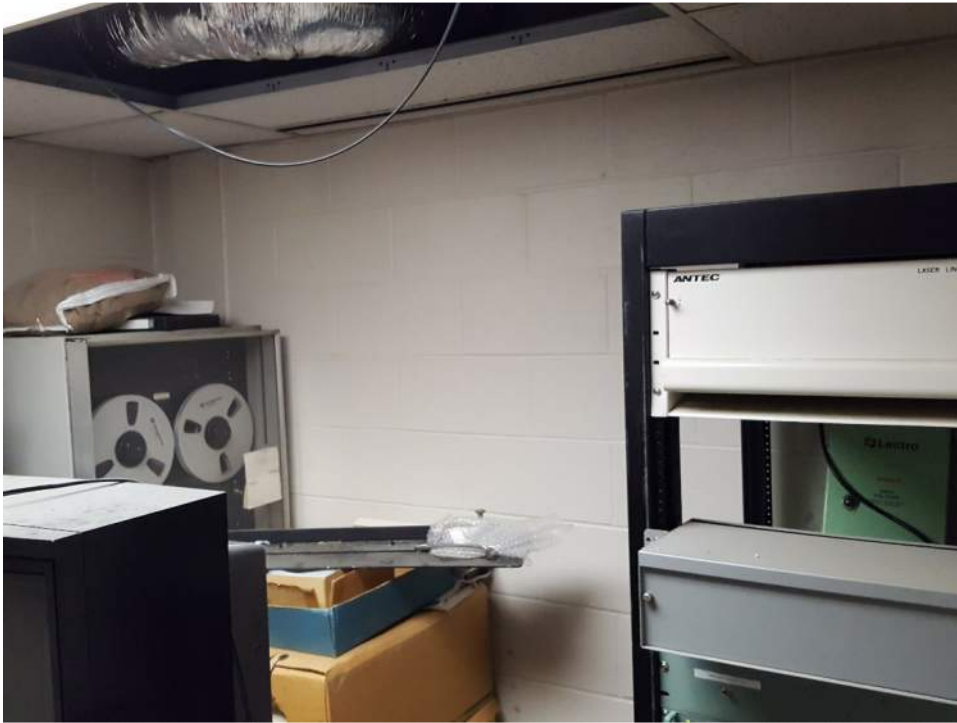
Figure 24: Obsolete equipment could be removed and the rooms used for other purposes.

- Obsolete Civil Defense Offices could be incorporated into the EOC Room.

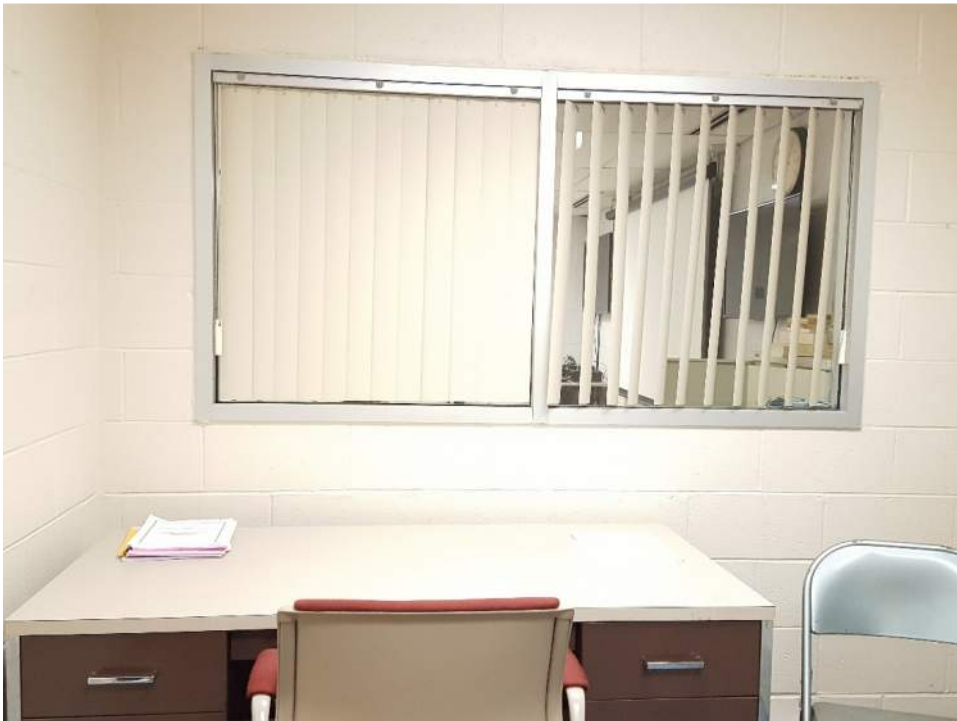
Figure 25: The former Director of Civil Defense Office lies vacant.

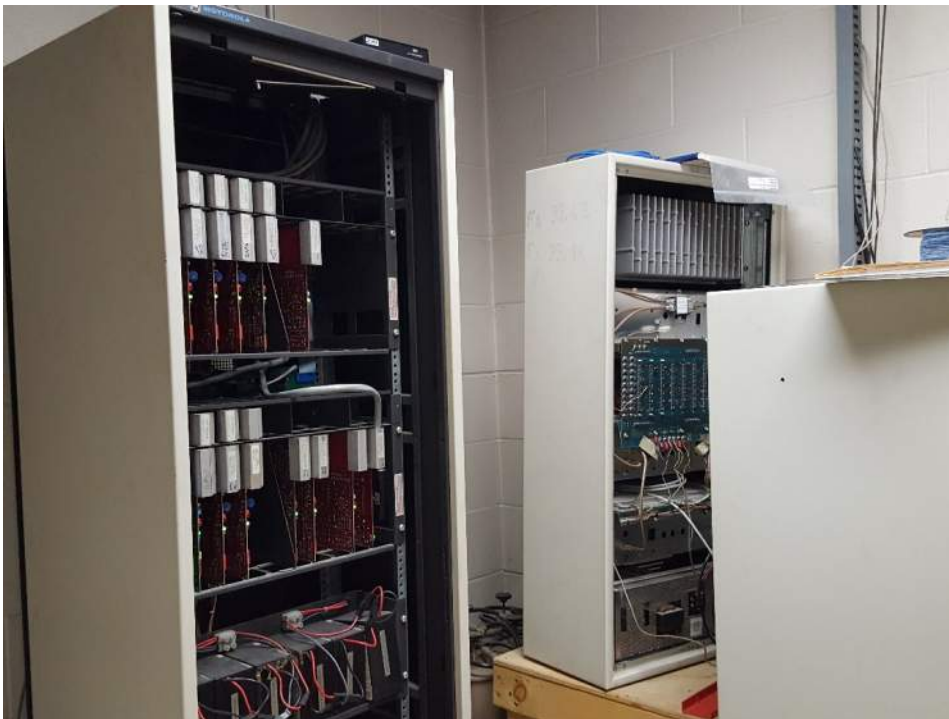
Figure 27: The Radio Equipment Room is an active space that could be better organized and obsolete equipment removed.

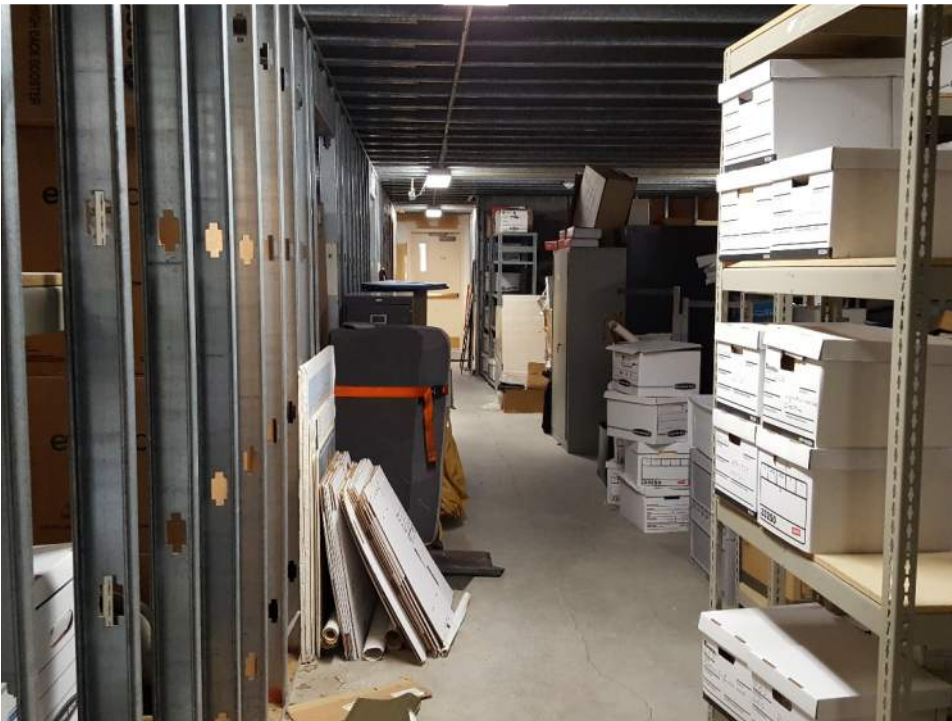
Figure 28: The Second Floor was intended to be finished at a future date. It currently houses Town records and Police Department storage and secure evidence areas.

- Storage for Chief and Deputy Chief for dress uniforms is lacking as is storage for office supplies in the administration area.
- A portion of records storage is remotely housed in the unfinished second floor.
