Re. 9 Holland Road, Sturbridge - Addressing Order of Conditions and Enforcement Order Items

Re. 9 Holland Road, Sturbridge

Site: 9 Holland Road, Sturbridge **Applicant:** Banjo Boy LLC

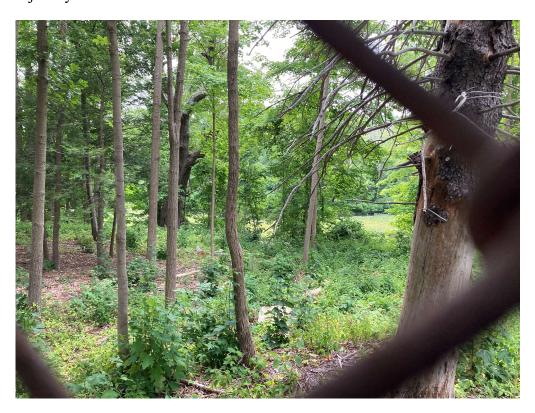
Photo 1 taken by EBT, Inc. on 8/16/2020 – Approximately 2' to 3' high Norway Maple sprouts arising from seedling and sapling stumps on the MacConnell property located east of 9 Holland Road.

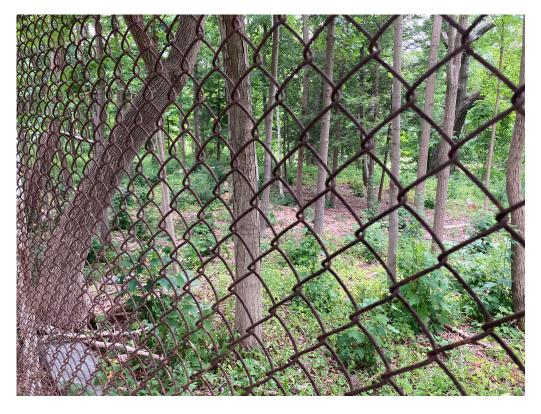
Photo 1 taken by EBT, Inc. on 8/16/2020 – Approximately 2' to 3' high Norway Maple sprouts arising from seedling and sapling stumps on the MacConnell property located east of 9 Holland Road.
