EBT Environmental Consultants, Inc.
GLENN E. KREVOSKY, CONSULTANT

May 5, 2022

Re. 263 & 269 New Boston Road, Sturbridge – Non-Vernal Pool Study

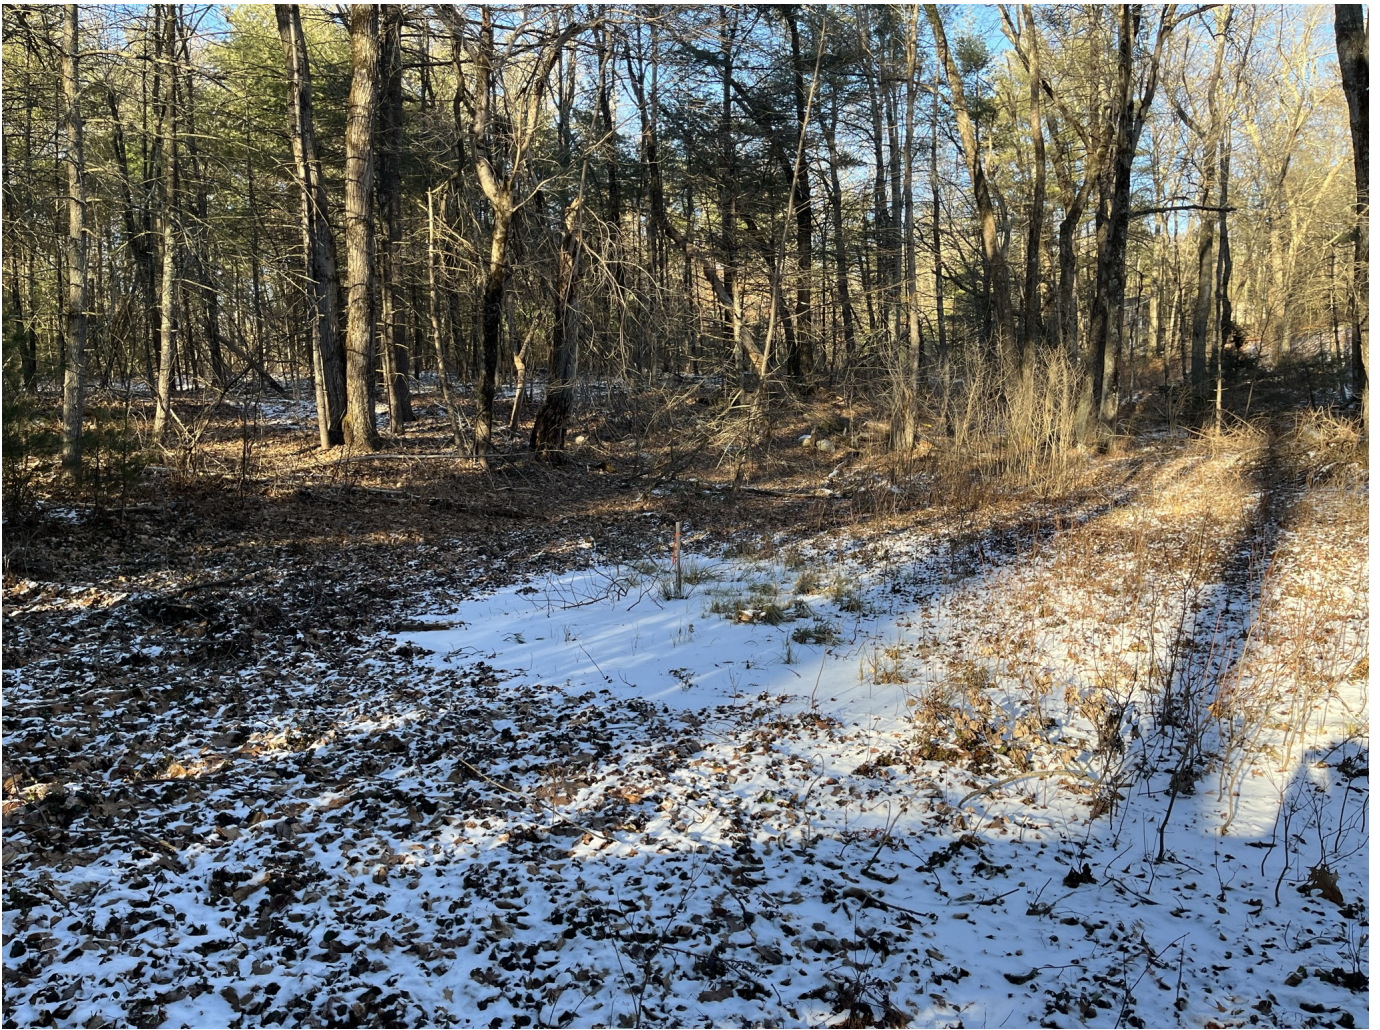
Photo 1 taken by EBT, Inc. on 2/20/2022 at 3:53pm – Pool located in the southwest corner of 269 New Boston Road. The frozen pool is approximately 16' long by 7' wide containing ~4" of ice. This was the beginning date of looking at the pool in 2022.

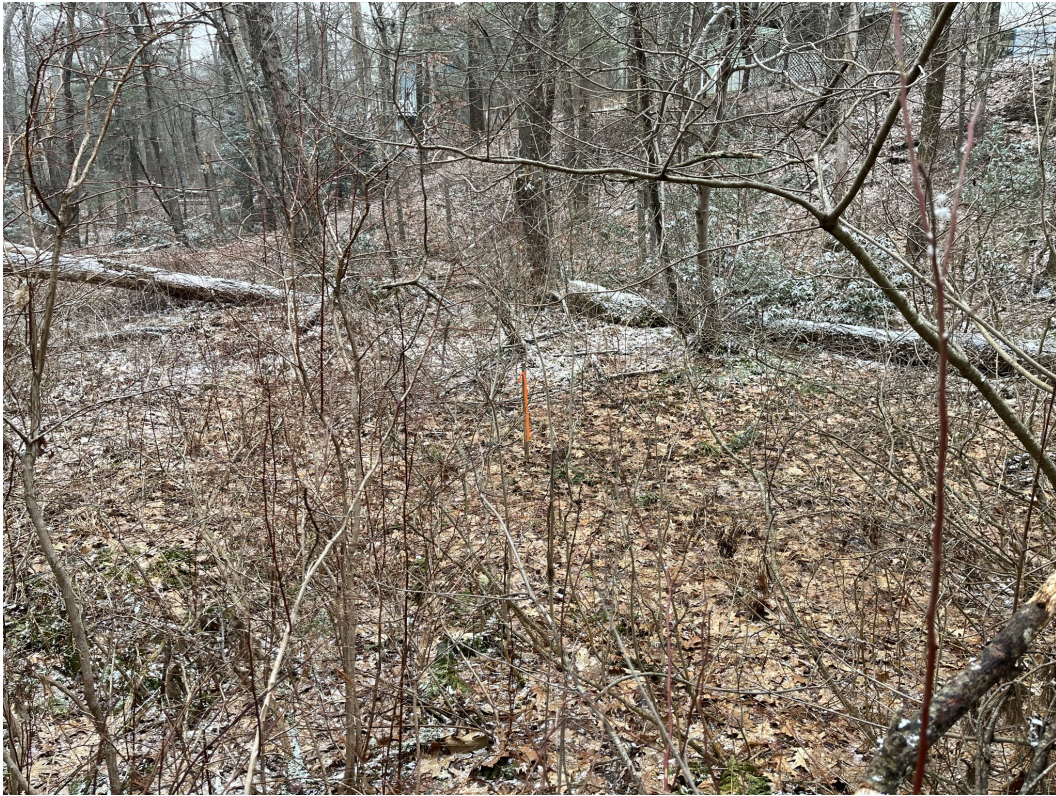
Photo 1 taken by EBT, Inc. on 3/9/2022 at 1:21pm – Potential vernal pool identified on MassMapper containing no water.

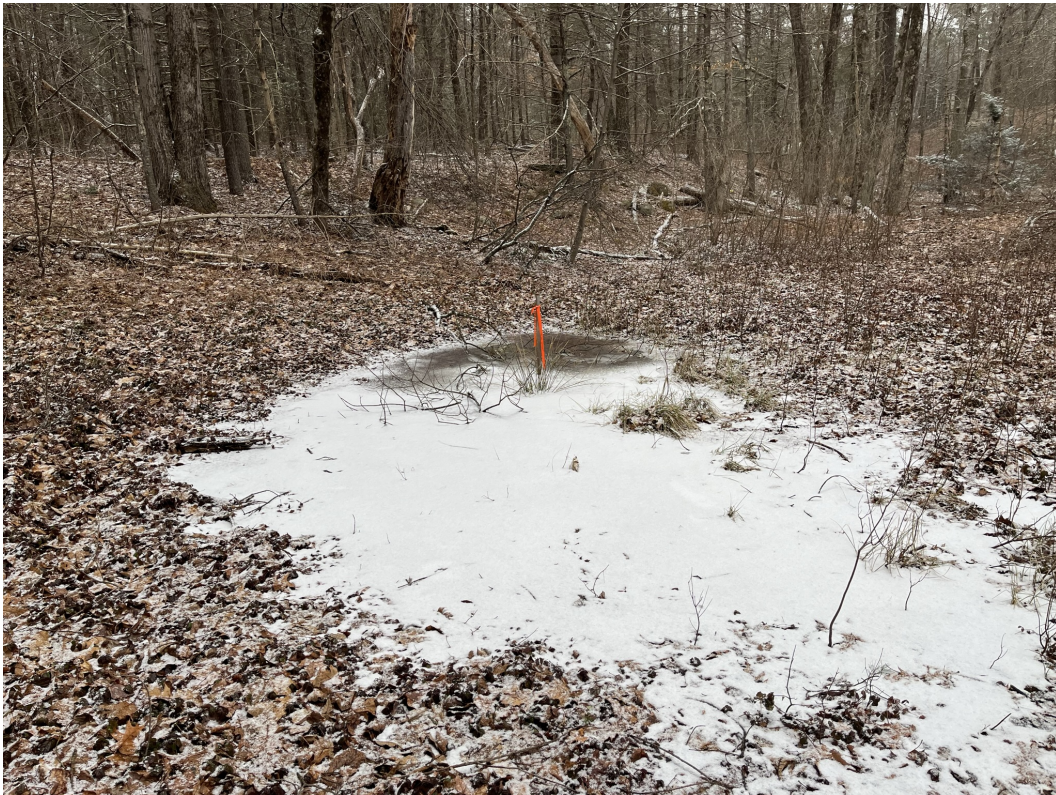
Photo 2 taken by EBT, Inc. on 3/9/2022 at 1:18pm – Pool located in the southwest corner of 269 New Boston Road. The pool is approximately 16' long by 7' wide containing ~4" of water, also ice covered.

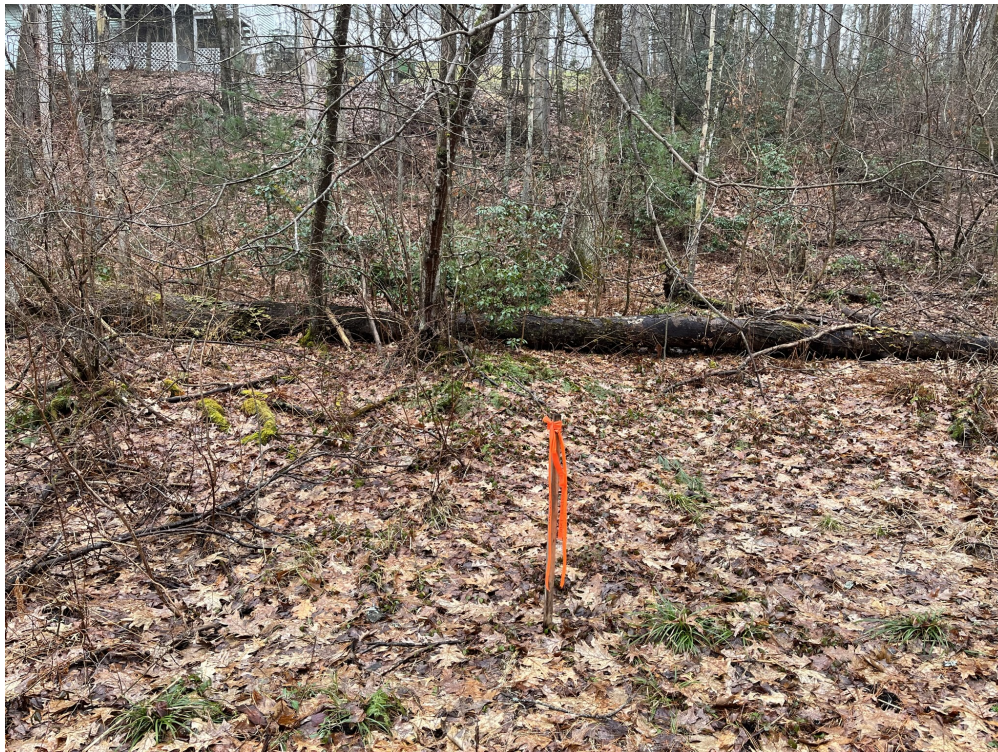
Photo 1 taken by EBT, Inc. on 3/19/2022 at 12:40pm – Potential vernal pool identified on MassMapper on 263 New Boston Road containing no water. The area also contained no water on 3/9/2022. EBT, Inc will be reviewing the site between 3/22/2022 and 3/23/2022.

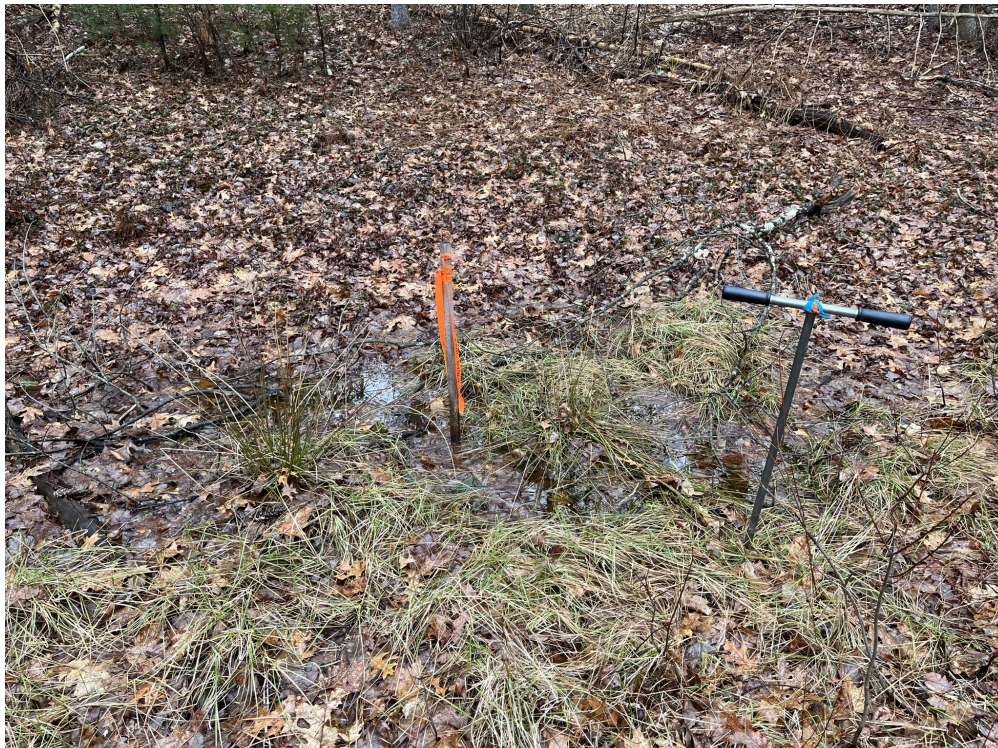
Photo 2 taken by EBT, Inc. on 3/19/2022 at 12:38pm – Pool located in the southwest corner of 269 New Boston Road. The pool is approximately 4' long by 4' wide containing ~1" to 2" of water. Glenn Krevosky of EBT, Inc seined through the spot of water and found no macroinvertebrates or amphibians. Prior to moving on the pool I waited for approximately 7 minutes to hear if there was any chorusing of Spring Peepers or Grey Tree Frogs, there were none.

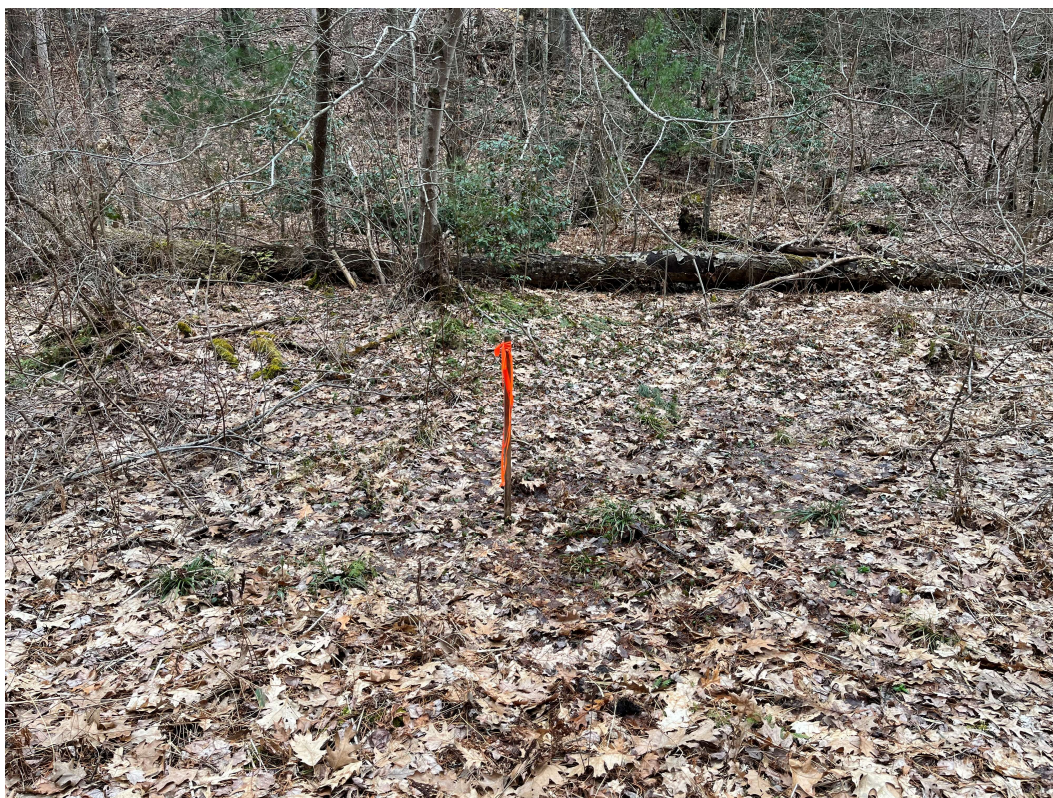
Photo 1 taken by EBT, Inc. on 3/26/2022 at 11:58am – Potential vernal pool identified on MassMapper at 263 New Boston Road containing no water.

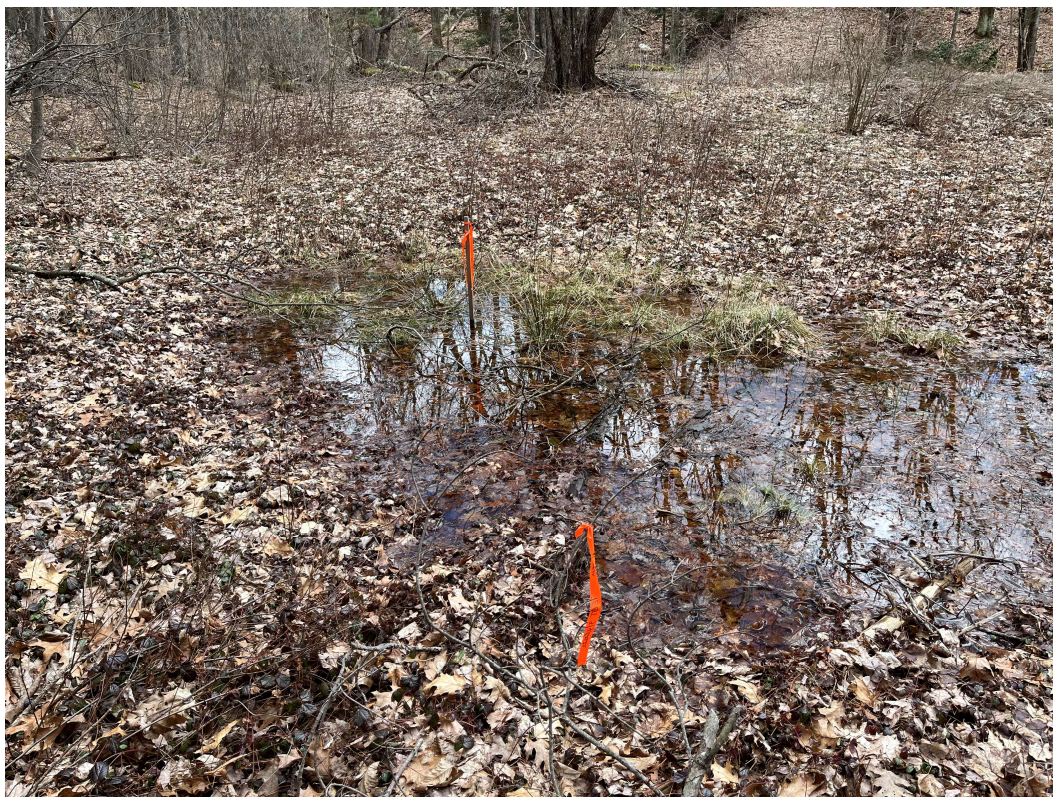
Photo 2 taken by EBT, Inc. on 3/26/2022 at 11:53am – Pool located in the southwest corner of 269 New Boston Road. The pool is approximately 13' long by 7' wide containing ~4" of water. National Weather Service recorded 1.31 inches of rain in Sturbridge between 3/24 and 3/25.

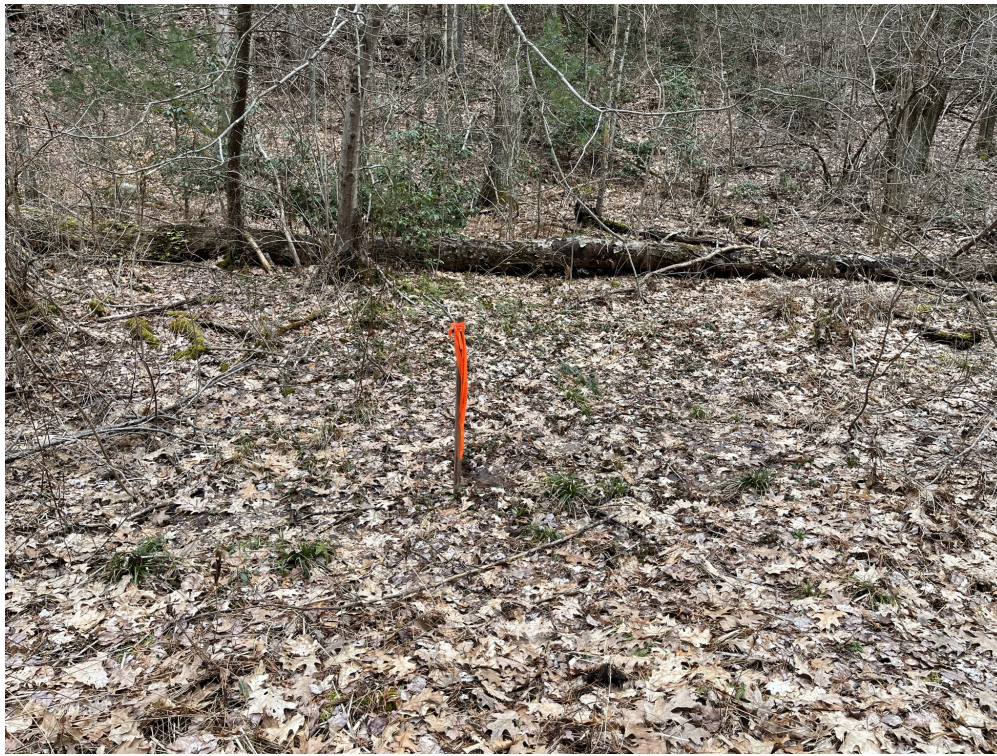
Photo 1 taken by EBT, Inc. on 4/10/2022 at 1:27pm – Potential vernal pool identified on MassMapper at 263 New Boston Road containing no water.

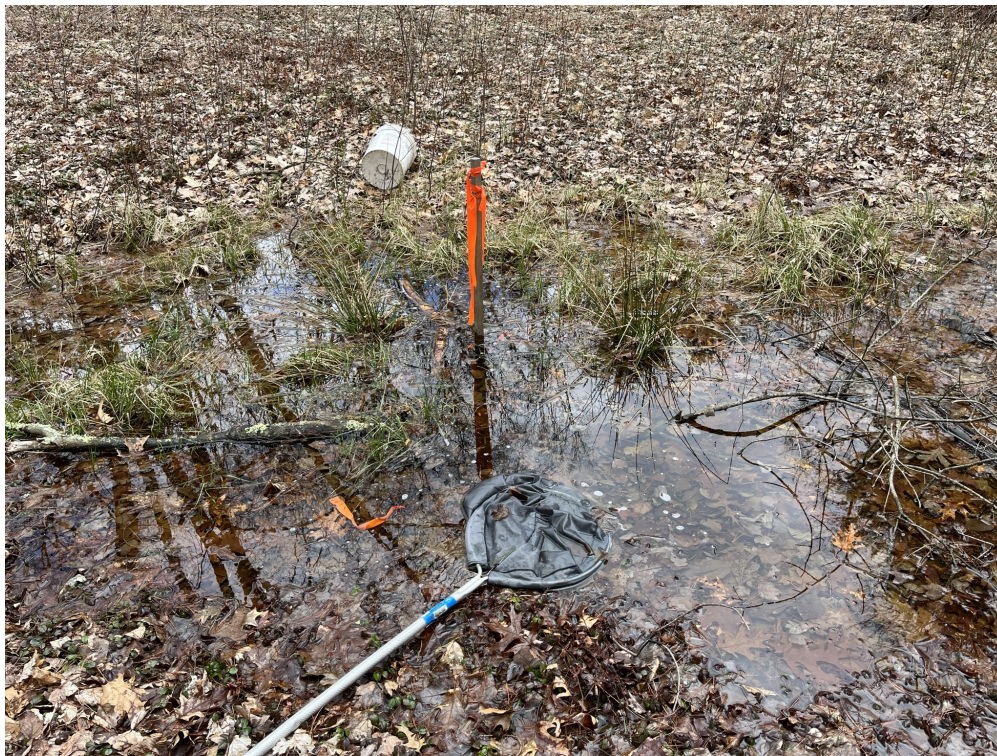
Photo 2 taken by EBT, Inc. on 4/10/2022 at 1:32pm – Pool located in the southwest corner of 269 New Boston Road. The pool is approximately 16' long by 9' wide containing ~6" of water. It rained approximately 1.4 inches at the end of the week (we cannot get more accurate data as the NOAA Online Weather Data is not functioning at this time). We paused for 10 minutes to hear for chorusing, non was recorded. We then went to the pool and seined and found no Fairy Shrimp and no Wood Frog or Ambystoma egg masses.

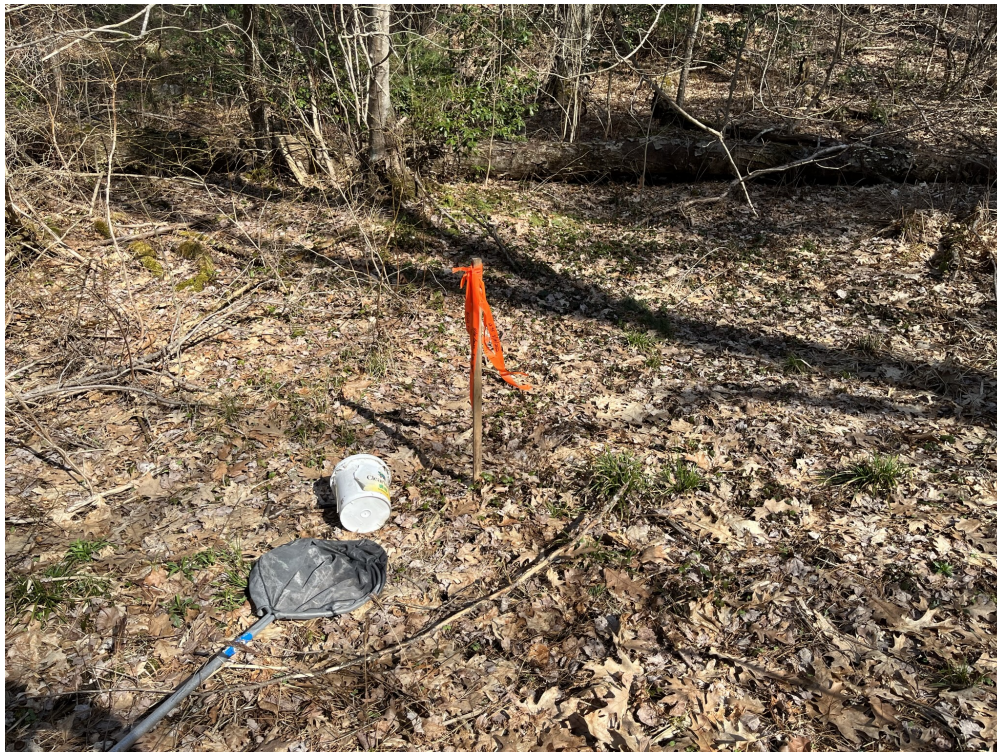
Photo 1 taken by EBT, Inc. on 4/14/2022 at 3:51pm – Potential vernal pool identified on MassMapper at 263 New Boston Road containing no water.

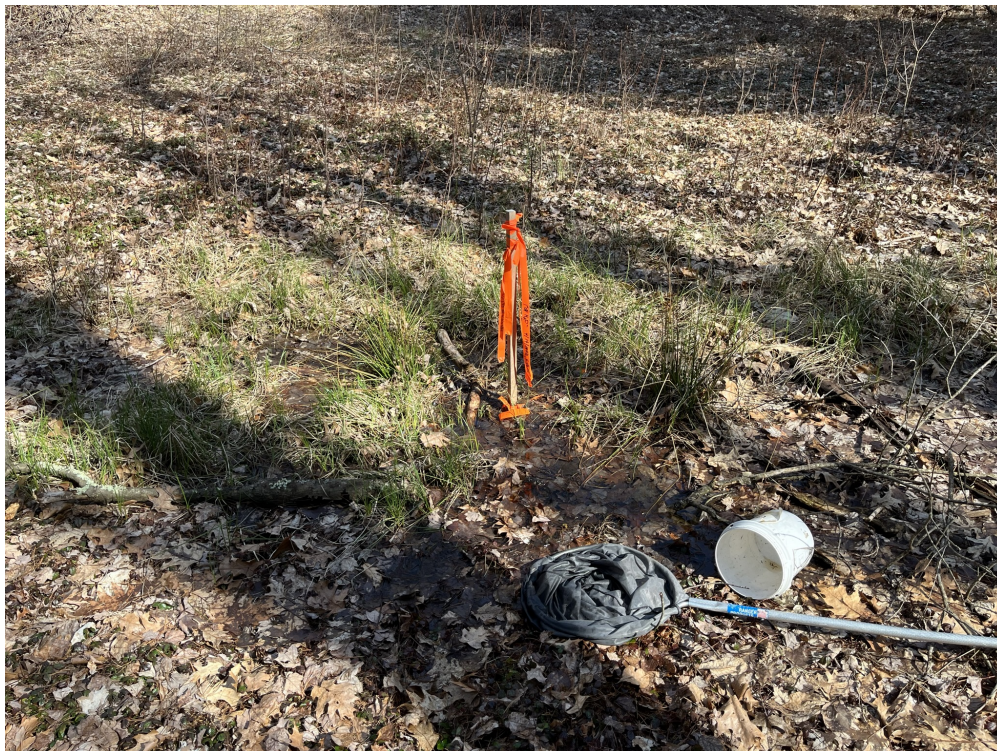
Photo 2 taken by EBT, Inc. on 4/14/2022 at 3:50pm – Pool located in the southwest corner of 269 New Boston Road. The pool is approximately 4' long by 4' wide containing ~1" of water. We paused for 10 minutes to listen for chorusing prior to accessing near the pool, none was recorded. We then went to the pool and seined and found no Fairy Shrimp and no Wood Frog or Ambystoma egg masses, but we did find mosquito larvae (third photo).

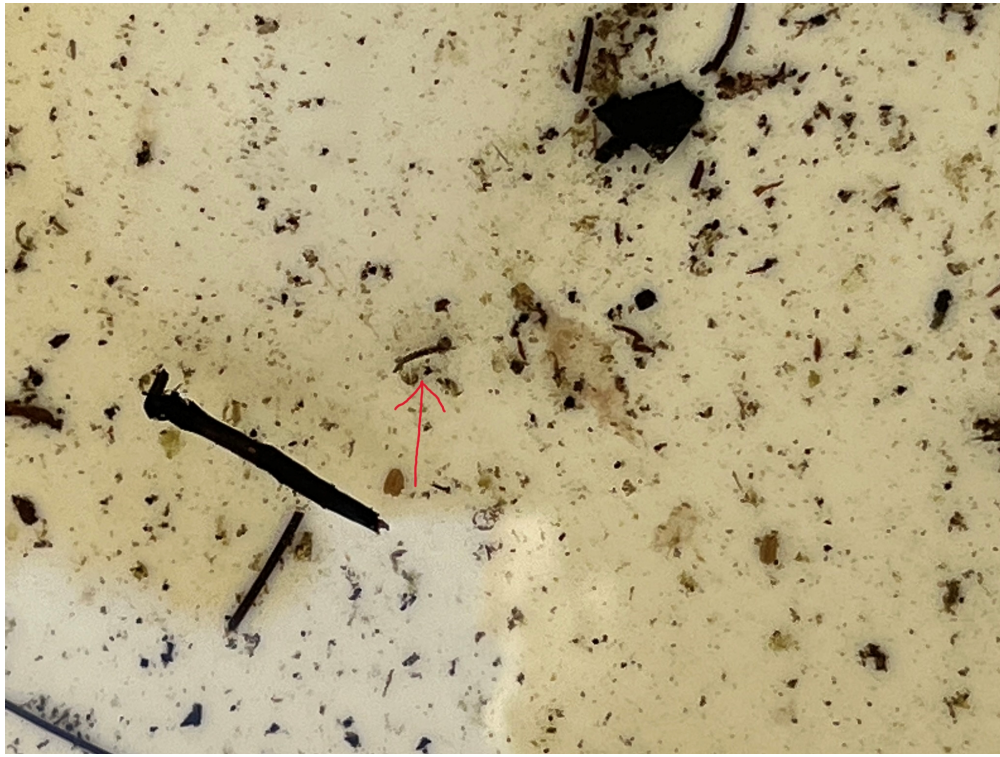
Photo 3 taken by EBT, Inc. on 4/14/2022 at 3:47pm – Showing mosquito larvae seined from the pool on 269 New Boston Road.

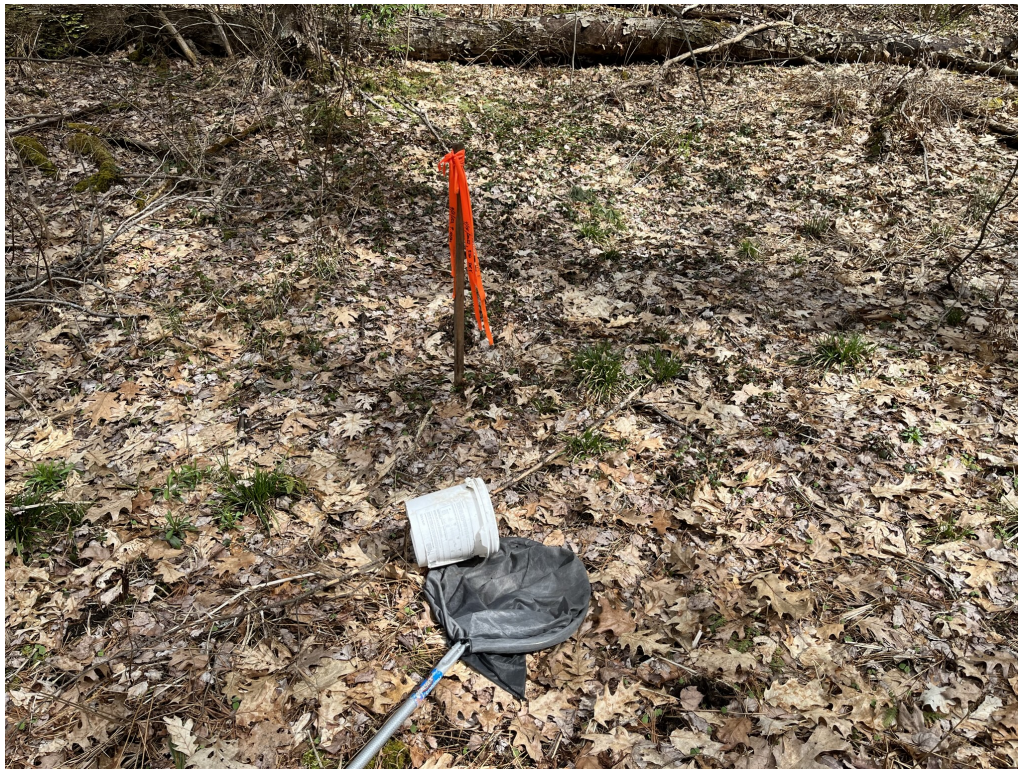
Photo 1 taken by EBT, Inc. on 4/17/2022 at 2:39pm – Potential vernal pool identified on MassMapper at 263 New Boston Road containing no water.

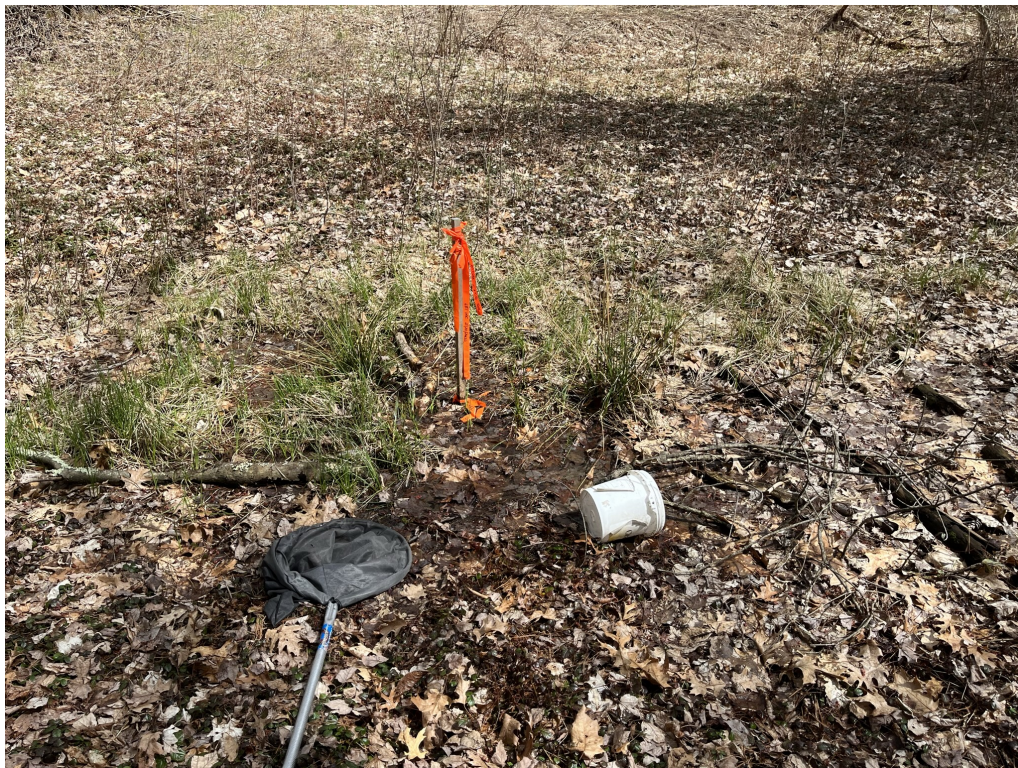
Photo 2 taken by EBT, Inc. on 4/17/2022 at 2:38pm – Pool located in the southwest corner of 269 New Boston Road. There is no open water at the pool, there is only leaves at the surface with water between them. We paused for 10 minutes to listen for chorusing prior to accessing near the pool, none was recorded. There was no volume of water to sein through.

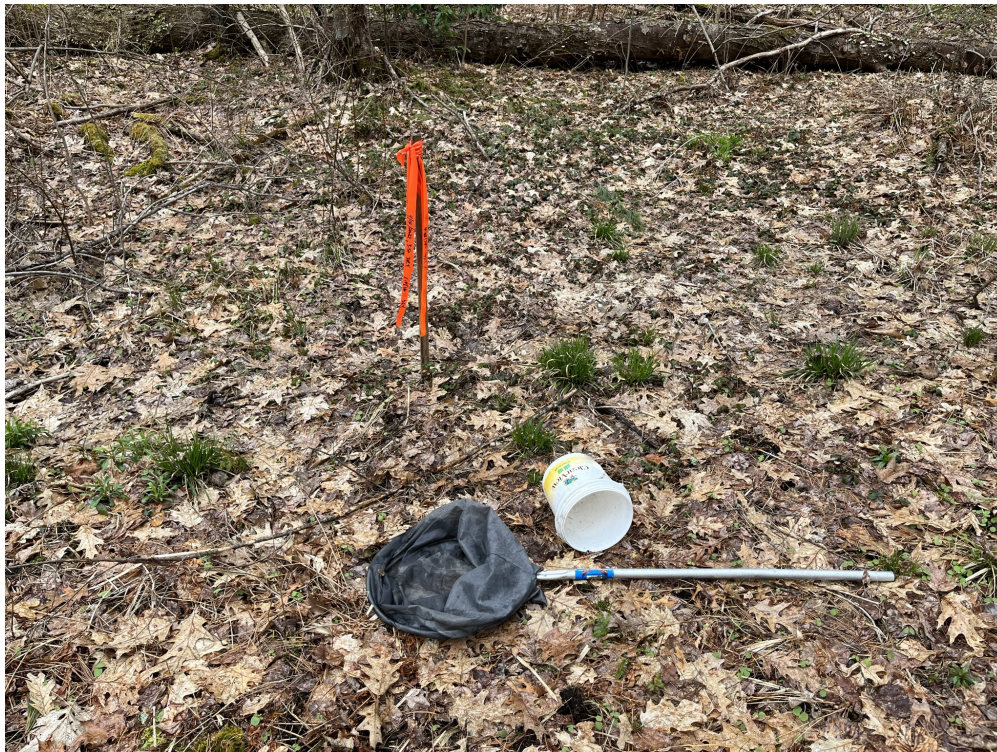
Photo 1 taken by EBT, Inc. on 4/24/2022 at 12:03pm – Potential vernal pool identified on MassMapper at 263 New Boston Road containing no water.

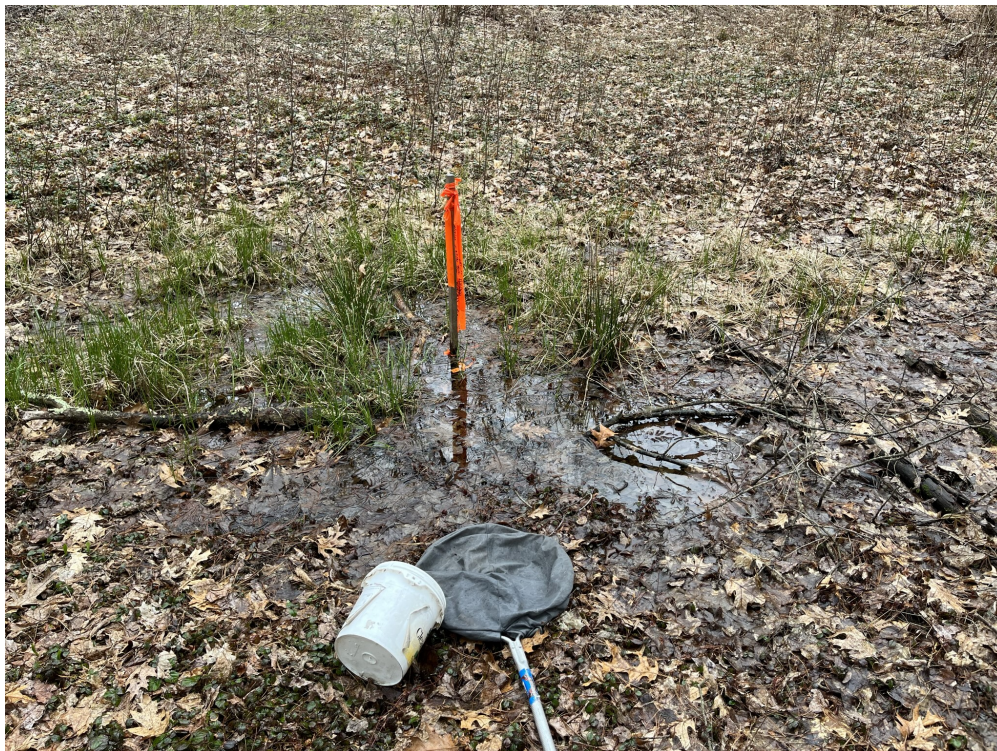
Photo 2 taken by EBT, Inc. on 4/24/2022 at 12:00pm – Pool located in the southwest corner of 269 New Boston Road. The area is approximately 5' by 4' with approximately 1.5" of water in the center - there was approximately 1.23 inches of rain on 4/19 (NOAA data). We paused for 10 minutes to listen for chorusing prior to accessing near the pool, none was recorded. We seined through the small volume of water and found only mosquito larvae.

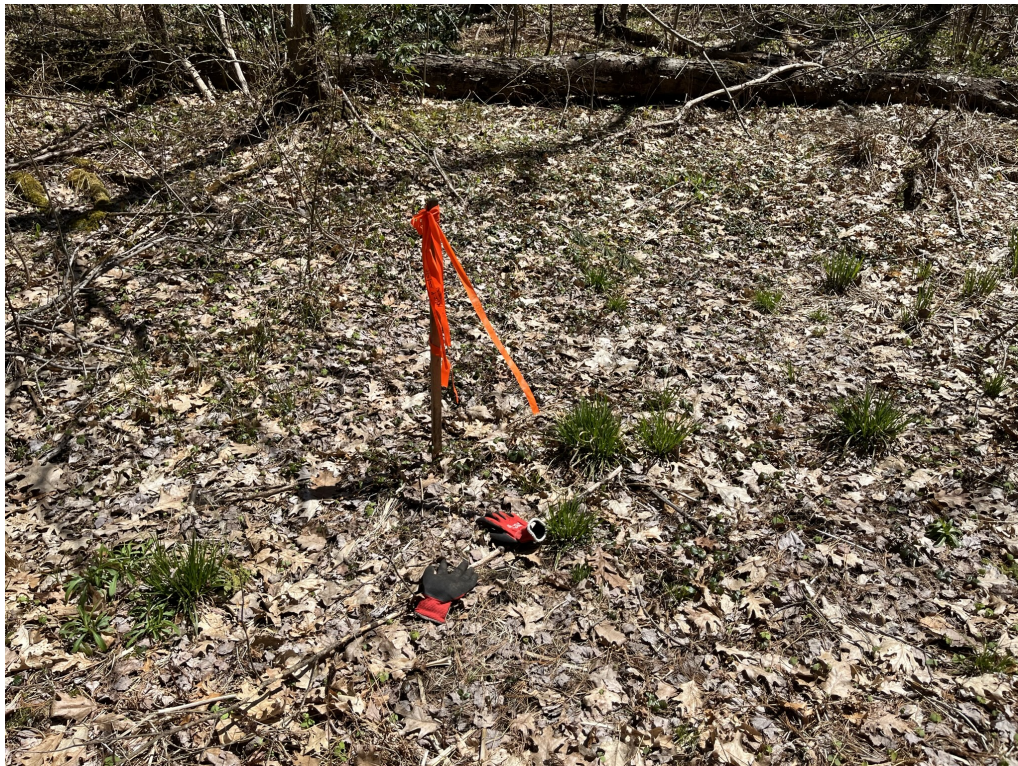
Photo 1 taken by EBT, Inc. on 5/1/2022 at 12:41pm – Potential vernal pool identified on MassMapper at 263 New Boston Road containing no water. No water was at the surface through the study period of March and April 2022.

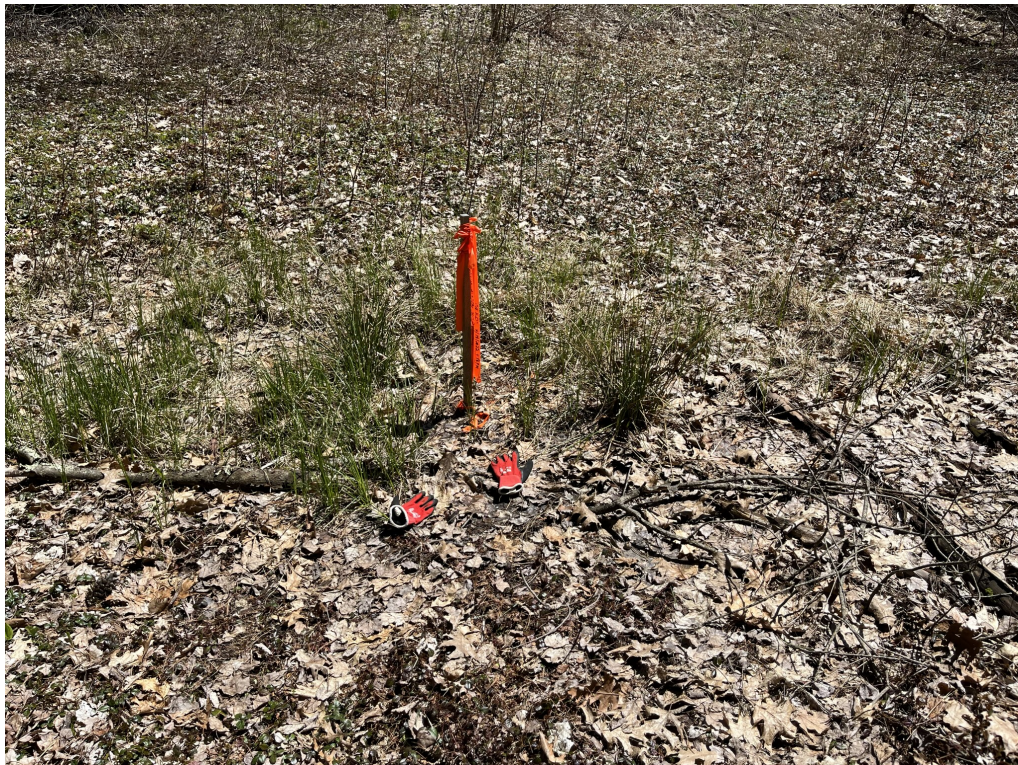
Photo 2 taken by EBT, Inc. on 5/1/2022 at 12:39pm – Pool located in the southwest corner of 269 New Boston Road containing no water. We paused for 10 minutes to listen for chorusing prior to accessing near the dried-up pool, no chorusing had occurred in the past nor was there chorusing at this time. There was no volume of water to sein through.
