Re. 263 New Boston Road, Sturbridge

BORDERING VEGETATED WETLAND DETERMINATION FORM

Project/Site: 263 New Boston Road City/Town: Sturbridge Sampling Date: 9/22/2023
 Applicant/Owner: Kenneth Leblanc Sampling Point or Zone: TP-1U
 Investigator(s): Glenn E. Krevosky Latitude / Longitude: 42°8'45" N, 72°4'46" W
 Soil Map Unit Name: Canton fine sandy loam, 8 to 15% slopes, extremely stony NWI or DEP Classification: _____

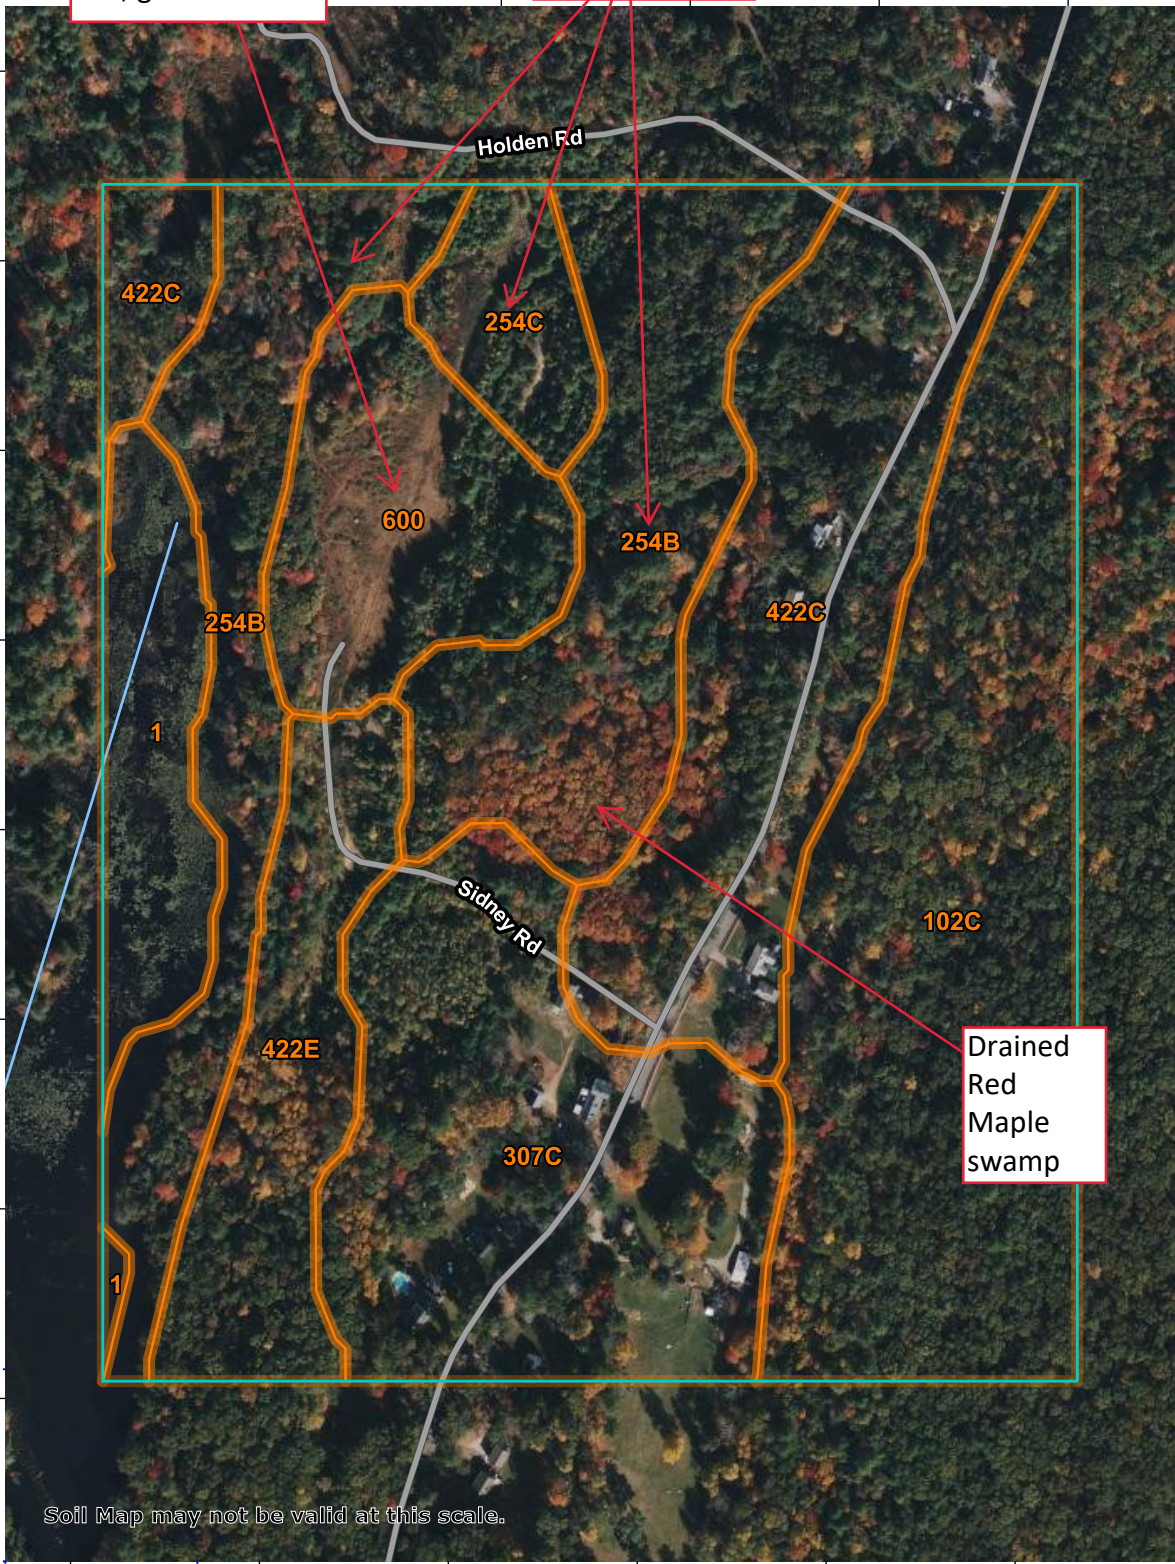
Merrimac -
Hydrologic Soil
Group A

Pits, gravel

Drained
Red
Maple
swamp

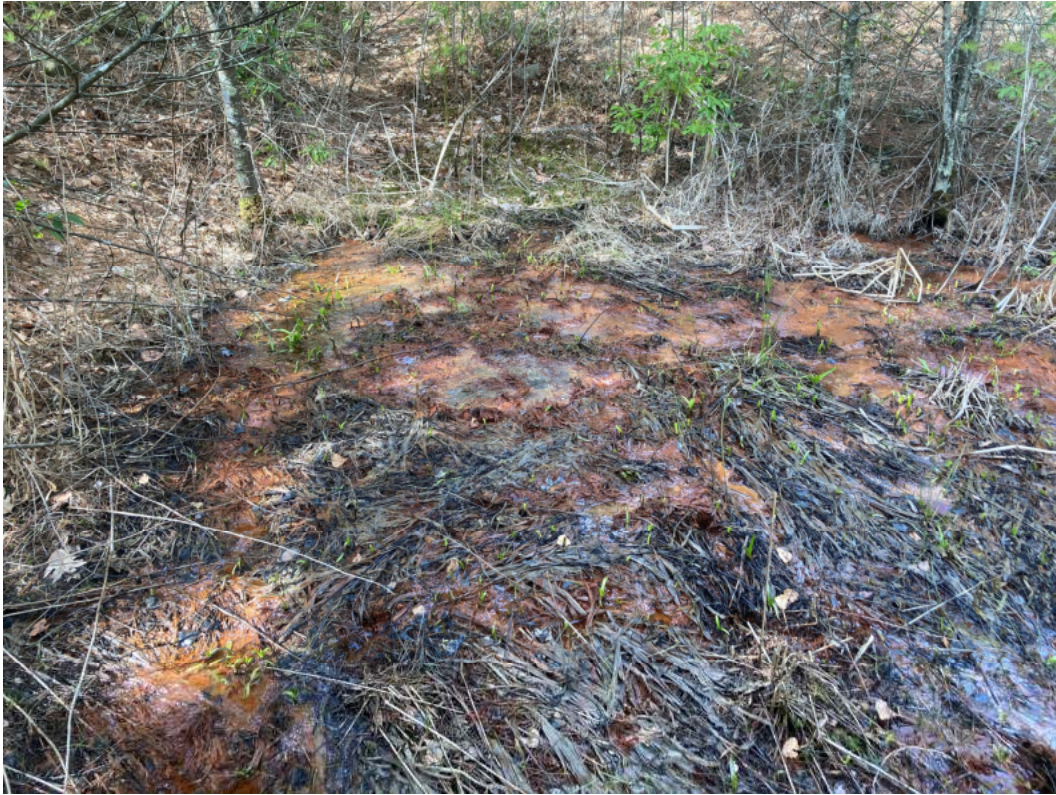
Photo 1 taken by EBT, Inc. on 4/9/2021 – Showing FE+2 to FE+3 significant ground water discharge at the western base of the 35± foot cut abutting the applicant’s property – the steep cut drained the Merrimac soil water table to the east bringing water soluble FE+2 with it.

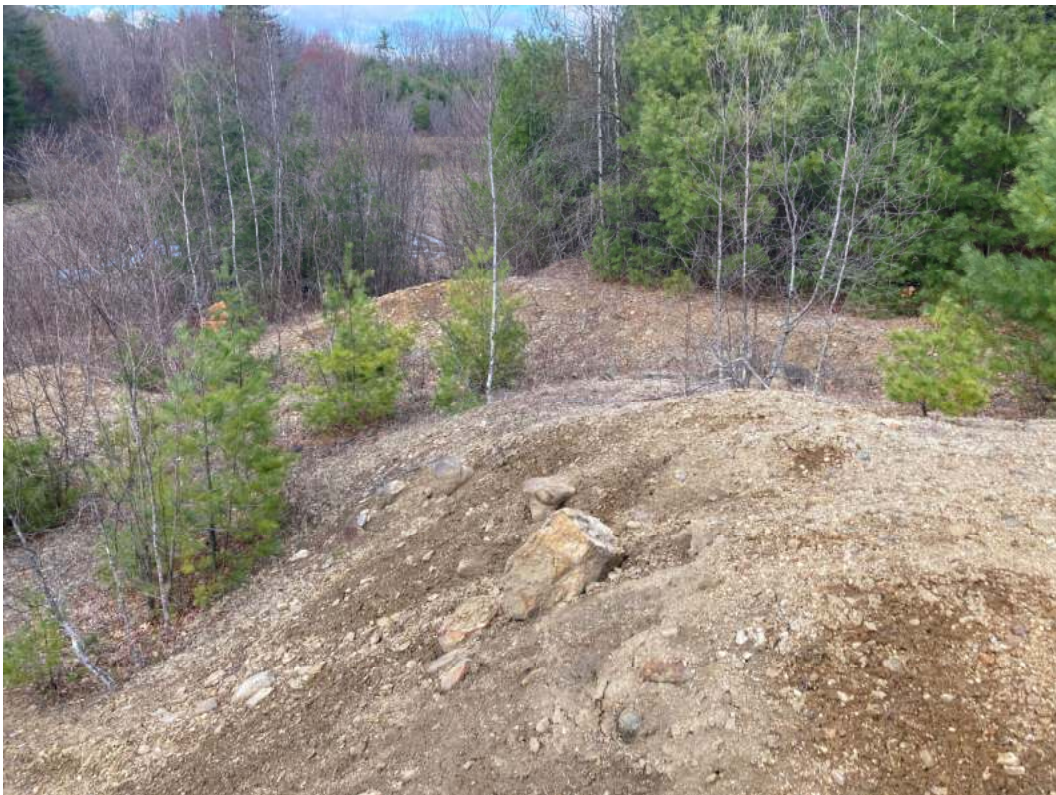
Photo 2 taken by EBT, Inc. on 4/18/2021 – Showing western slope of gravel pit abutting the Ken Leblanc property.

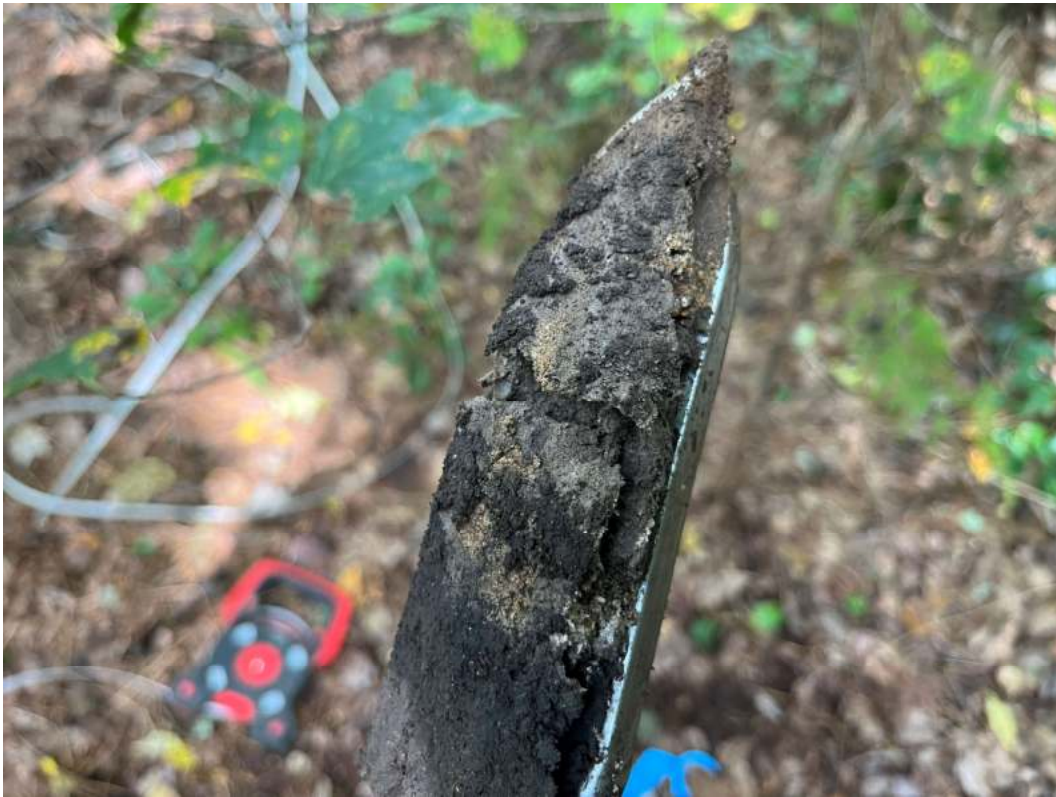
Photo 3 taken by EBT, Inc. on 9/22/2023 – Showing what was described in the peer reviewer’s letter as a sand layer which is a layer with some sand in it and silts and clays. This layer is not as porous as to what was alluded to.

Contained within this document is evidence that the thin layer of sand within a matrix of silt, clay and organics (see Exhibit 3A, Photo 3) did not drain the wetland between SCC Wet 1 through 5 and SCC Wet 101 through 105. This layer was not formed by a gravel pit, as the pit was located ~430 feet to the west - during the agricultural era there may have been erosion from the slope to the east. The peer reviewer's report did identify Eastern White Pine but did not identify the other dominant upland plants Black Birch, Witch Hazel, Mountain Laurel and Hay Scented Fern also growing within the narrow delineation the peer reviewer placed (SCC Wet 1 through 5 and SCC Wet 101 through 105). EBT, Inc. performed DEPs new 2023 BVW Determination Form (see Exhibit 1A), which indicates upland plants dominate the narrow glacial outwash feature and also indicates there was no water table (during this high-water table time of the year) within 30" of the mineral soil surface (see Exhibit 8A). The other exhibits listed below outline the historical sequence of the area through USGS mappings and aerial flyover (see Exhibit 4A to 7A). In addition, the somewhat excessively drained Merrimac soil types at the site are shown (see Exhibit 2A) overlying the application property and extending into the former gravel pit. The formation of the gravel pit with its 35' deep cut on its eastern flank is what caused the draining of the land to the east (and the potential vernal pool - see Exhibit 3A, Photos 1 & 2 and Exhibit 9A). The soils identified within the narrow ravine are relic hydric soils, meaning they were formed within the water table or under water but have been drained. This draining is what allowed the upland plants identified in the data form to dominate the narrow glacial outwash feature in contention.

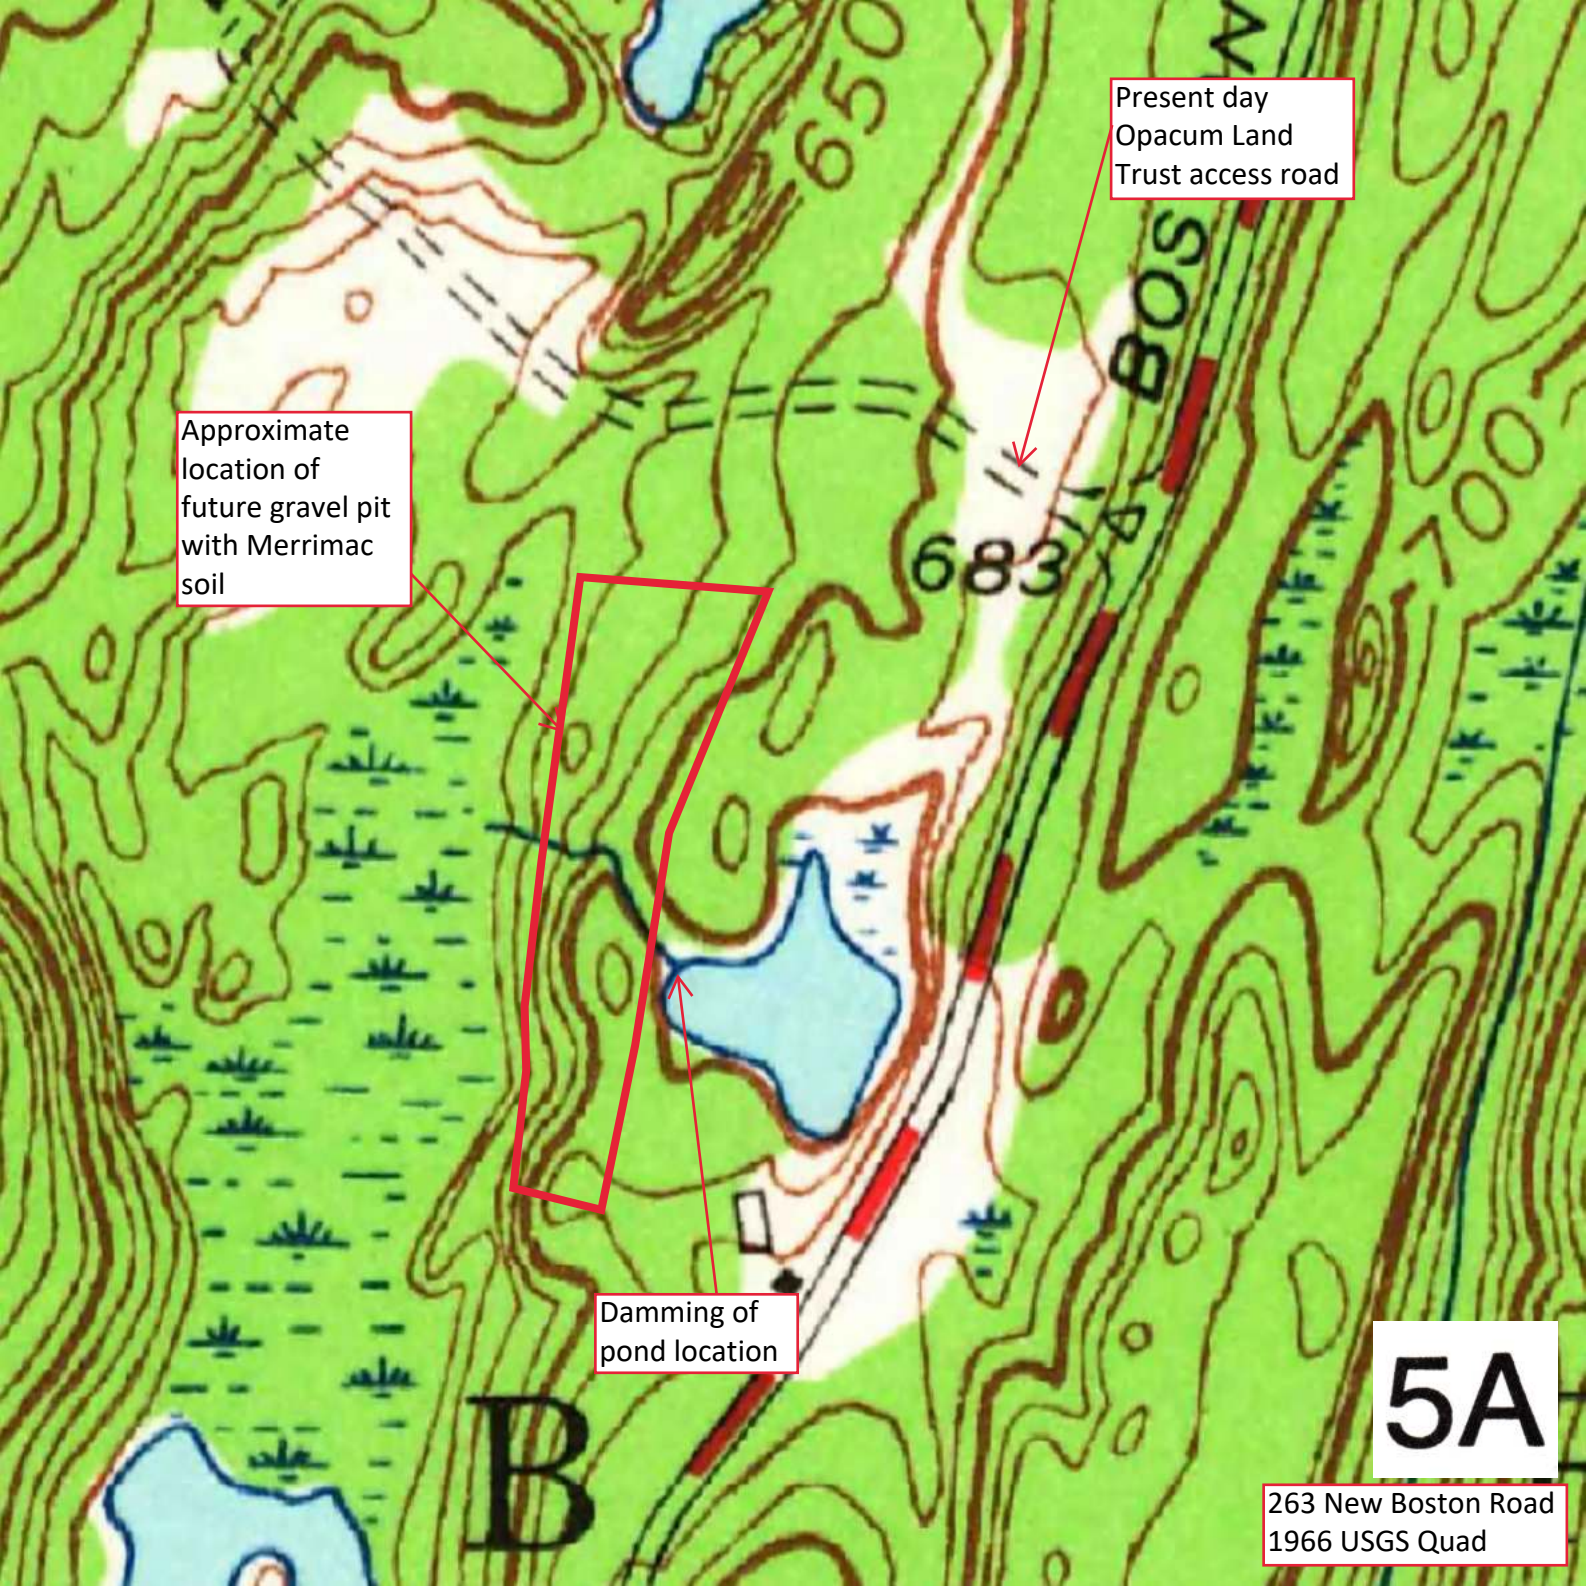
5A

Approximate location of future gravel pit with Merrimac soil

Present day Opacum Land Trust access road

Damming of pond location

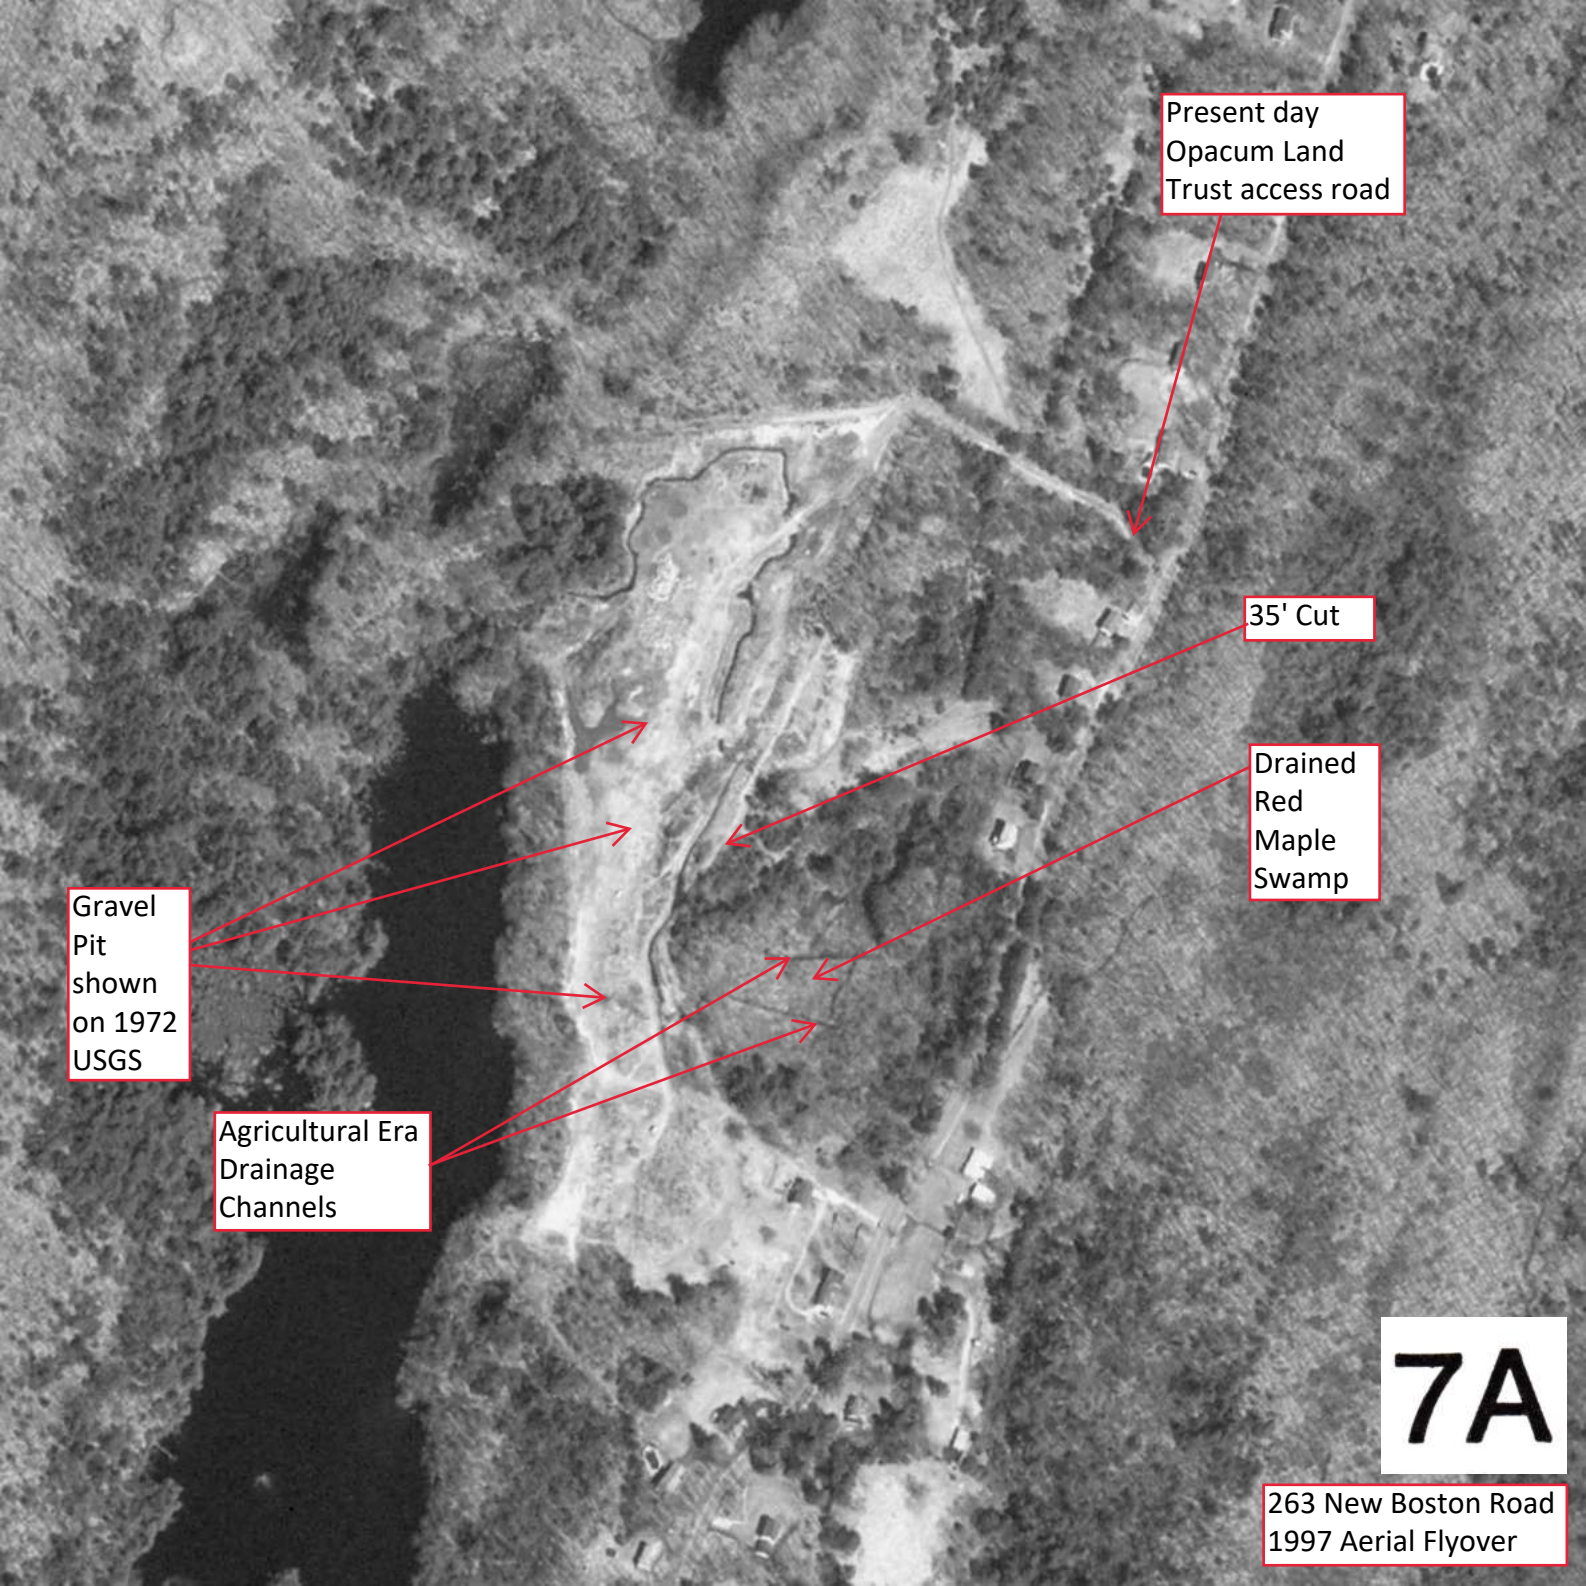
7A

Present day
Opacum Land
Trust access road

35' Cut

Drained
Red
Maple
Swamp

Gravel
Pit
shown
on 1972
USGS

Agricultural Era
Drainage
Channels

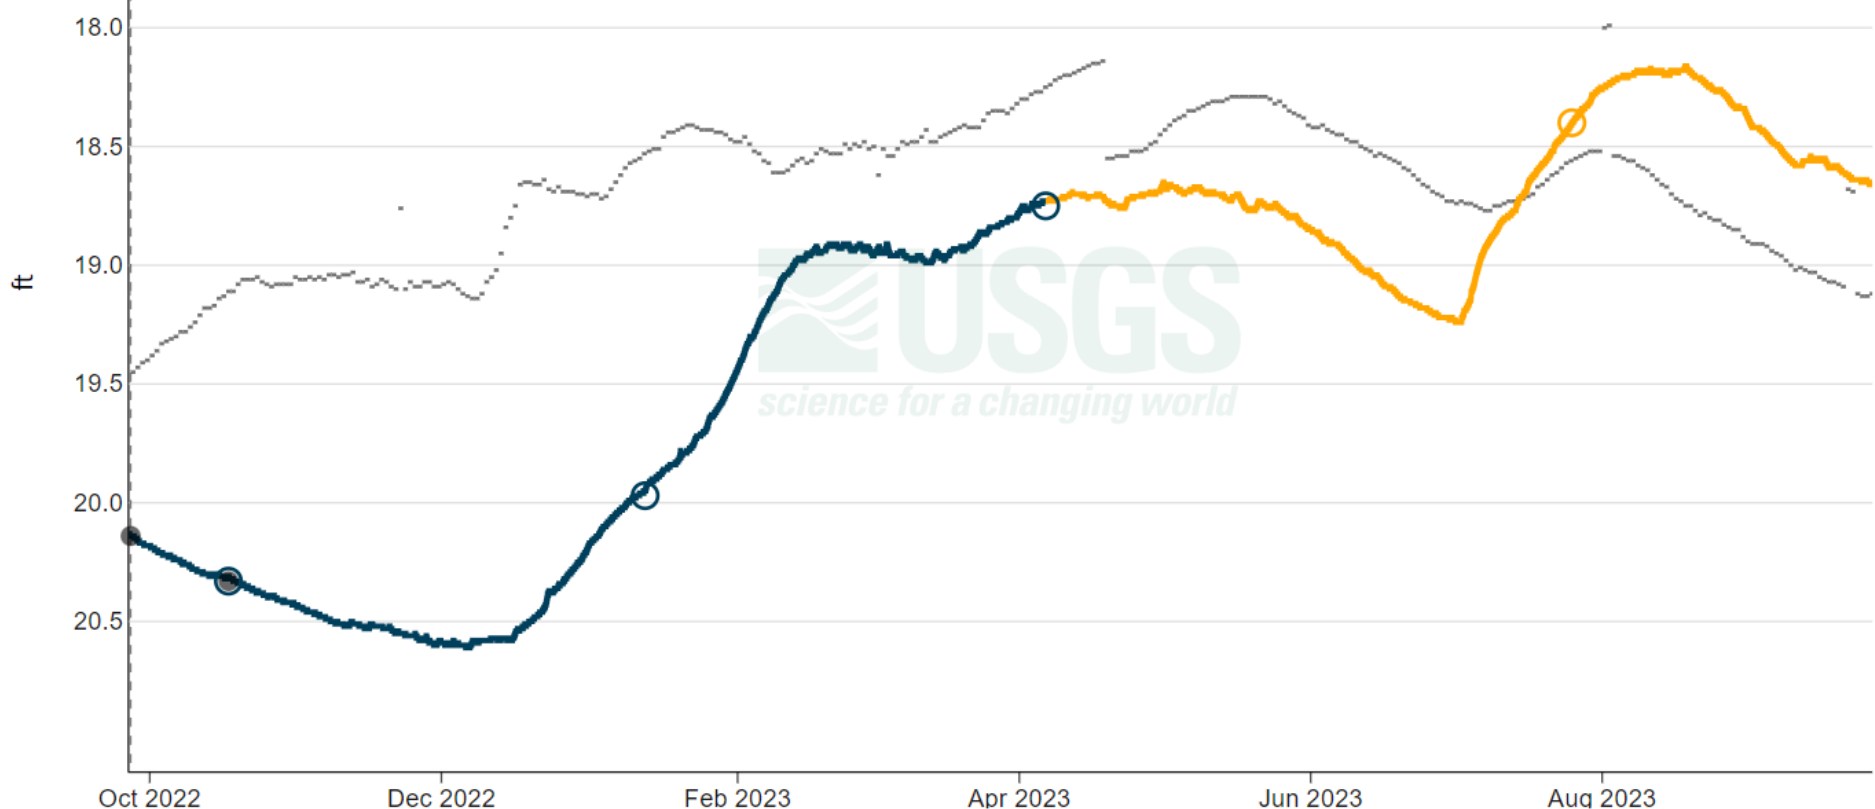
Show **8A**

Ma-Wuw 2R West Brookfield, MA - 421410072081101

September 26, 2022 - September 26, 2023

Depth to water level, feet below land surface

20.14 ft - Sep 27, 2022 12:00:00 AM EDT

20.33 ft - Oct 17, 2022 11:19:00 AM EDT
