**Re: Notice of Intent Application – Heating Fuel Release Emergency Response & Remediation Activities
53 Caron Road, Sturbridge, MA
CMG ID 2019-137**

Continued remediation activities as outlined in the Immediate Response Action Plan for 53 Caron Road, prepared by CMG Environmental, Inc. (dated 9-6-2019). All remediation activities are in response to a leak from an above-ground storage tank holding heating fuel on July 8, 2019.

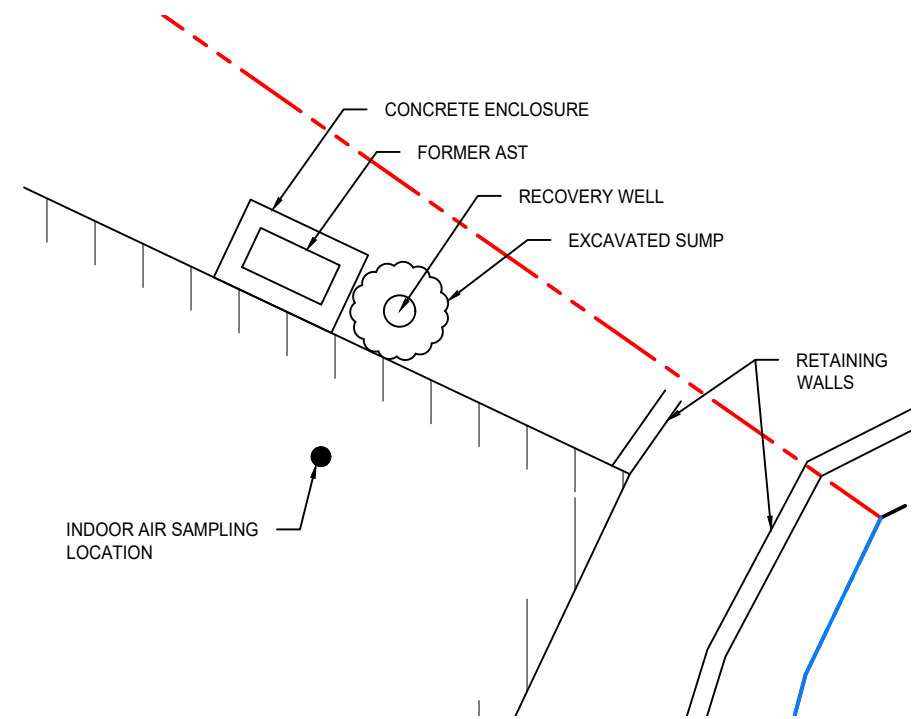
FIGURE 2: SITE PLAN

from the AST, which they calculated as approximately 150 gallons. CMG inspected the Site and observed the source of the release to be an aboveground copper fuel line for the AST. We also noted an oil sheen coming from a retaining wall along Cedar Lake, measured at 21' from the release area.

AST RELEASE AREA DETAIL
