CONSERVATION COMMISSION AGENDA

March 2, 2021 @6:00 pm
Virtual Meeting

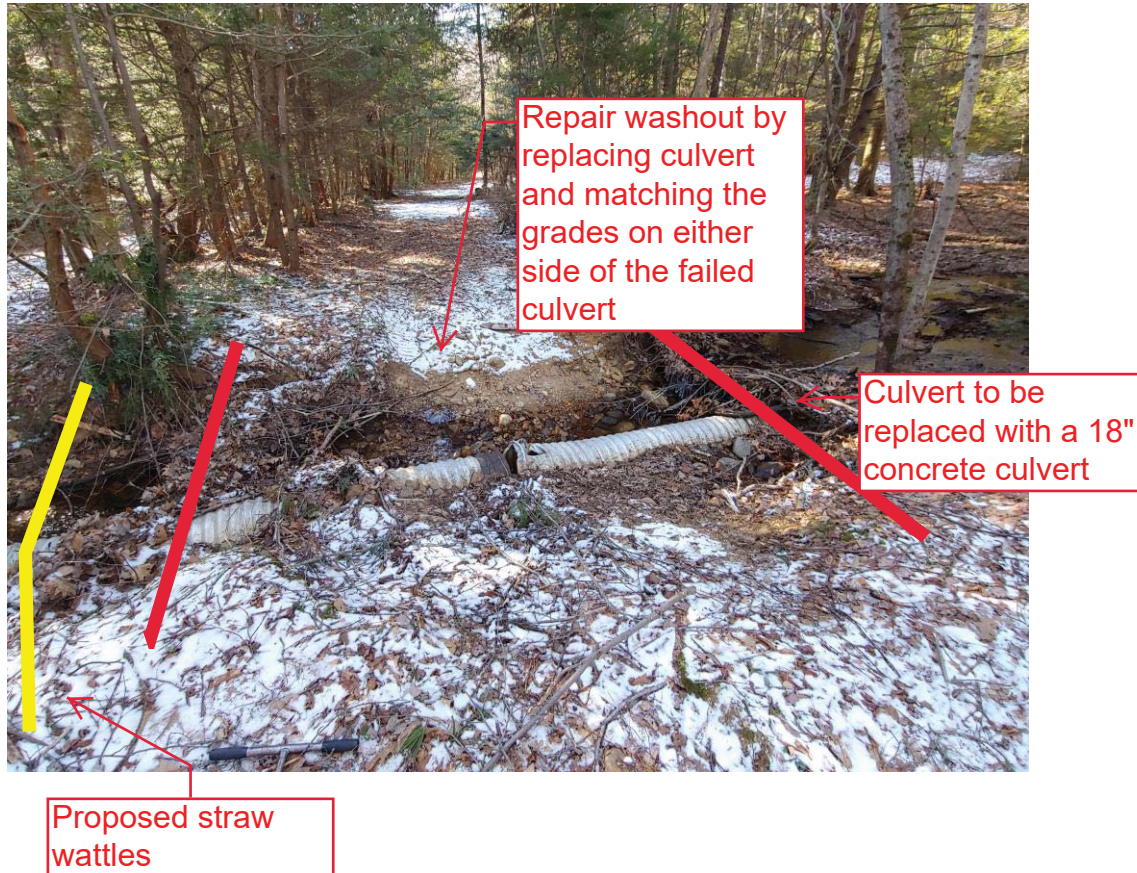
Culvert Repair Protocol

1. Work will be conducted during a no flow or minimal flow period;
2. Install erosion control barrier consisting of straw wattles on the downgradient side of the work area;
3. Replace the existing damaged culvert with a new 18" concrete culvert. The existing length of the culvert is 22-feet. The new culvert will be the same length. The increased size will increase the capacity make the culvert less susceptible to clogging;
4. Clean gravel/crushed stone will be installed to match the grades on either side of the washout.
5. Once fully stabilized and the erosion control barrier will be removed.

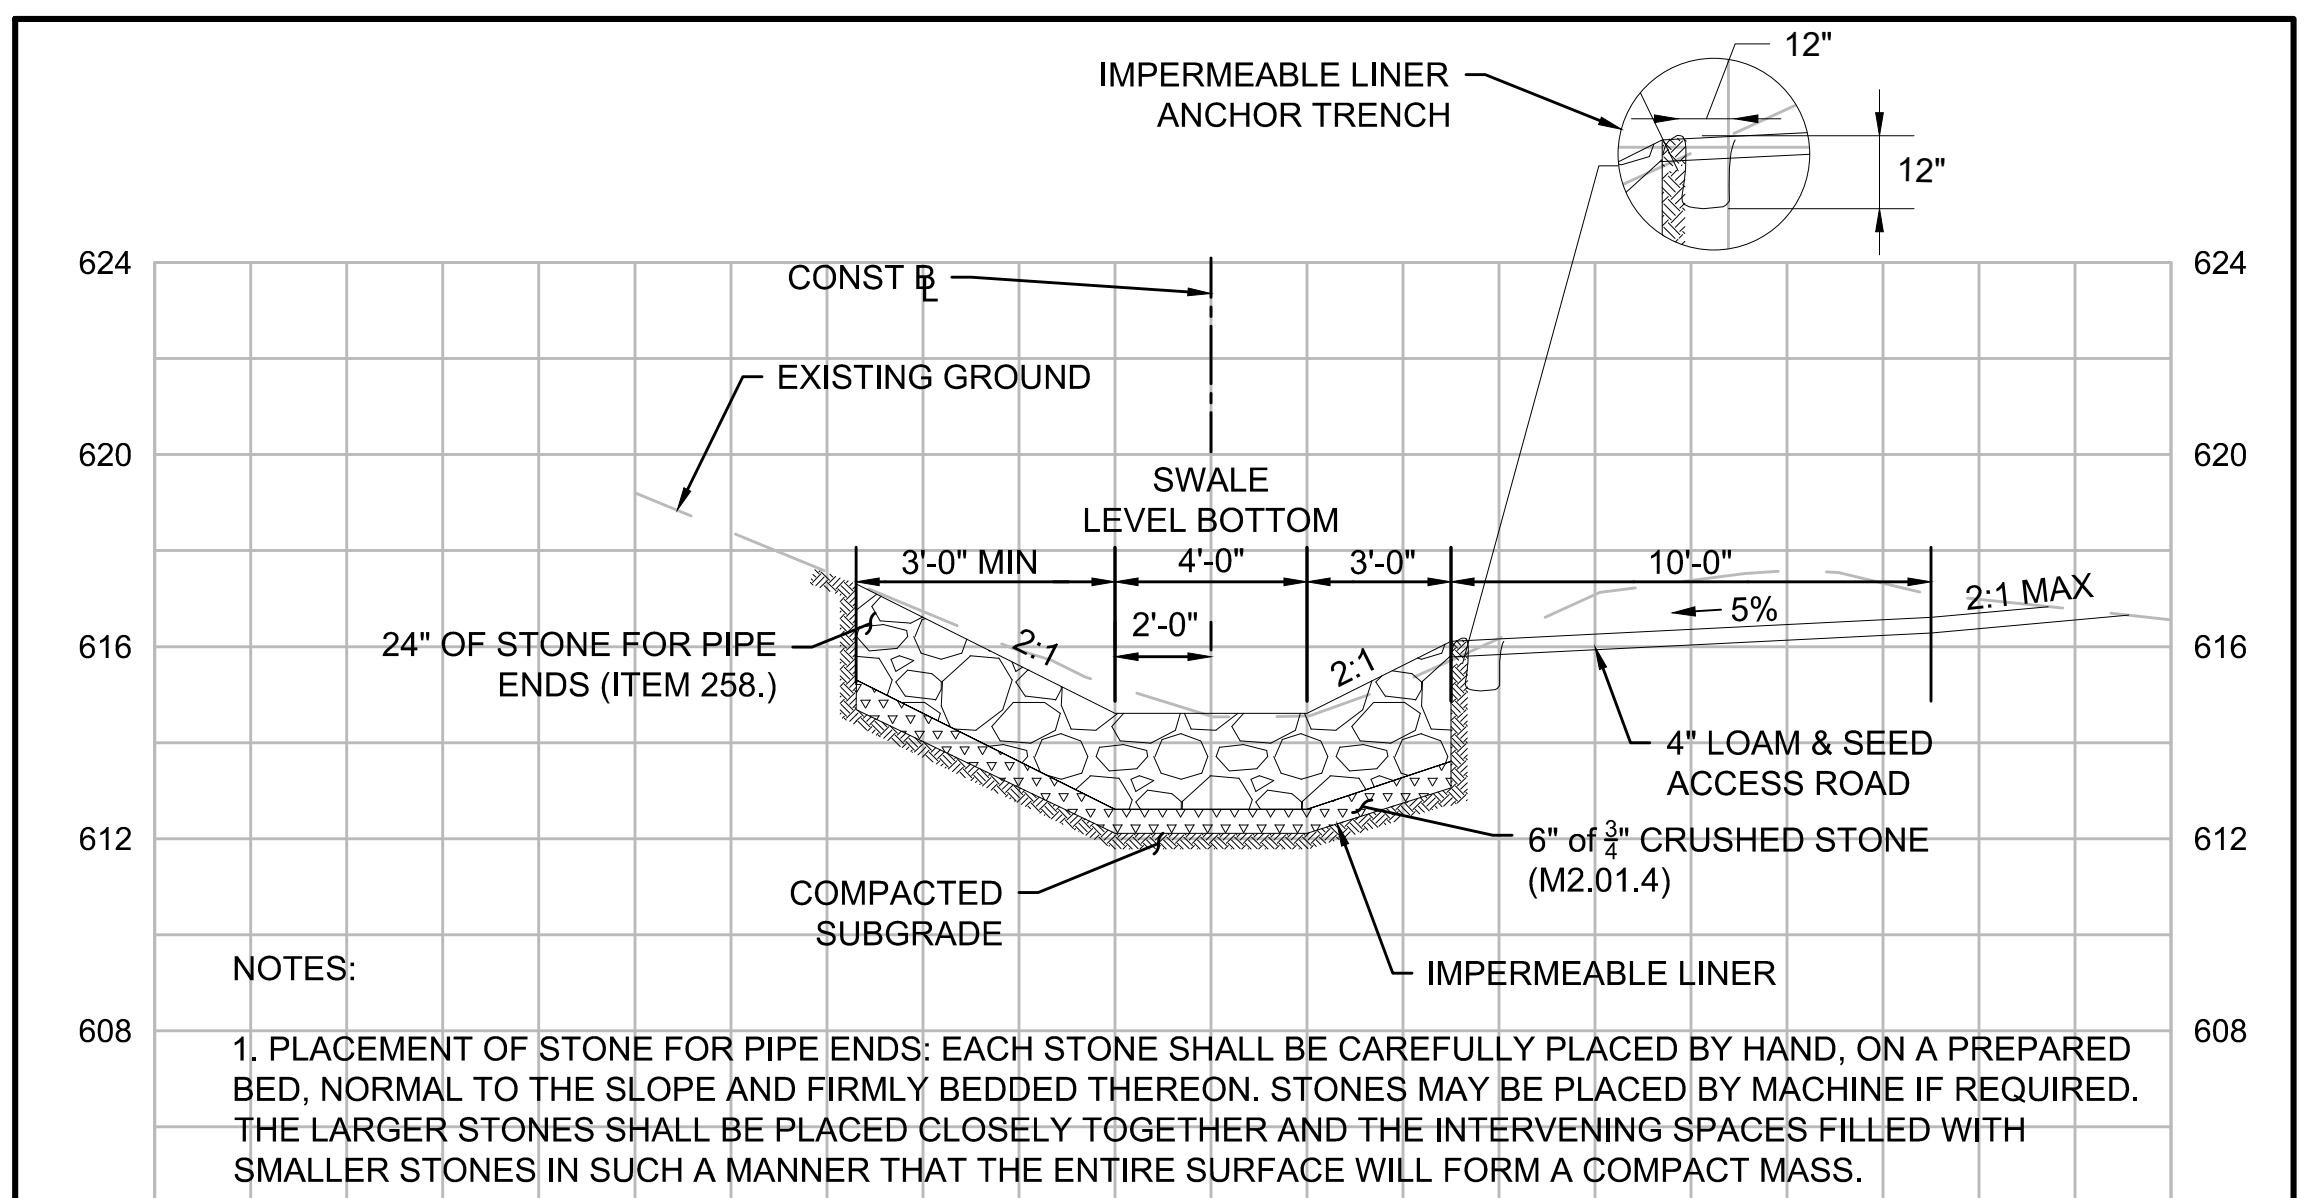
SECTION C-C
 SCALE: 1" = 4'

NOTES:
 1. PLACEMENT OF STONE FOR PIPE ENDS: EACH STONE SHALL BE CAREFULLY PLACED BY HAND, ON A PREPARED BED, NORMAL TO THE SLOPE AND FIRMLY BEDDED THEREON. STONES MAY BE PLACED BY MACHINE IF REQUIRED. THE LARGER STONES SHALL BE PLACED CLOSELY TOGETHER AND THE INTERVENING SPACES FILLED WITH SMALLER STONES IN SUCH A MANNER THAT THE ENTIRE SURFACE WILL FORM A COMPACT MASS.

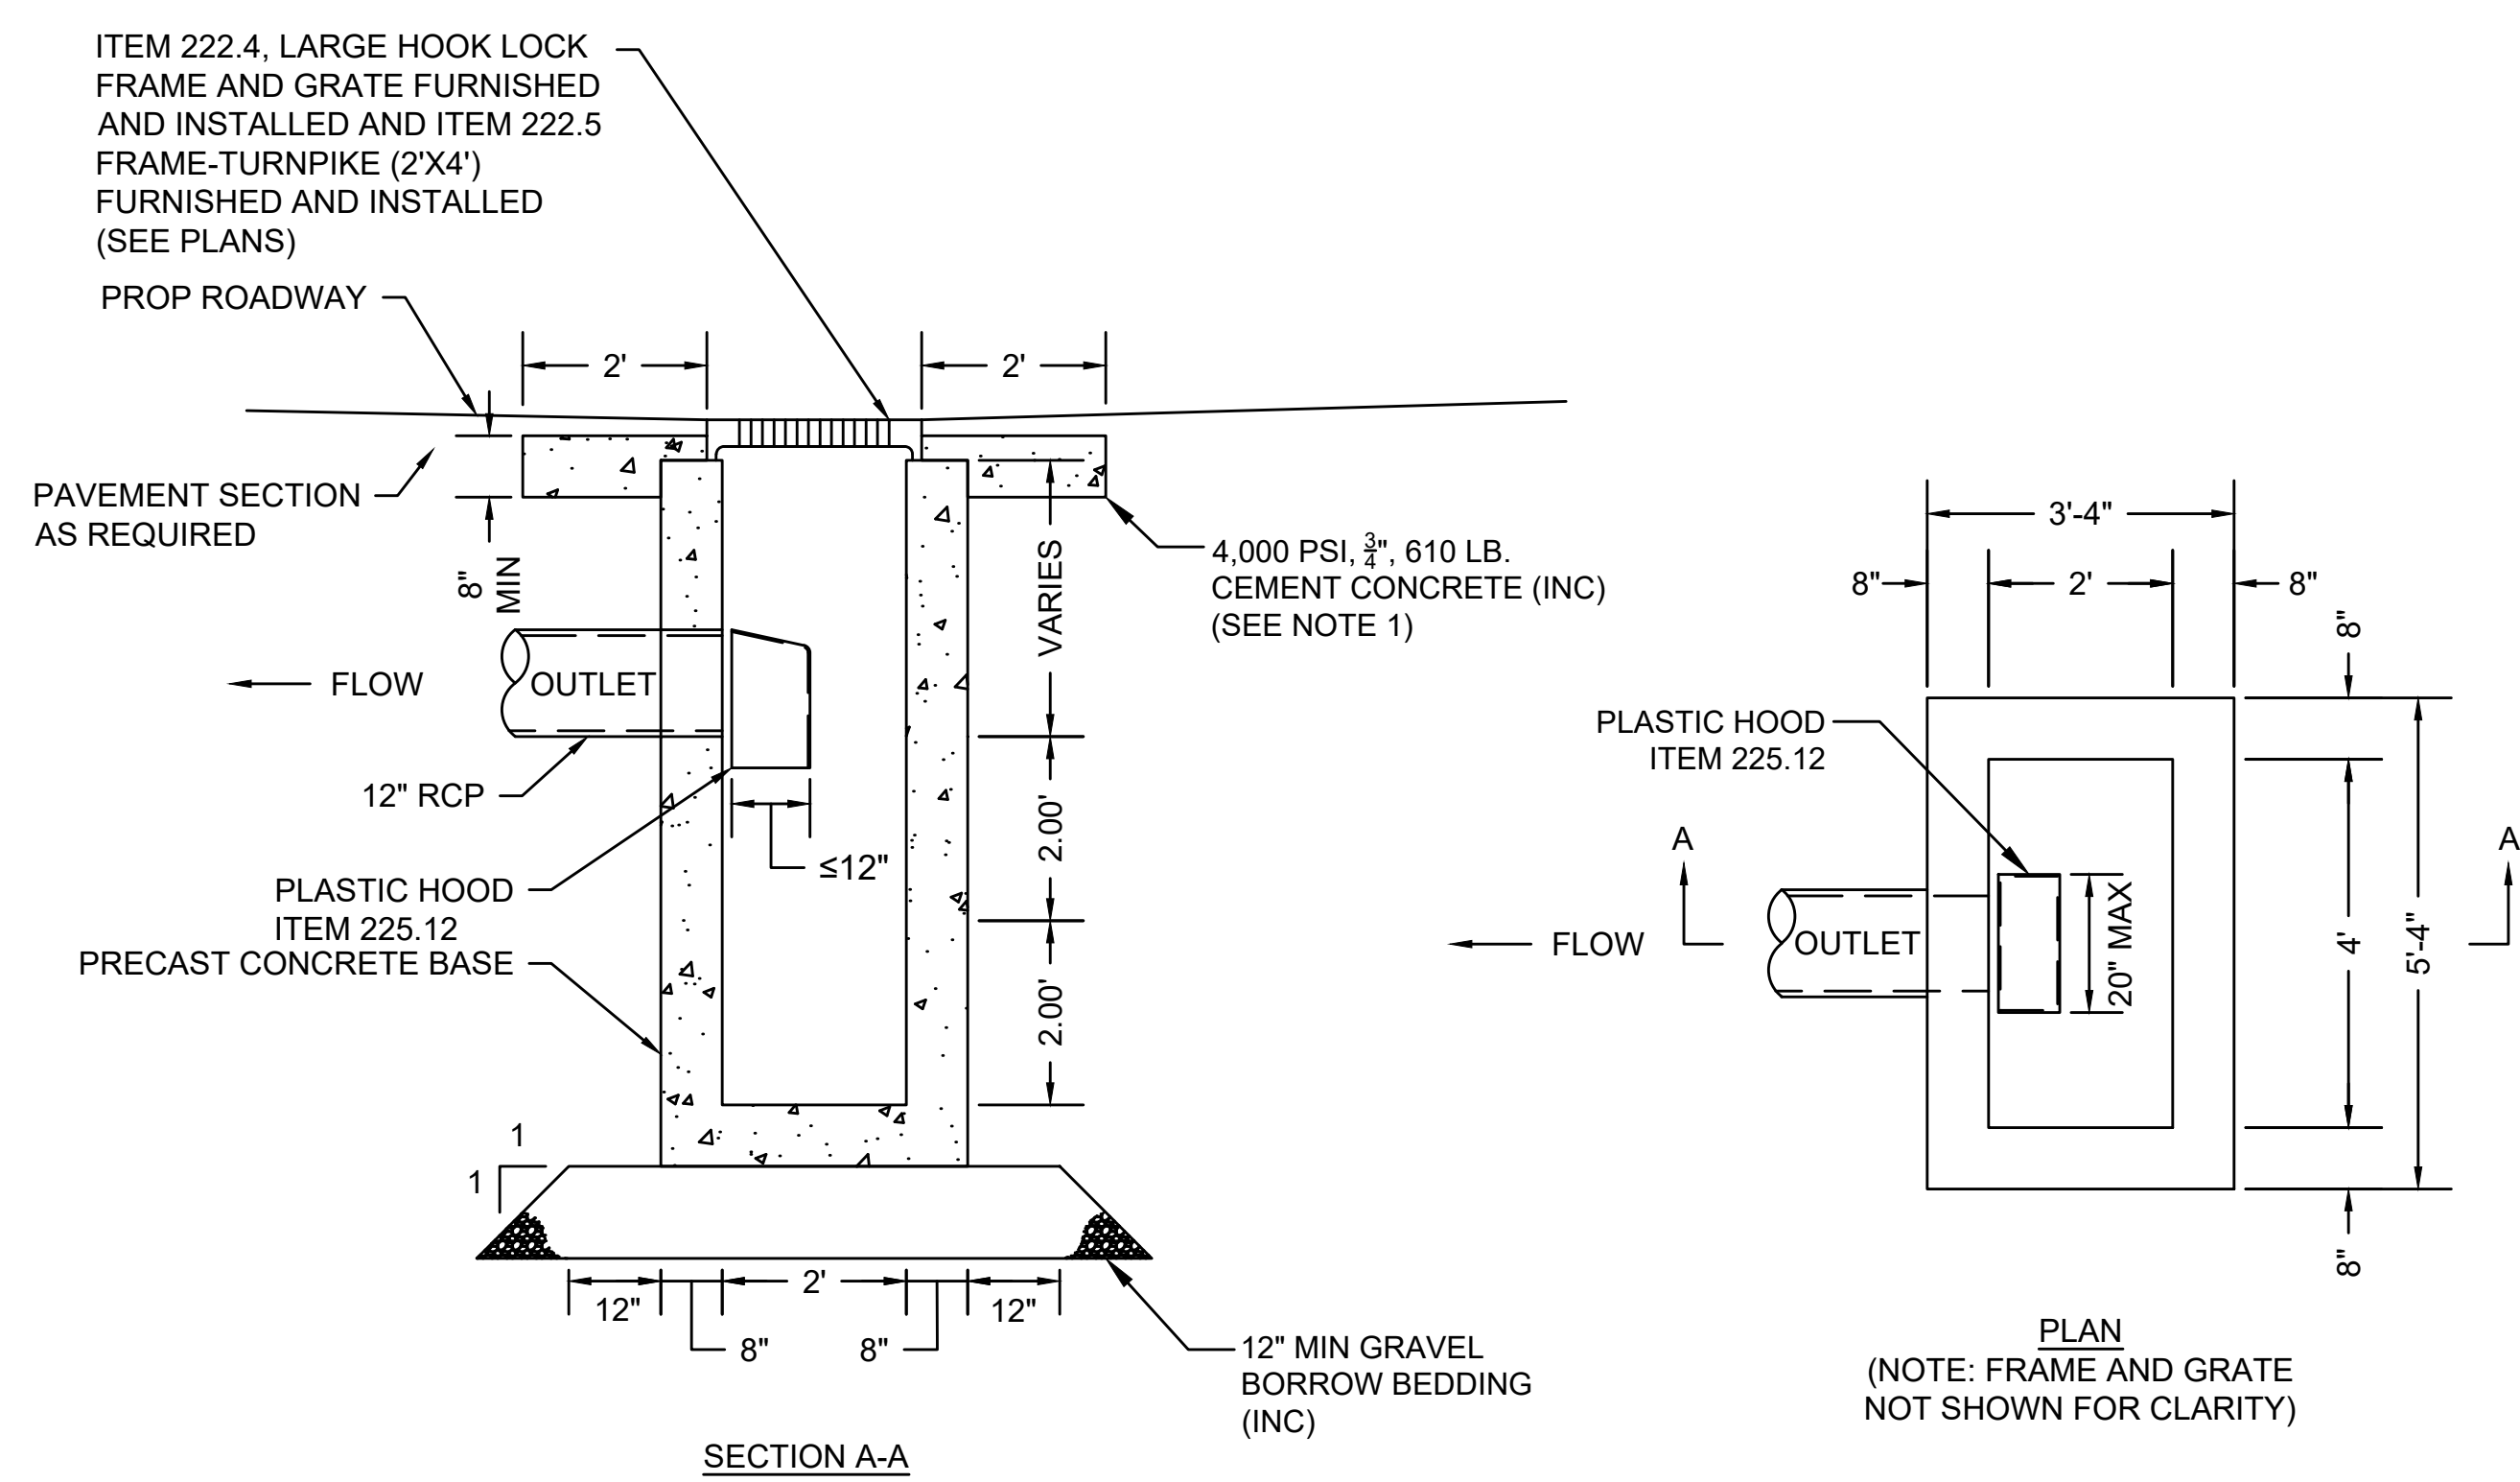
SPECIAL DROP INLET
NOT TO SCALE

NOTE:
1. 4,000 PSI, 3/4", 6' 0 LB. CEMENT CONCRETE REQUIRED FOR 2'-0" AROUND BASIN, CEMENT CONCRETE REQUIRED AS NECESSARY BETWEEN INLET AND BARRIER. GRADE ALL CEMENT CONCRETE TOWARD DRAIN TO INLET. PAYMENT INCLUDED IN COST OF ITEM 209.2

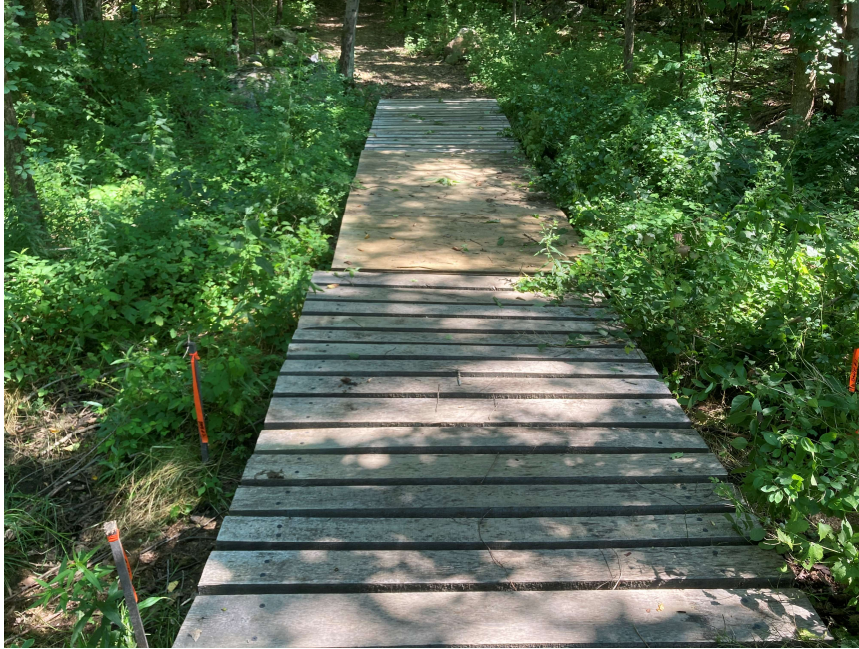
Photo 1 taken by EBT, Inc. on 7/19/2020 – Showing the 40.36’ long foot bridge with a section of plywood decking which needs to be replaced.

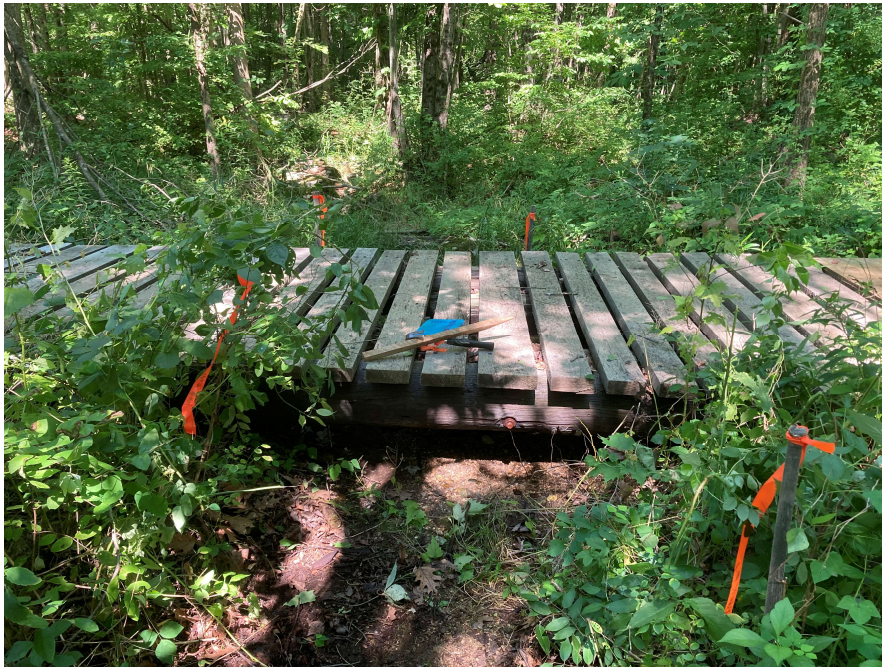
Photo 2 taken by EBT, Inc. on 7/19/2020 – Showing the general spacing of the 2” planking and the 8” height of the bottom of the pole at the brook flow location over the intermittent stream bottom.

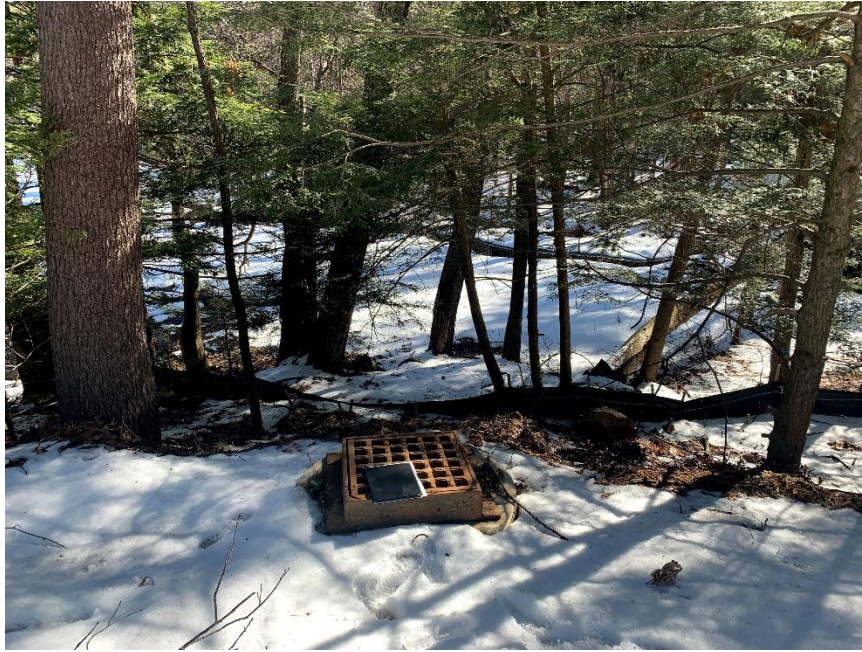
Figure 1: Looking at Hydrodynamic Separator East Toward Pond

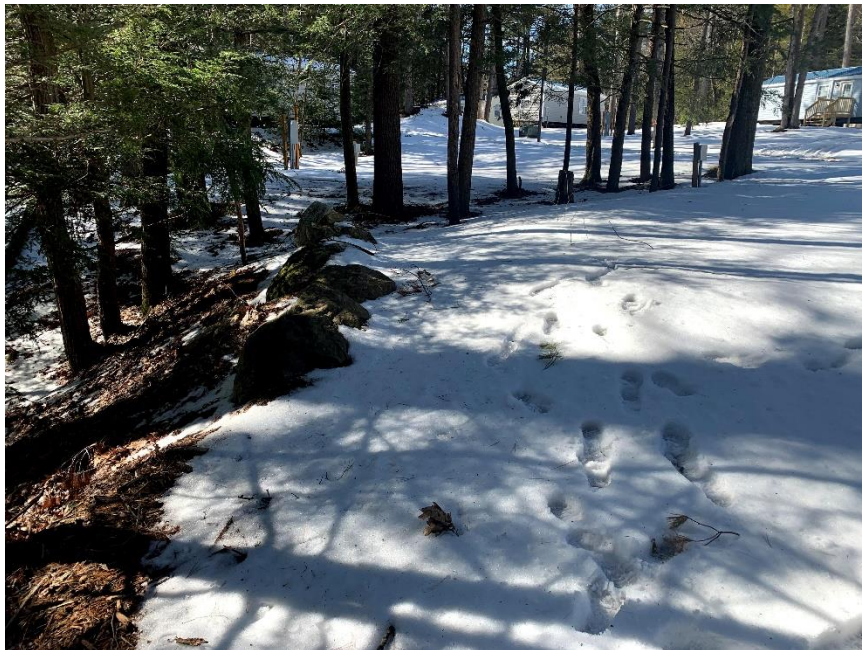
Figure 2: Standing on Hydrodynamic Separator Looking South at Proposed Swale in Site 902/903

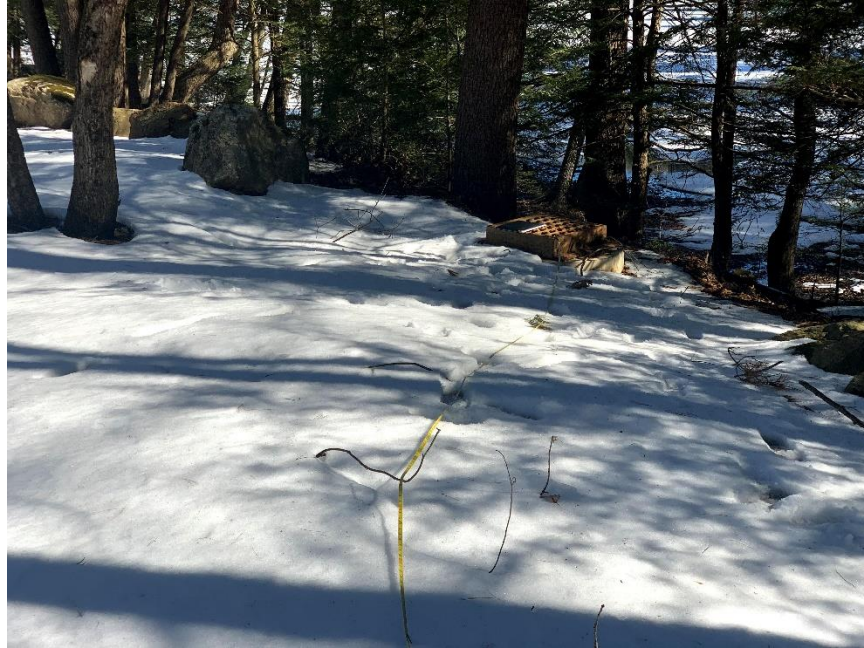
*Figure 3: Facing Northeast at Hydrodynamic Separator from Proposed Swale in Site 902
(yellow tape indicates rough location of swale)*

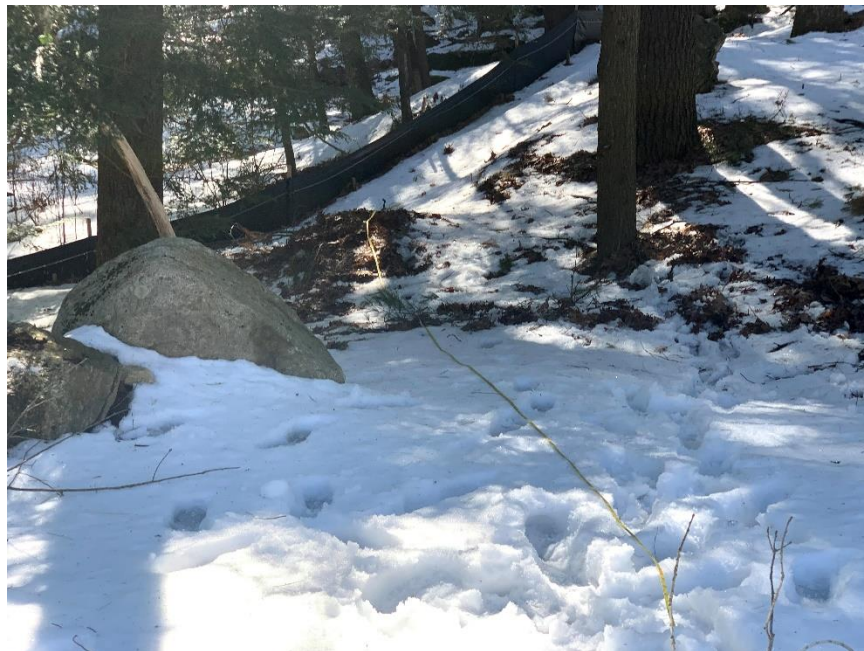
Figure 4: Facing Southeast in Site 902 Showing Outlet of Proposed Swale (yellow tape indicates rough location of swale)
