Geotechnical Investigations, 469A Main Street Trail and Bridge Project

Main Street / Stallion Hill Road
Sturbridge, Massachusetts

Notice of Intent

Re: **Notice of Intent**
Geotechnical Investigations, 469A Main Street Trail and Bridge Project
501 Main Street, 483A Main Street, 469A Main Street, and 52 Stallion Hill Road
Sturbridge, Massachusetts

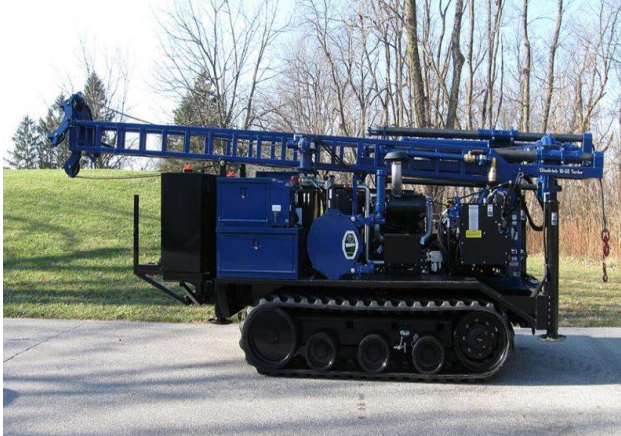
Figure 1: Diedrich D-50 Track Mounted ATV, Geotechnical Boring Rig; Machine Proposed to be Used to Collect Data.

The borings will be completed within the proposed pedestrian bridge and boardwalk footprint. A Geotechnical Boring Rig¹, as seen in Figure 1, will be advanced to each boring location. Each boring will be advanced with hollow-stem augers or flush joint casing using drive and wash methods. A boring is proposed near each abutment of the proposed pedestrian bridge (Borings 2 & 3) and will be advanced to a target depth of approximately 40-feet below ground surface, or refusal, whichever is shallower. Boring 1 is proposed within the footprint of the proposed boardwalk and will be advanced to target depths of approximately 30-feet below ground
