Three Oaks Environmental

Re: Additional wetlands information
235 & 237 Pondunk Rd.

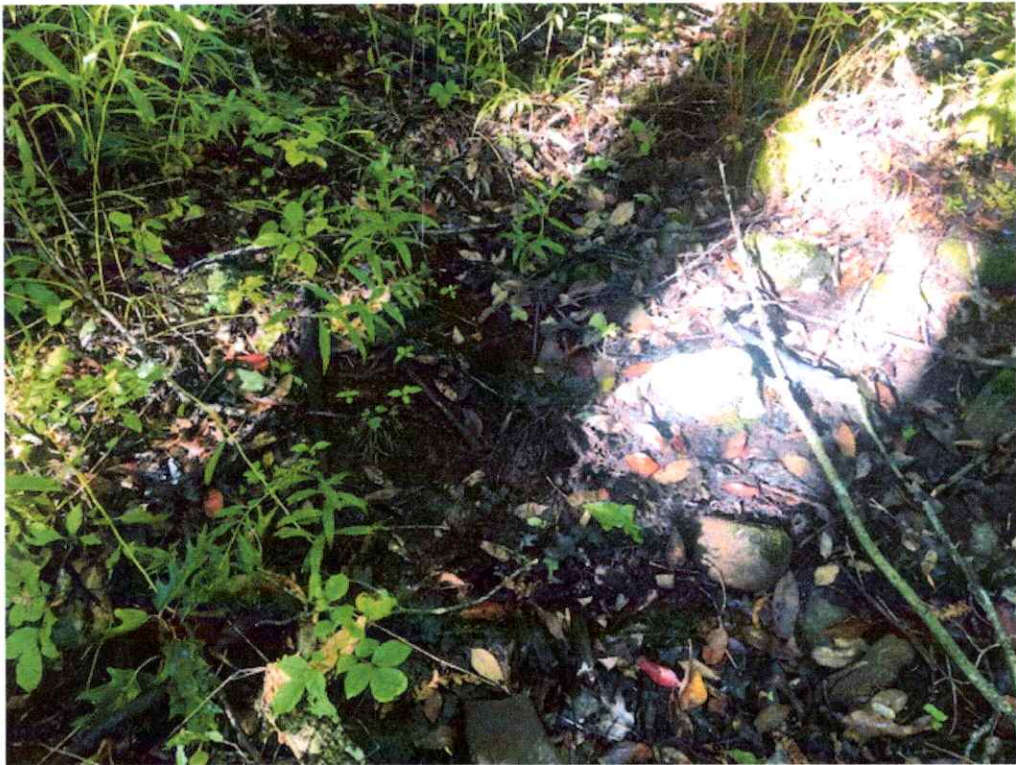
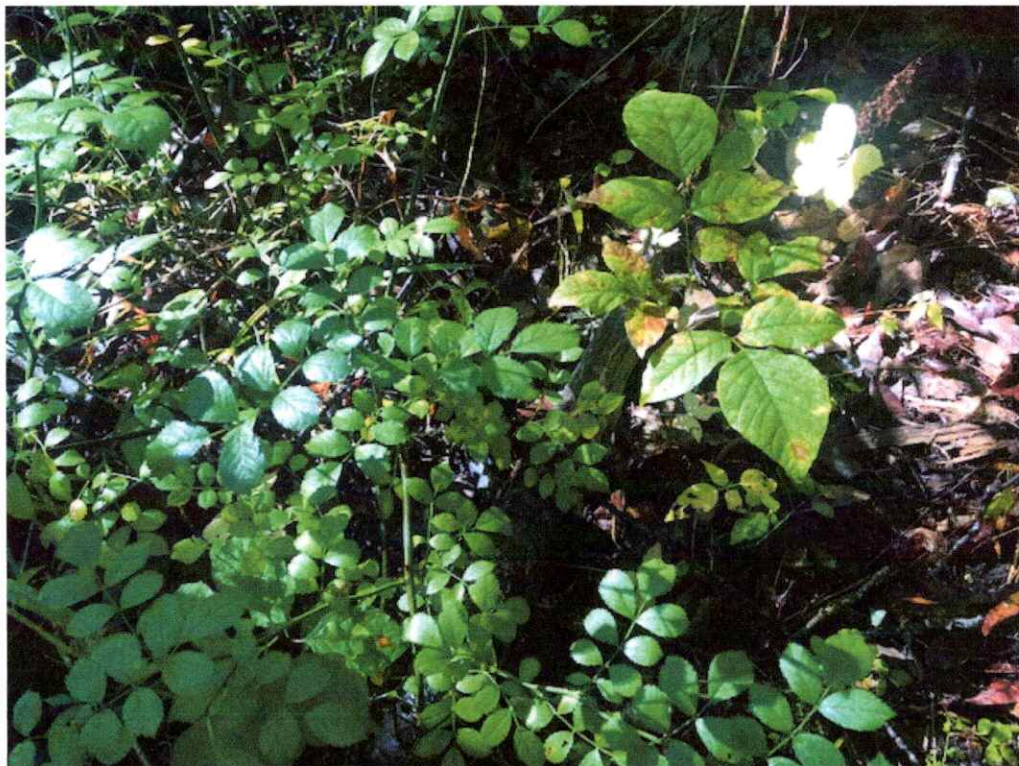
Vegetation along upland rise between the study plot and the wetland line

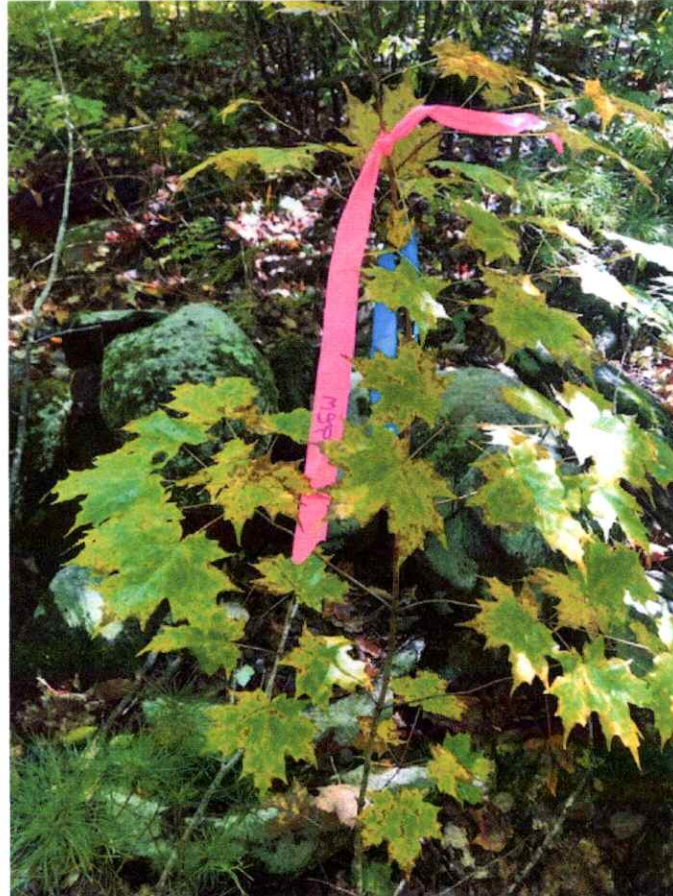
Pink flags with the original wetland numbering coincide with the recent blue flags as seen on this sugar maple.

I also placed pink flagging on the existing wetlands line that corresponds to the numbers shown on the most recently revised plan. The survey crew had incorrectly located flag W26 and had two flags labeled W27. One of those W27 flags, at the stonewall on the property line, has been corrected as W26 on the plan.

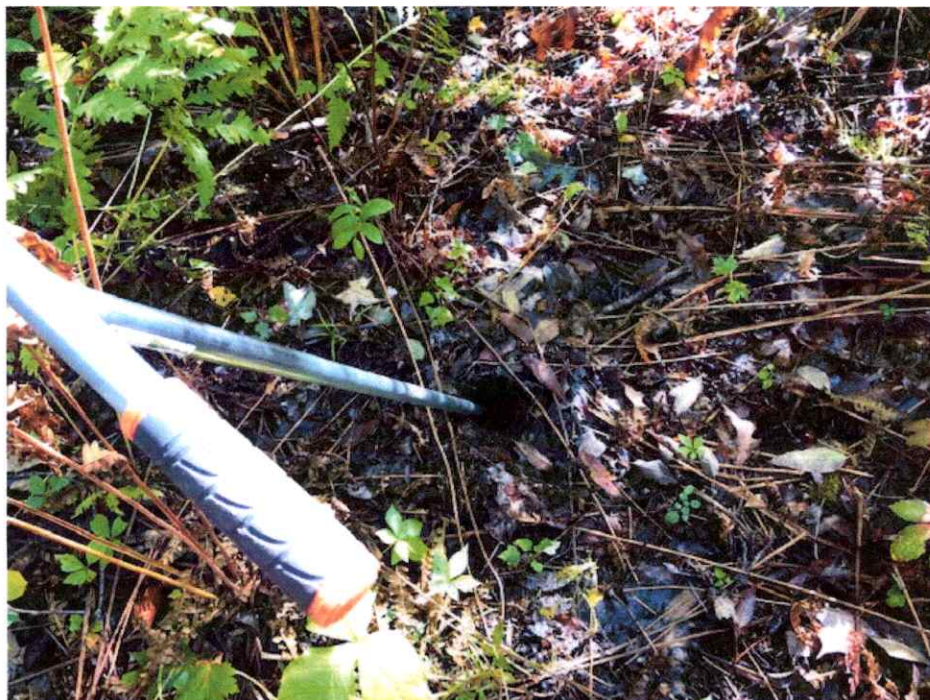
Soil augur location chosen along the flow path identified in the field today

I examined a depression with some wetland vegetation present and then followed a flow path from it towards the downgradient BVW. The flow path breaks up a short distance from the depression where there is an upland rise. I analyzed a spot within the apparent flow path which was a low area upgradient of the upland rise. The herbaceous layer was mixed. I performed an analysis of the plant community using the DEP wetland delineation data method (see attached). I was unable to auger more than 4 inches into the depression further upgradient that we had identified in the field during the site inspection this morning. I did find an area between the rocks and within the flow path we identified in the field where I was able to auger over 14 inches before hitting rock.

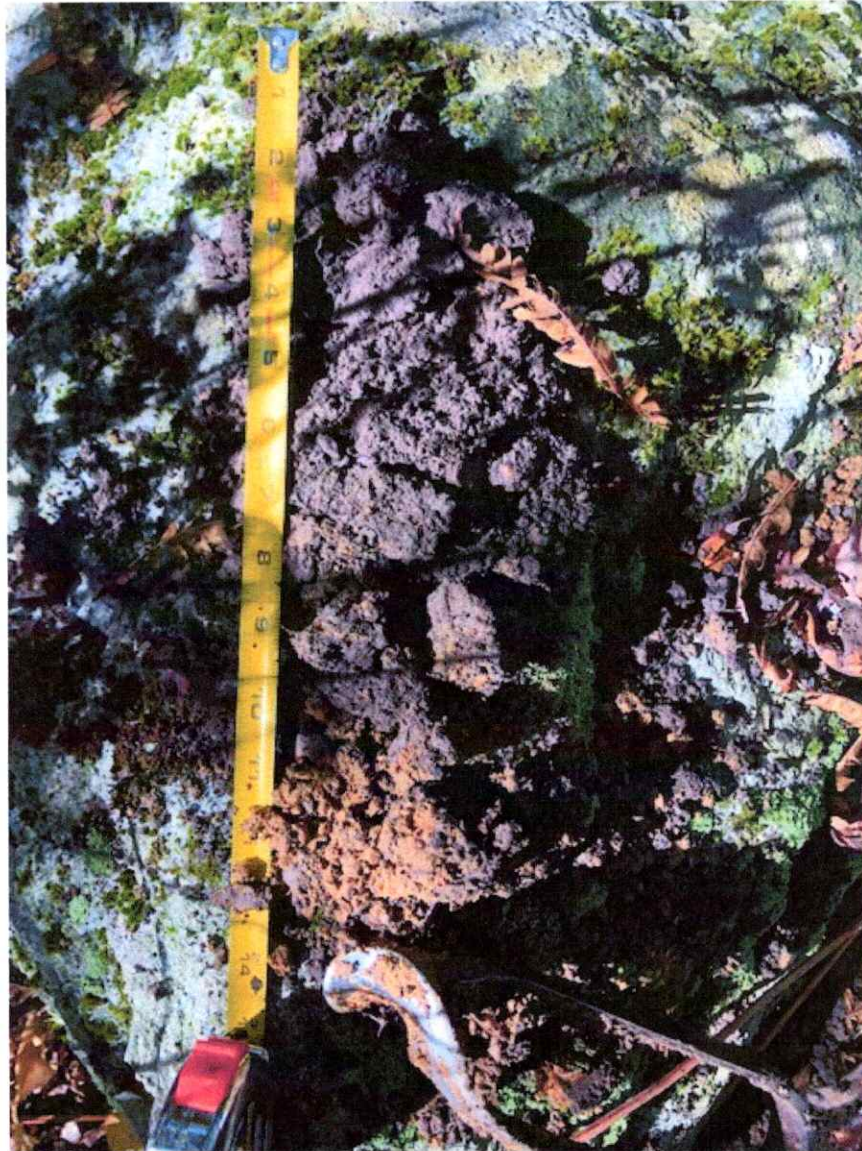
I placed the soil sections I augered, as noted in the previous photo, on top of a nearby gray rock. The first 10 inches was 10YR3/1, next 4 inches 10YR4/4

I had found the A horizon plow layer to be about 10 inches thick with a 10 YR3/1 munsell color, and the B horizon to be 10YR 4/4. Then I checked the Soil Web app on my phone and saw the soil to be identified as Woodbridge. The NRCS soil description is comparable to what I had identified. With the A horizon being 10YR3/2 and the B horizon 10YR4/4. The overall vegetation analysis conducted just downgradient of the soil hole also indicates an upland plant community in excess of 50%.. I have included the following photos and descriptions as well as the data sheet for the plot I analyzed.

Small pockets of wetland vegetation exist within small depressions (pits) in the overall upland plant community. Soil analysis confirms that this area is an upland even while possessing a mixture of wetland and upland plant species. The attached data sheet also indicates that the plant community exceeds 50% upland species.
