# Massachusetts Department of Environmental Protection Bureau of Resource Protection - Wetlands WPA Form 8A – Request for Certificate of Compliance

November 30, 2023

Re. 9 Holland Road, Sturbridge – Request to Lift of Enforcement Order, dated 10/30/2019

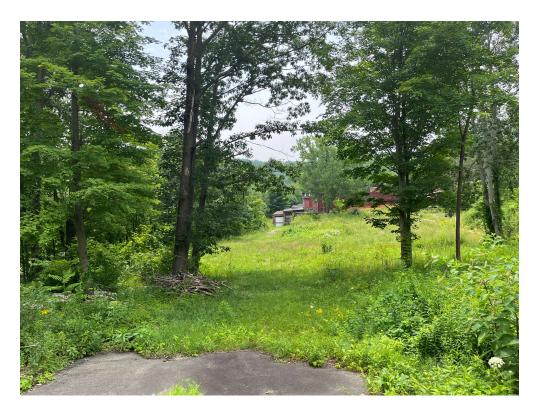
Photo 1 taken by EBT, Inc. on 7/19/2023 – Looking west showing the stable entrance off of Route 20 downgradient of DOTs twin catch basins (the subject of stormwater overflow). The applicant has been keeping the catch basin grates clear of debris so Route 20's stormwater does not flush through 9 Holland and cause sedimentation into the Quinebaug River (as had been occurring prior to EBT, Inc's involvement in the project in 2019).

One of the issues with the site when EBT, Inc became involved was erosion across 9 Holland into the Quinebaug River caused by concentrated runoff from the DOTs clogged catch basins on Route 20. We have been working with DOT over the last few years and they have now filed a Notice of Intent (DEP File #300-1175) to install twin drop inlet catch basins which will handle the flow from Route 20, attenuate the colloidals and nutrient in the flow and then discharge the water to the Quinebaug River – a rare muscle habitat.

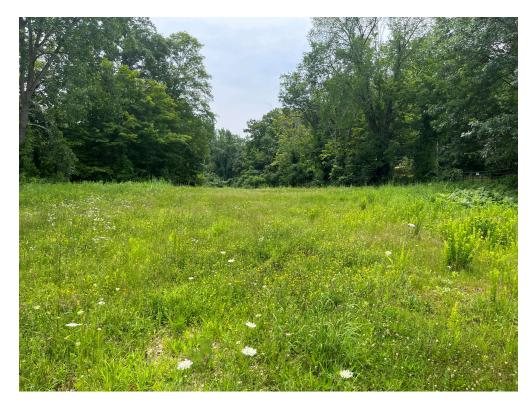
Photo 2 taken by EBT, Inc. on 7/19/2023 – Looking west with the mill structure behind the photo taker to the east showing a stable herbaceous layer within the yard. All yard areas surrounding the mill structures are stable.

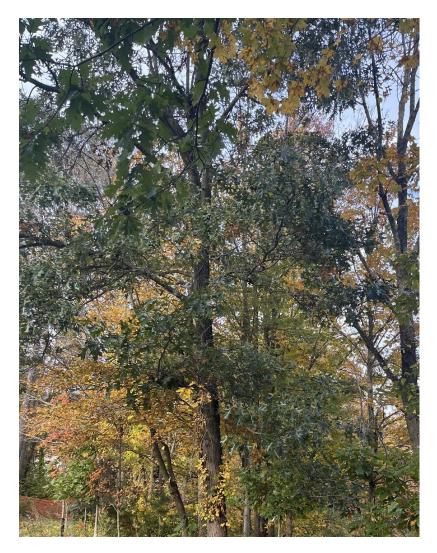
Photo 3 taken by Richard Connelly on 10/6/2023 – 23 saplings were planted on 5/21/2021, as required by the Commission. The photo shows a typical example of the vigor of all of the saplings.

The applicant, Richard DiBonaventura of Banjo Boy LLC, through their representative, EBT Environmental Consultants Inc., is requesting the enforcement order for 9 Holland Road be lifted. Twenty-three saplings were planted (listed below) on 5/21/2021 to replace the unpermitted trees cut as agreed upon a the Sturbridge Conservation Commission meeting on 2/2/2021. The forest is growing back at 595 Main Street (Blackington LLC) where a portion of the clearing took place. All work outlined on the Repair and Clean-Up plan dated 4/10/2016 has been completed.

- (5) Red Maple (2" To 2.5" Caliper)
- (6) Swamp White Oak (2" To 2.5" Caliper) •
- (5) Northern Red Oak (2" To 2.5" Caliper)
- (6) Black Gum Tupelo (2" To 2.5" Caliper)
- (1) White Oak (2" To 2.5" Caliper)

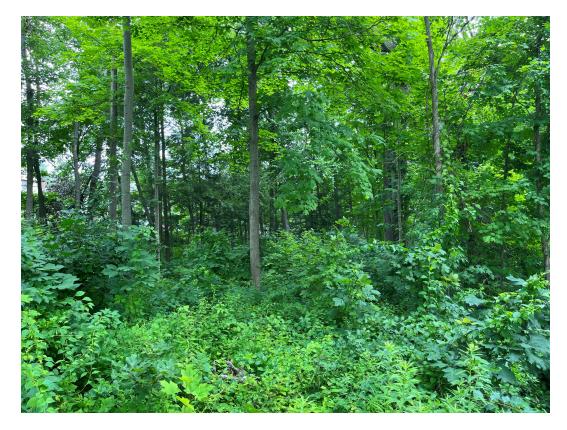
Photo 4 taken by EBT, Inc. on 7/16/2022 – Standing on the eastern property boundary of 9 Holland Road looking into the Blackinton LLC (595 Main Street) property where the forest undergrowth saplings and bushes have grown back from the original violation cutting, which occurred in 2019.
