The Worcester South Agricultural Society Exhibition Hall
362 Main Street
Sturbridge, MA

Prepared by Jennifer B. Doherty
For the Sturbridge Historical Commission
May, 2016

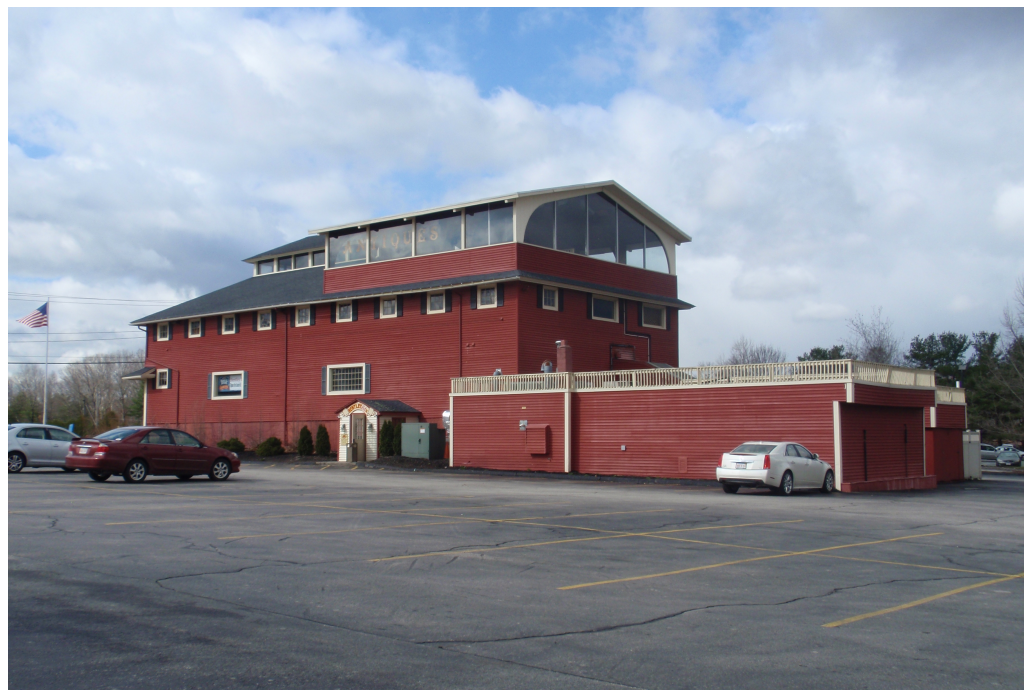
Over the years, space has been added to the exhibition hall, primarily at the rear and on the roof.

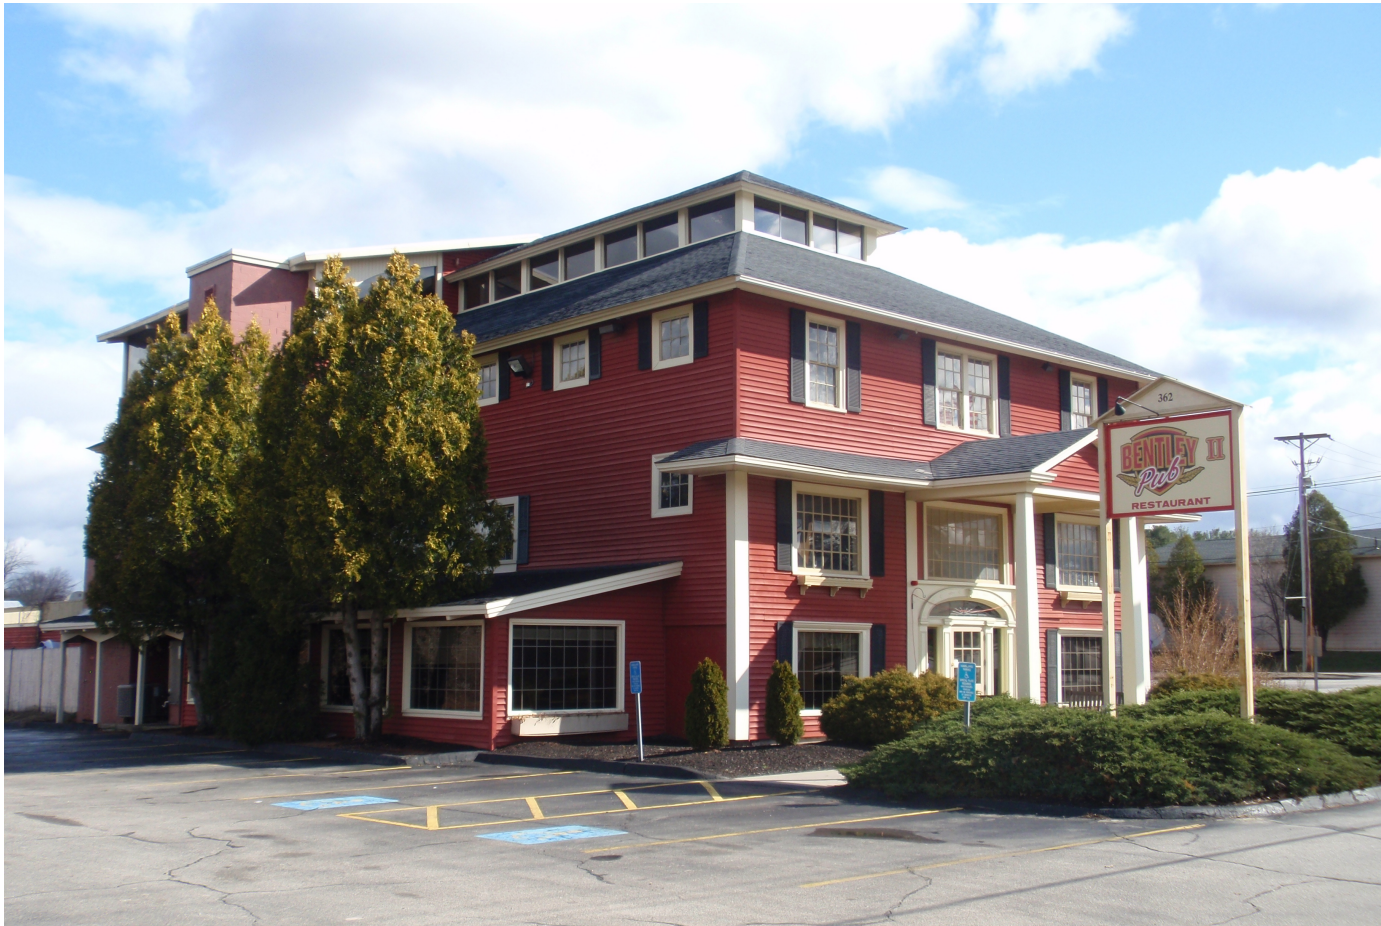
The main façade and west elevation of the exhibition hall today. The Federal style door surround is an addition to the utilitarian building, and appears to have been taken from another building.

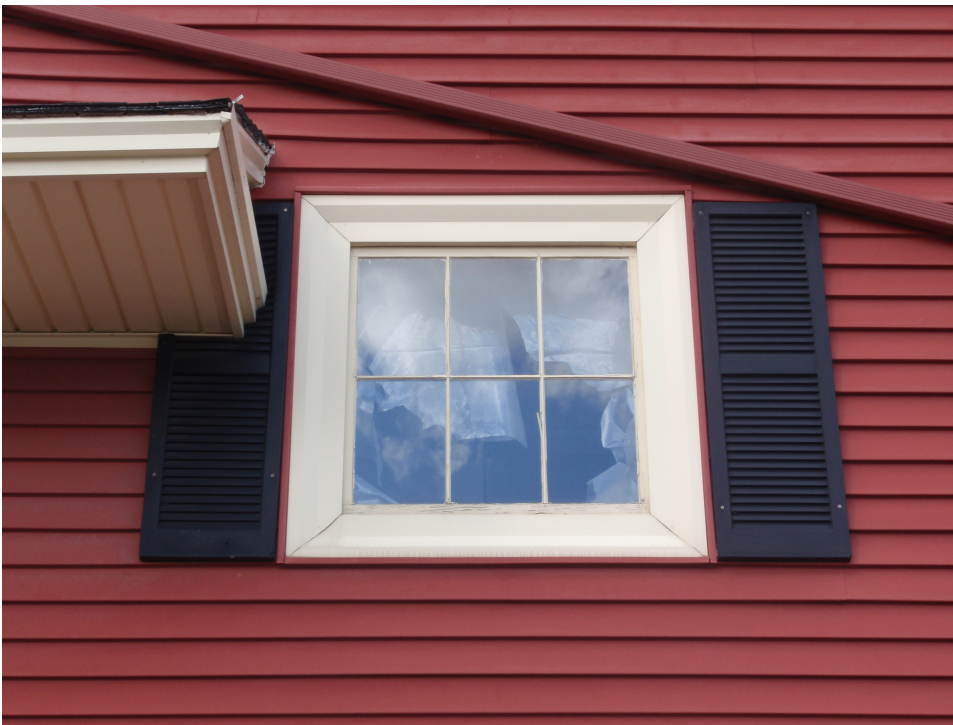
Most of the windows are blocked from the interior and thus are not accessible. However from the exterior this sash, and others like it, appears to be original to the building.

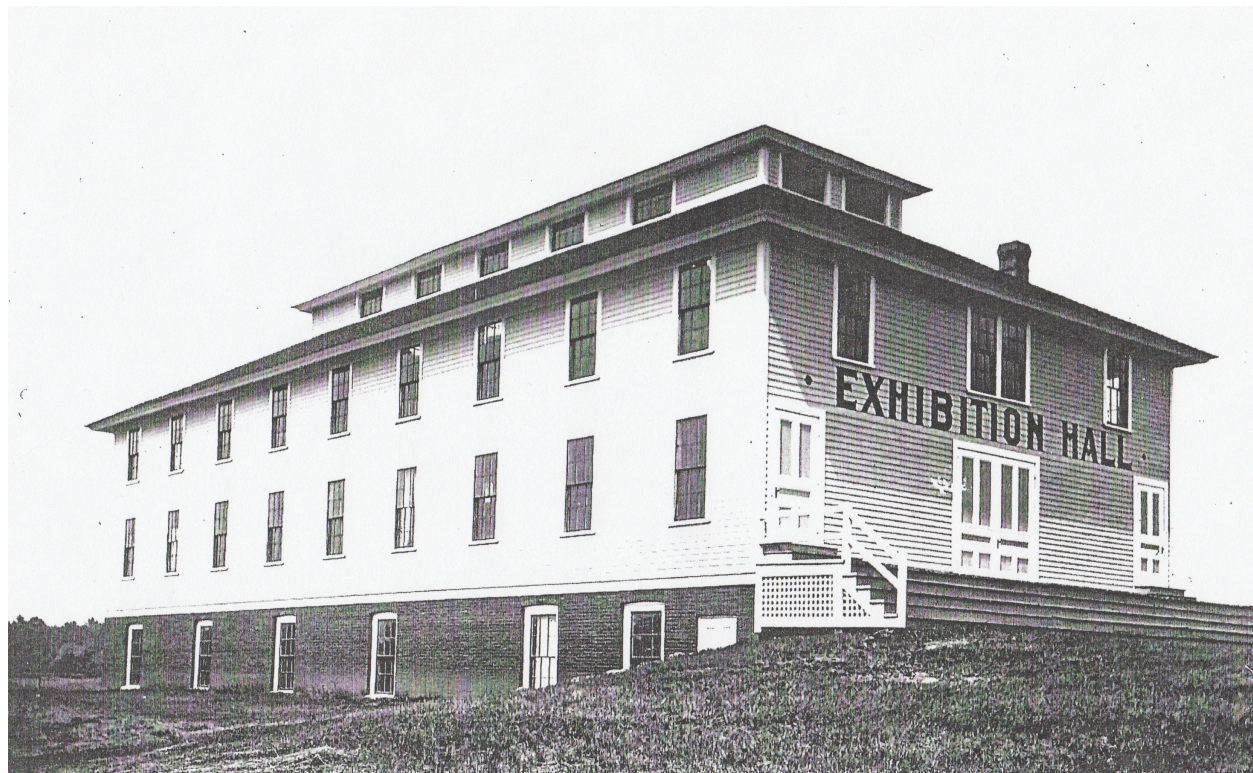
Undated photograph of the exhibition hall courtesy of Robert Briere/Sturbridge Historical Society.

An undated historic photograph shows the exhibition hall as it likely looked when it was constructed. A rise of land led up to the front of the building, with a set of wooden stairs running across the width of the building. The main façade had three entry doors, a set of double doors in the center with a single door at either corner. The five-panel doors are typical of the mid-19th century. An entry door is also visible on the west elevation of the basement, at the front of the building; today this door is bricked in but the lintel is still visible. The hall had regularly-spaced six-over-six sash windows on all three levels. The monitor on the roof had what appear to be divided light fixed-sash windows, but it is difficult to tell from the photograph how many panes they had. A chimney is visible on the east elevation, towards the front of the building. There is no remaining evidence of this chimney. Based on the small size of the chimney and the date of the building, it would have served a stove, possibly only in the

restaurant part of the exhibition hall. The exhibition hall has little trim or ornamentation, with plain, narrow window surrounds and similar cornerboards; the cornice is difficult to make out, as it is in shadow.

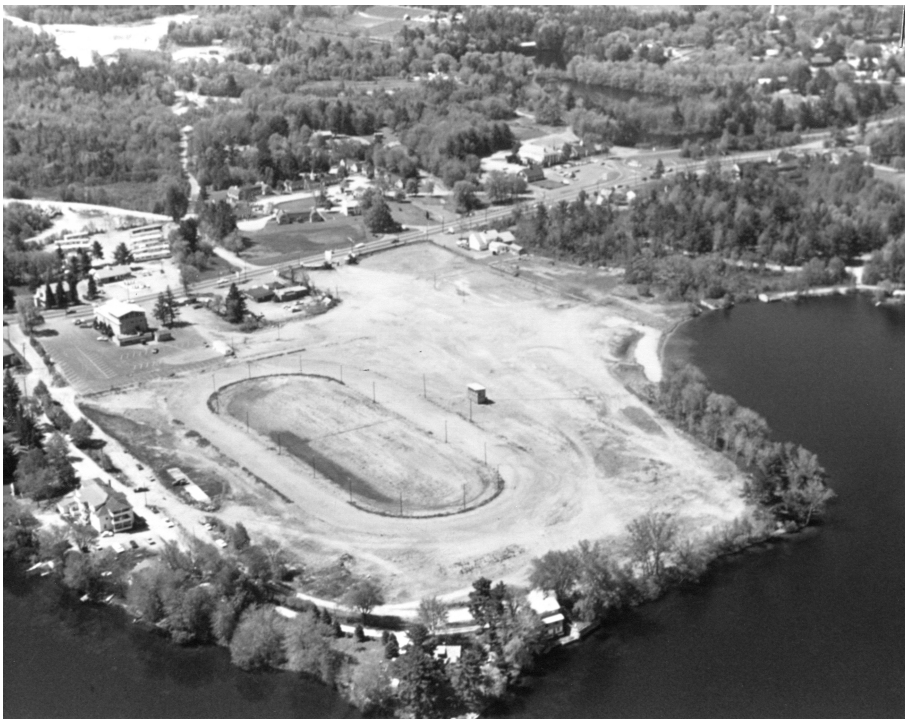
This aerial image from the 1970s shows the fairgrounds after it had closed but before much of the major development in the area occurred, particularly the development of the Sturbridge Host Hotel & Conference Center. From STU.B, Massachusetts Historical Commission Area Form.

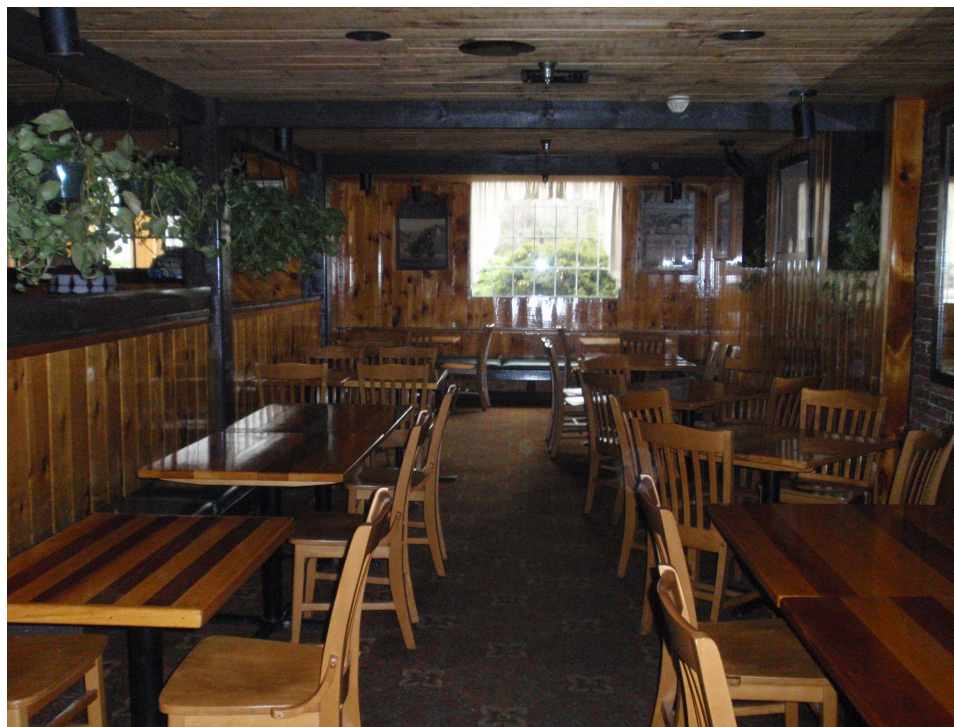
The restaurant in the basement of the exhibition hall.

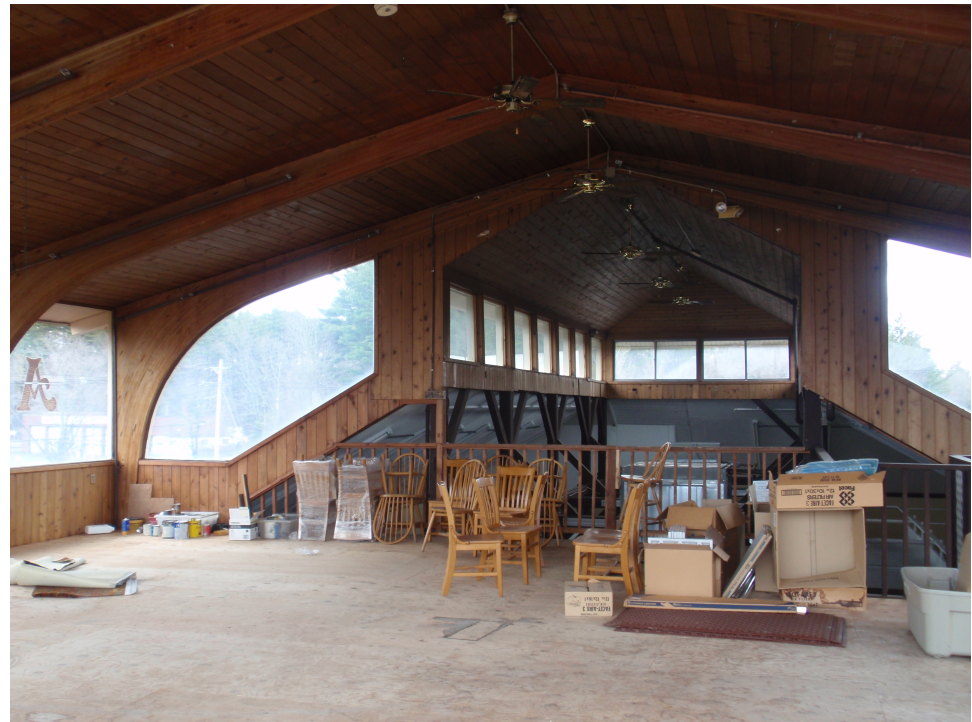
The added third level at the rear of the building is open to the space below.

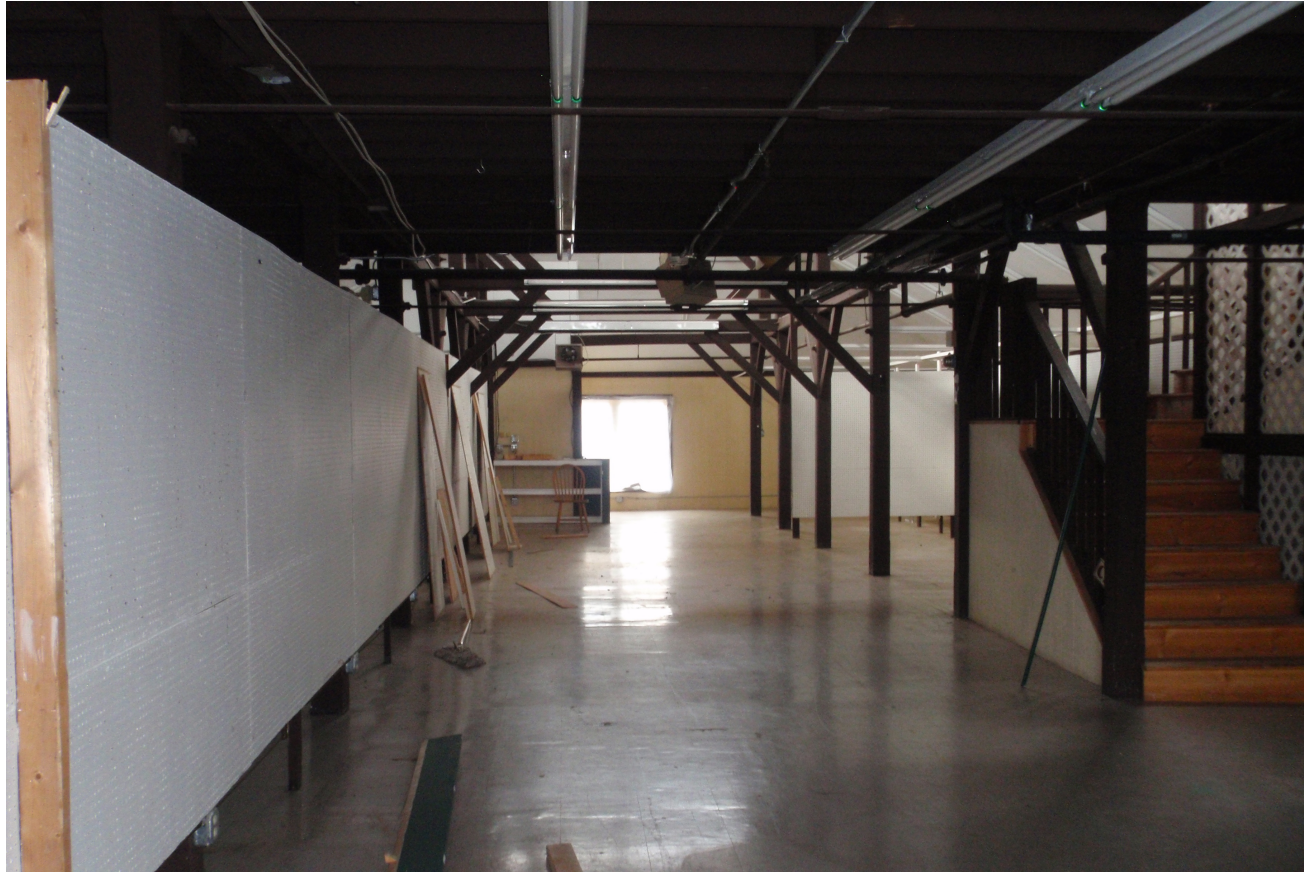
While the basement retains its historic use as a restaurant, the upper floors of the hall have been modified and most recently served as an antique store.

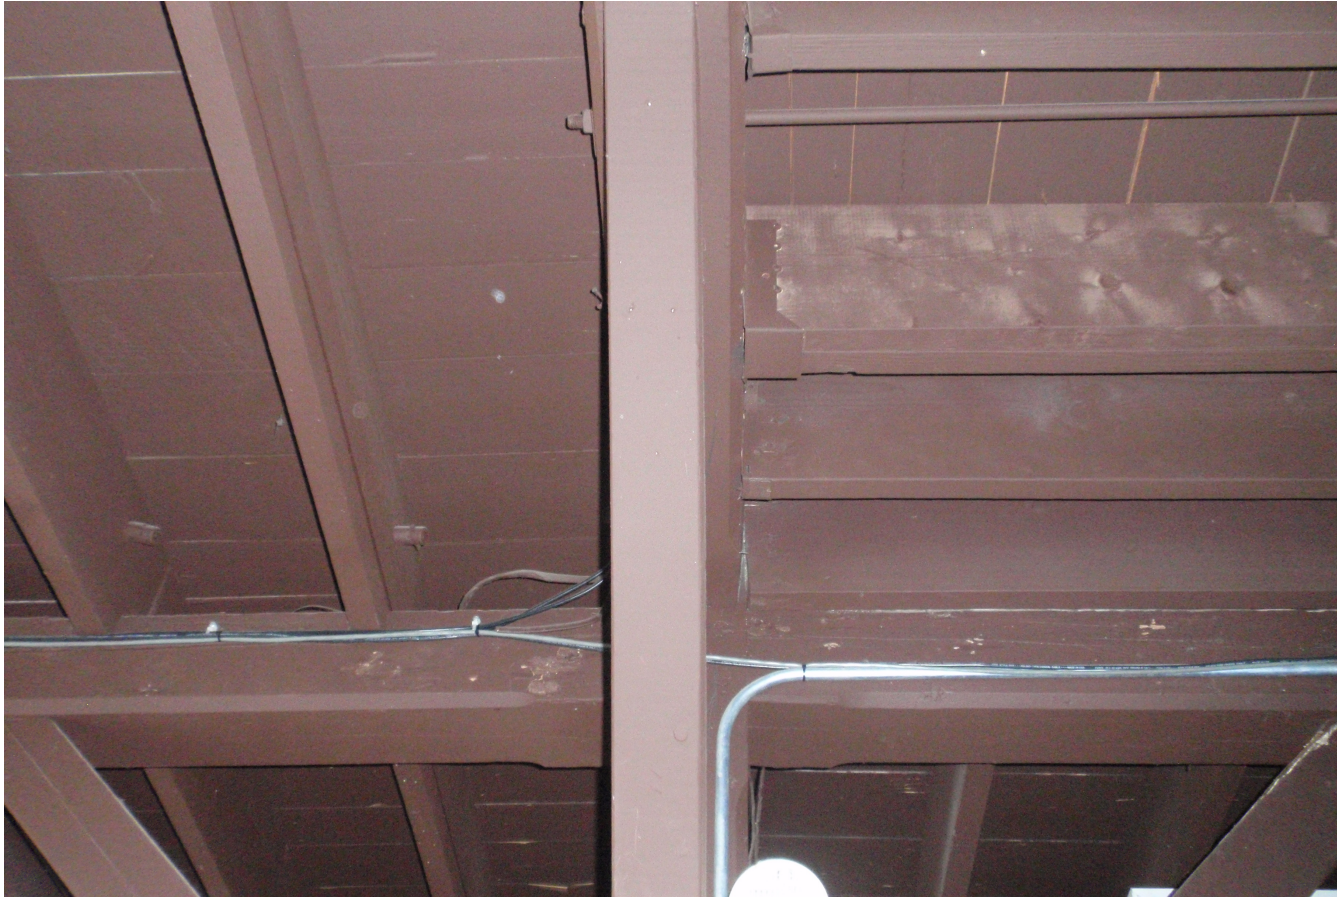
This view of the ceiling shows how a floor has been added to the middle of the second floor. On the left and at the bottom are the original joists and floorboards of the second floor. On the right, new joists were added with modern metal joist hangers. Note that the new joists and floorboards run in a different direction than the old, distinguishing the work. See below for an illustrated diagram of the work.

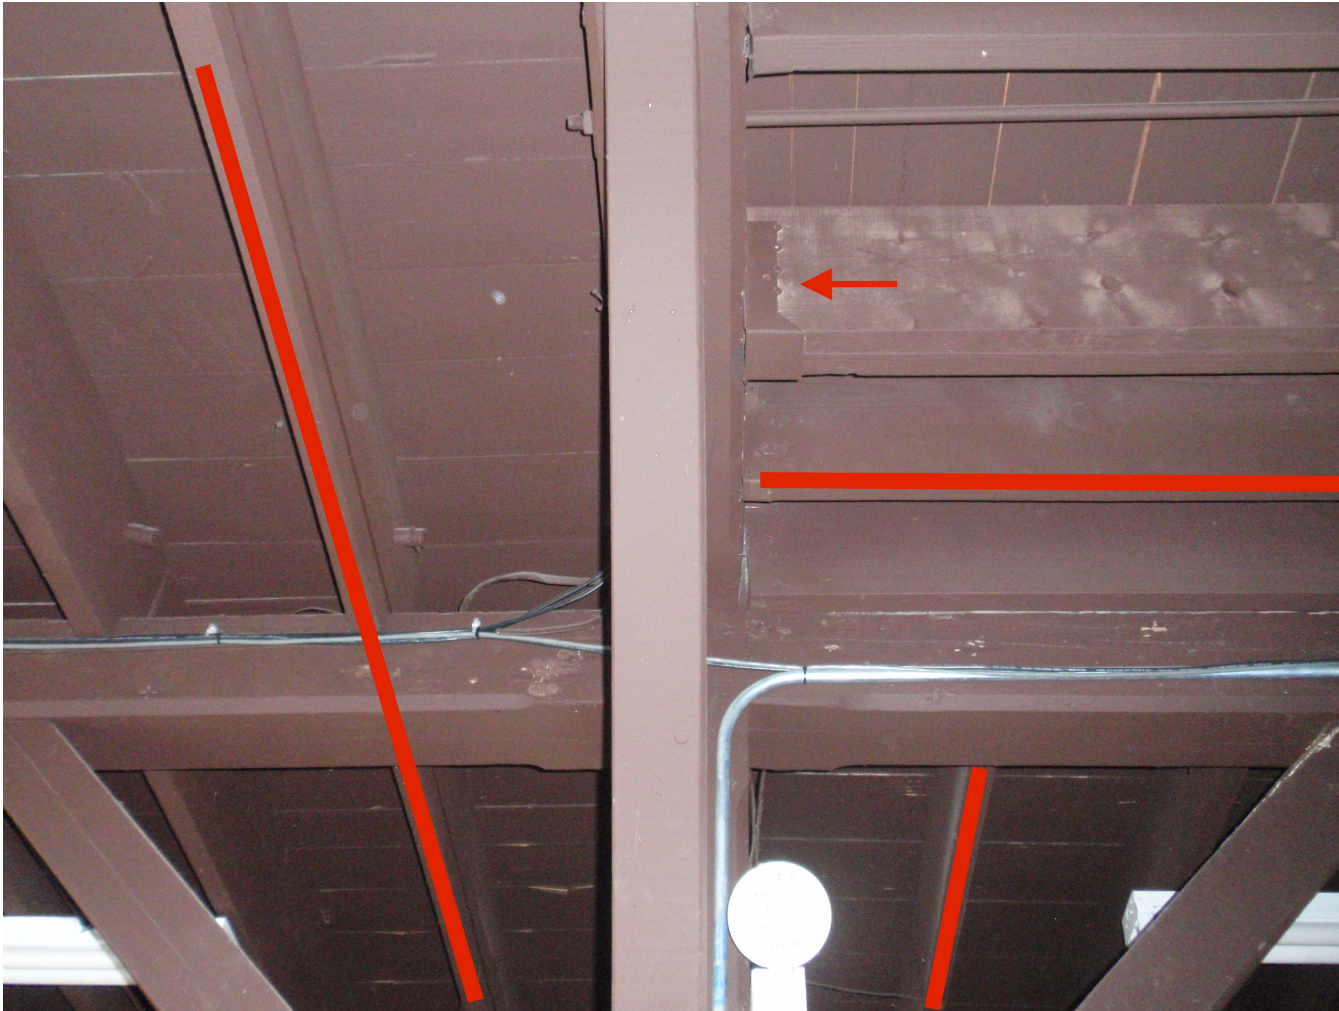
Highlighted here in red is the evidence of the filled floor as seen in the southeast corner of the building. The lines show the north-south orientation of the joists at the left and bottom of the image that are the original floor framing. The joist in the upper right hand corner is a newer joist as indicated by its east-west orientation. The arrow indicates a metal joist hanger that was used to install the newer joists, an indication of their more recent addition to the building.

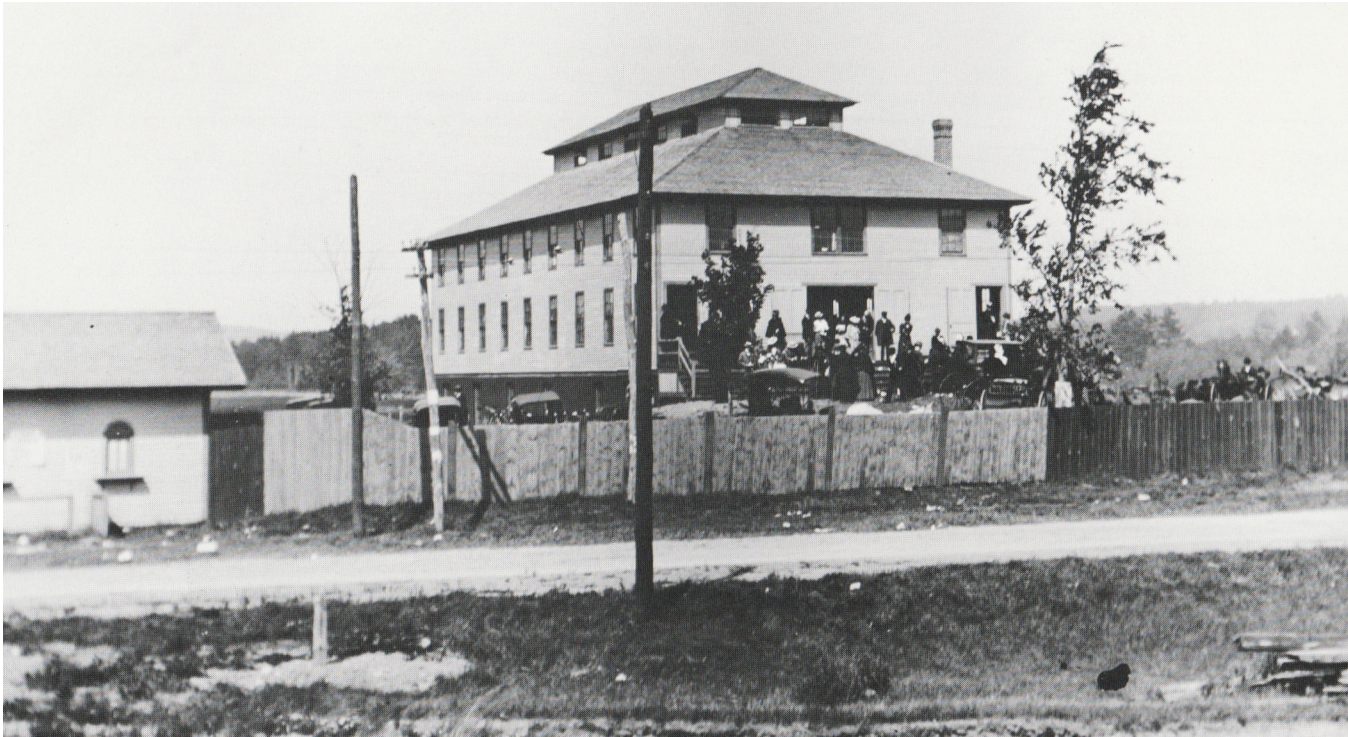
This undated image of the exhibition hall shows crowds entering the building through three first floor entrances on the main façade. From Burns' Sturbridge.

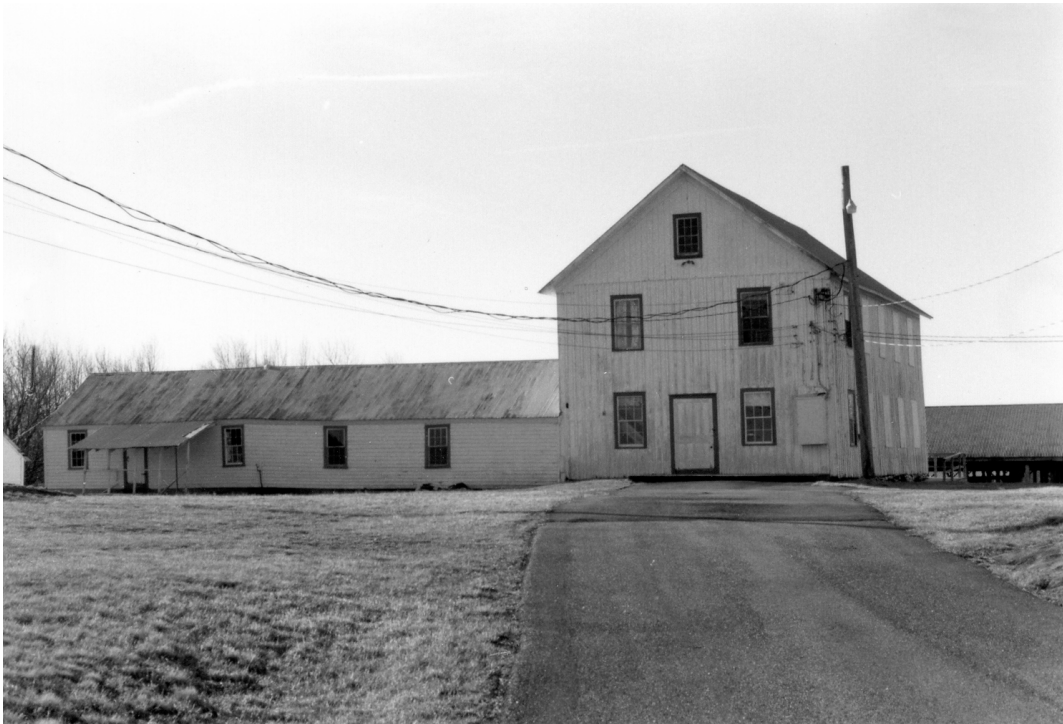
The Middlefield Agricultural Hall (MIF.33), constructed in 1859, is a two-and-a-half story end-gable building, identical in shape to the WSAS exhibition hall although smaller in size and with several other differences. The Middlefield agricultural hall has a fieldstone foundation, is covered in wood clapboards and board-and-batten siding, and has a tin roof, in contrast to the brick foundation and the hipped roof with monitor of the WSAS exhibition hall. Like the WSAS exhibition hall, the Middlefield Agricultural Hall is a utilitarian building with little trim or ornament. The Middlefield agricultural hall is the only documented extant fairgrounds building that most closely resembles the WSAS exhibition hall. While other fairgrounds retain late 19th and early 20th century buildings, they are often animal barns or exhibition halls in a different form. It is likely that other buildings similar to the WSAS and Middlefield exhibition halls did exist, but they were torn down as fairs ended and fairgrounds developed, or as they aged and new fairgrounds buildings were constructed.

The Middlefield Agricultural Hall, taken in 1998 at part of the MIF.B documentation of Middlefield Center.
