# CONDITIONS ASSESSMENT AND FEASIBILITY STUDY

8 BROOKFIELD ROAD  
STURBRIDGE, MA 01566

April 14, 2015

Prepared for:  
Town of Sturbridge, Massachusetts

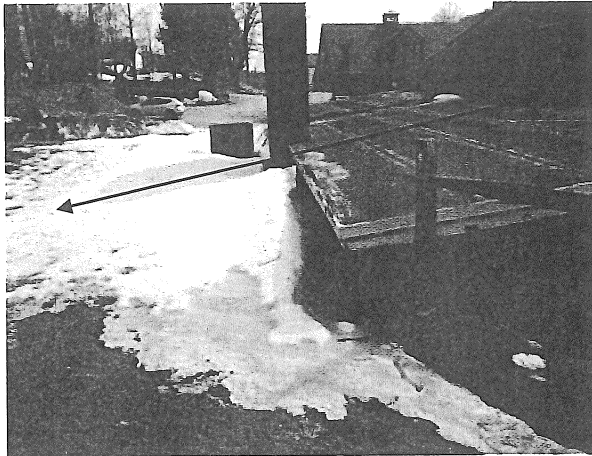
Photo No. 3. North side of building, facing east

Swale North of Building

An onsite drainage system consists of a catch basin at the western stone masonry retaining wall, a manhole with an open drain and a second catch basin located on the southern edge of the parking lot. The parking lot catch basin was not observed due to a snow stockpile. Greg Morse, Sturbridge DPW Director indicated that the drainage at the building had work done to it and was in operating condition with no known issues with the system or with water entering the building due to faulty drainage. He indicated that the drainage system connected with the drainage system crossing Main Street. The catch basin at the toe of the stone masonry retaining wall was in fair operating condition and appeared to properly collect seepage from the retaining wall. The manhole with open drain west of the building appeared to function properly; however, the manhole top is elevated above the pavement and may cause a trip or snowplow hazard. If improvements are made to the parking lot, modifications to the manhole structure to allow the replacement of the manhole top with a catch basin frame and grate should be investigated.

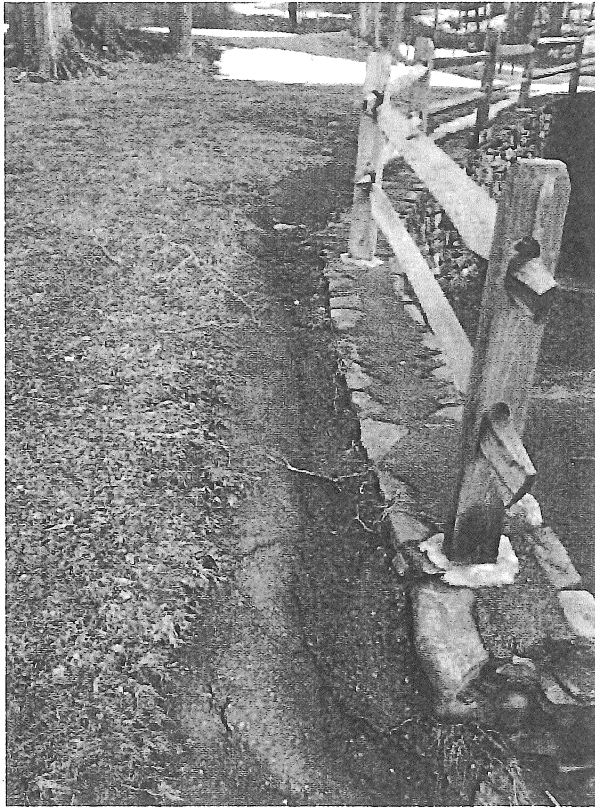
Photo No. 7. Paved swale facing northeast

The building does not have gutters to control roof runoff. A paved swale made of hot mix pavement was installed to convey stormwater runoff draining from the northern roof edge. The paved swale is split at the chimney to convey flows east to the restaurant parking lot and west to the manhole with open drain. Both swales appear to be functioning; however, there aesthetic appearance and functionality could be improved by replacement or an overlay of new pavement. The discharge point of the eastern swale appears to have been disturbed during earthwork to install a newly paved dumpster pad. The discharge point should be reviewed at the time of any building or parking lot improvements to determine if repairs are warranted.

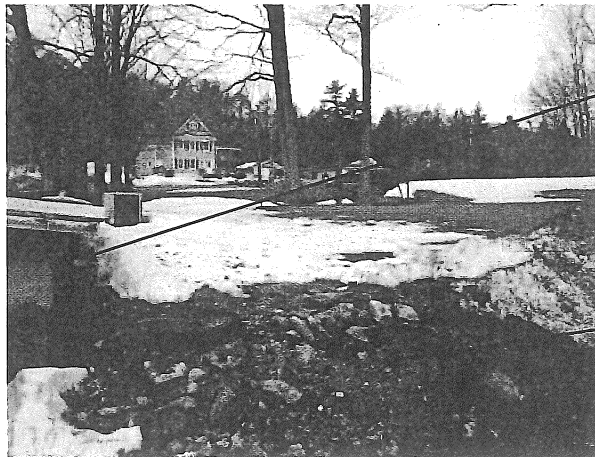
Paved Swale for Roof Runoff  
draining East

Earth Disturbance at the  
Northeastern corner of the  
Building

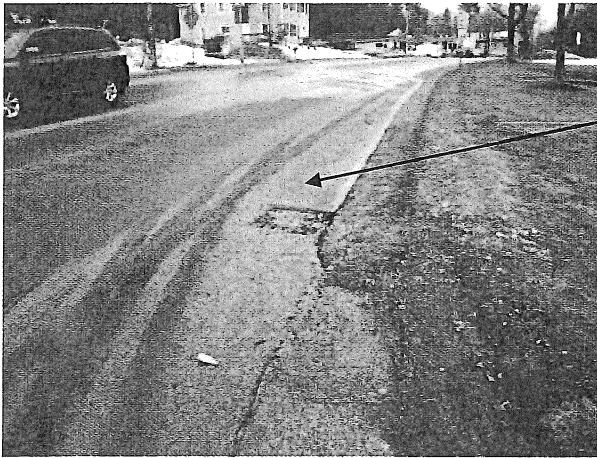
Photo No. 9. Brookfield Road at corner of access drive, facing north

Stormwater runoff from Brookfield Road is collected by catch basins and bituminous Cape Cod berm. It appears minimal runoff enters the parking lot from the curb cut access in this area. If future improvements are made to the parking lot, a new driveway apron should be considered with a 1-inch lip at the edge of the road to prevent Brookfield Road runoff from entering the parking lot.

Brookfield Road Drainage  
and Sightline looking North  
from Access Drive

Access to the site is off of Brookfield Road just north of the intersection with Main Street. The Brookfield Road and Main Street intersection is controlled by a signal light. Sightline from the access drive is minimal looking to the north up Brookfield Road. (See Photos No. 9 and 10.) Sightline to the south appears to be acceptable.

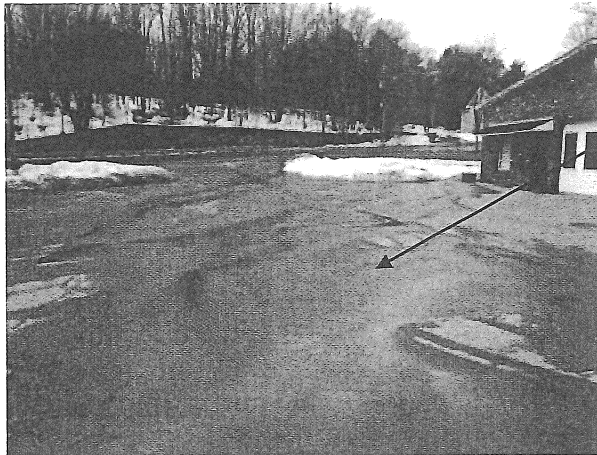
Photo No. 11. Site parking lot and access drive, facing west

The site includes a paved access drive and parking lot. The pavement on site appears to be in serviceable condition and does not warrant replacement. Pavement adjacent to the western side of the building includes a swale to provide positive drainage away from the building and to the manhole with open drain. Cracking is evident in the pavement; however, there were no signs of subbase failure observed during the inspection.

Paved site Access and  
Parking South of Building

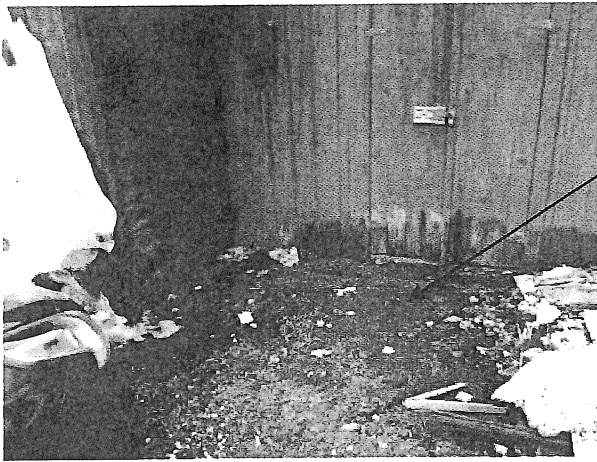
Photo No. 13. East side of building at oil tank fill, facing west

Millings were placed east of the building, adjacent to the restaurant property. This area appears stable, but should be reviewed at time of building repair to ensure that proper grades are set to drain surface runoff away from the building.

Area of Millings East of Building, South of Dumpster Pad and Concrete Barrier Wall

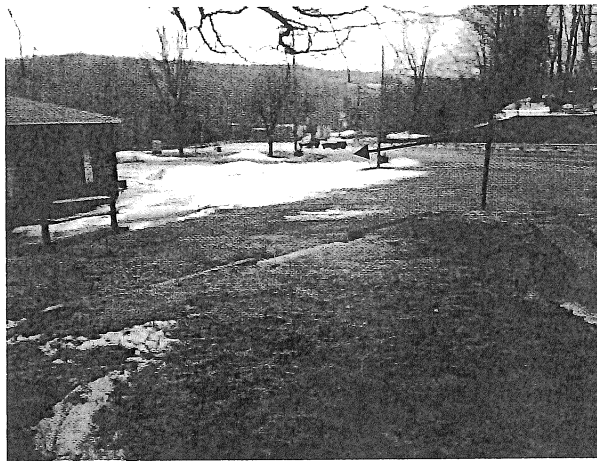
Photo No. 14. Southwest corner of site, facing south

Access Drive and Sightline looking South

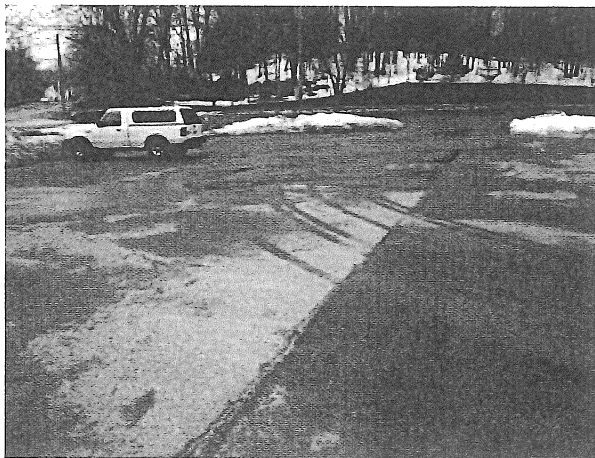
Photo No. 16. Parking lot and access drive, facing west

Parking space striping is no longer apparent in the parking lot and should be replaced once parking and traffic flow is designed. A handicap parking sign is located on the west side of the front of the building. No handicap space or loading striping is present. A handicap van space and loading area must be installed in accordance with the future site design as required by the Massachusetts Architectural Access Board (AAB).

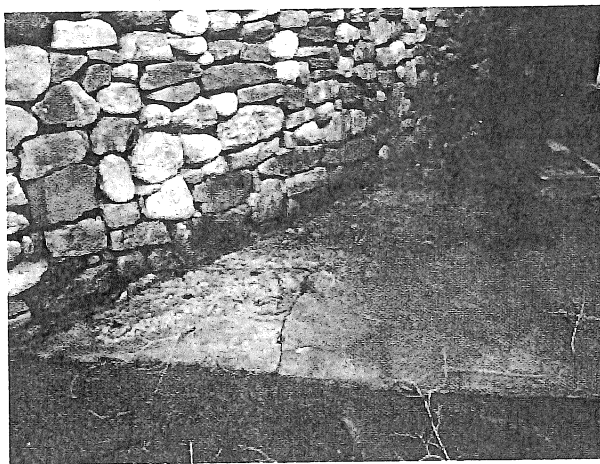
Photo No. 18. Stone masonry retaining wall, facing north

The stone masonry retaining wall appears to be in good condition. Seepage was present at the toe of the wall. The seepage was clear and did not appear to be piping soil from behind the wall. A small void was present at the toe of the wall north of the catch basin. This void should be further investigated and patched with rock and mortar. The void does not appear to be a structural issue.

Void in Stone Masonry  
Retaining Wall

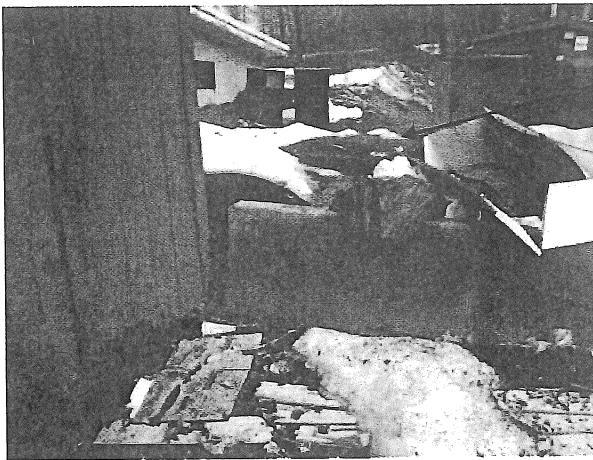
Photo No. 19. Concrete barrier wall east of building, facing north

Newly Paved Dumpster Pad

Concrete Barrier Retaining  
Wall on the East Side of the  
Building

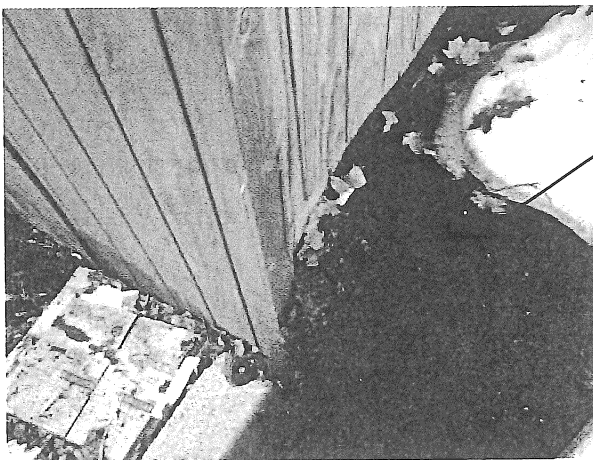
Photo No. 20. Concrete barrier wall at the corner of the oil tank room addition

The concrete barrier wall is experiencing subsidence at the corner of the building and western edge of the wall. This appears to be due to soil eroding from a gap between the wall and the building. The gap should be filled to retain soil behind the wall and the low areas at the building filled to direct surface flows away from the side of the building.

Erosion and Subsidence at  
Wall and Building

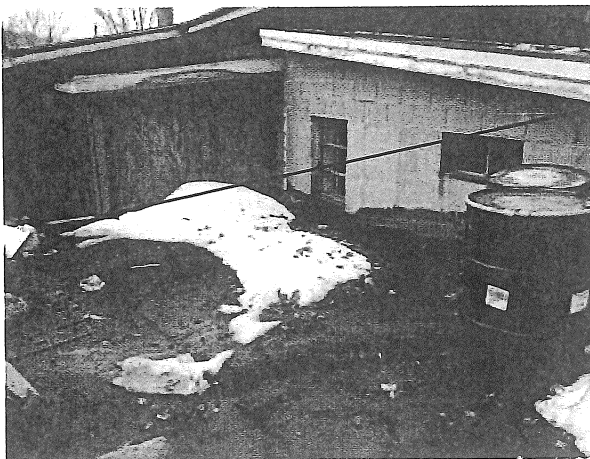
Photo No. 21. Newly paved area behind dumpster pad, facing southwest

Concrete Barrier Wall

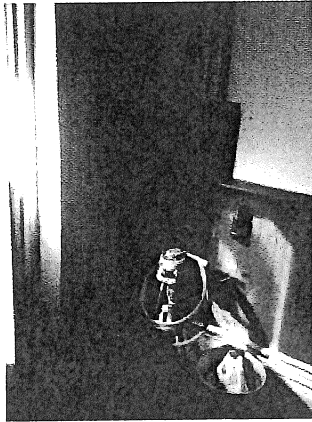
The domestic cold water piping enters the building near the front entrance and is routed to a water meter. The main pipe riser has an isolation valve, hose attachment and a take off for the exterior hose bibb. The main pipe is then routed to the plumbing fixtures located throughout the building. The piping is not insulated and appeared to be in fair condition with no signs of deterioration/leakage. The valves appeared to be in good condition.

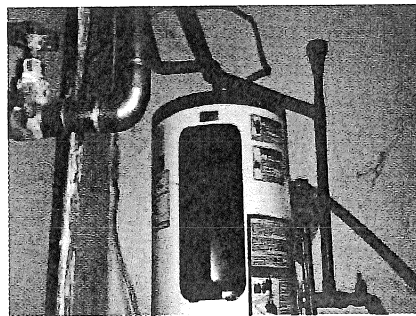
The domestic hot water is provided by a six (6) gallon electric water heater mounted above an abandoned water heater in a storage closet. Hot water is provided to the bathroom sinks via copper piping routed at the ceilings. All the domestic hot water piping is not insulated and appeared to be in poor condition with deterioration/leaks. The water heater was installed 2004 and appeared to be in fair condition.

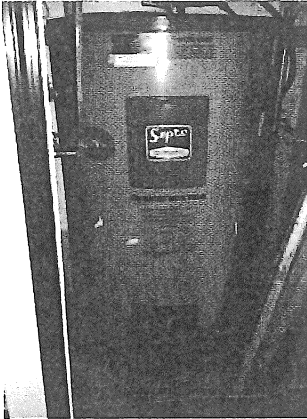
An eighty (80) gallon electric water heater has been abandoned within the storage closet . Since the unit is no longer in operation, the unit should be removed.

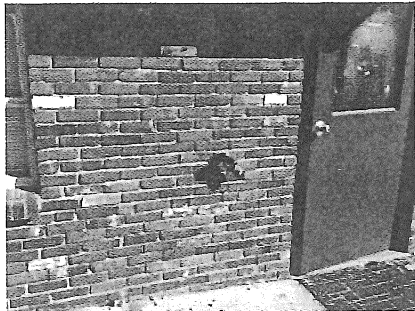
An exterior hose bibb was observed in the front of the building. Piping to the fixture is not insulated. The hose bibb and piping appeared to be in good condition.

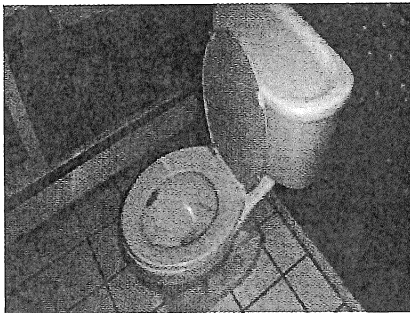
The bathroom located adjacent to the kitchen has a tank type water closet. The domestic cold water piping appeared to be in fair condition. The water closet and associated accessories appeared to be in good condition.

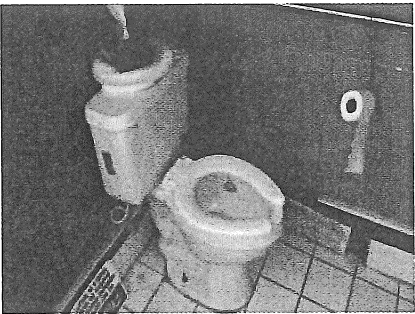
The large bathroom has a tank type water closet that appeared to be in good condition. The domestic cold water piping and isolation valve appeared to be in good condition.

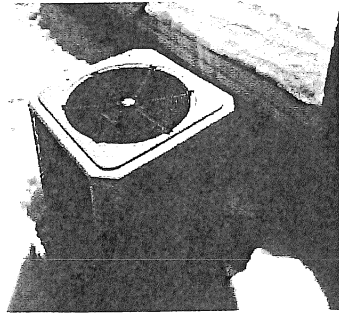
An air cooled condensing unit is located in the rear of the building. Manufactured by the York Company the unit provides five (5) tons of cooling. The refrigerant line set is insulated and routed to the attic. The unit appears to be over twelve (12) years old in poor condition with deterioration present.

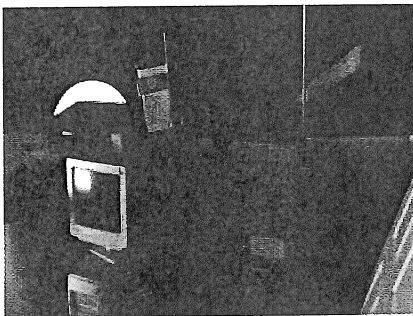
The attic is equipped with a horizontal modular air handling unit that provides 2,000 CFM. The unit is manufactured by the York Company and sits on a condensate pan with a plug type condensate pump. The unit is over eight (8) years old with minor deterioration and appeared to be in fair condition.

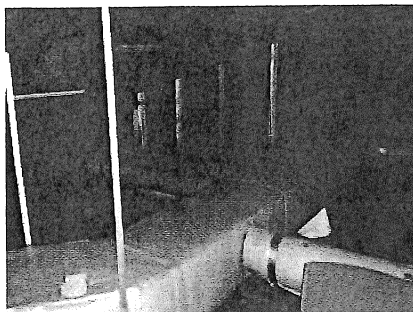
Ductwork distribution is located within the attic. The main ductwork is rectangular with round duct take offs. Flexible ductwork is routed down to the diffusers. All the ductwork is insulated and appears to be in good condition.

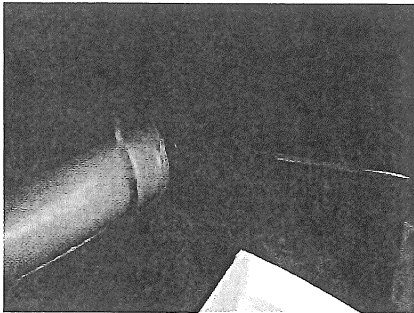
Flexible ductwork is routed to the supply/return grilles. The ductwork appears to be in good condition.

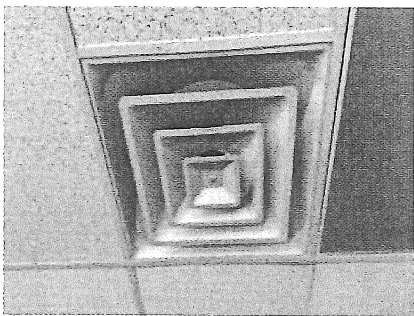
The large room and corridor has several ceiling mounted cone type supply diffusers. Each diffuser is 24"x24" and appeared to be in good condition with debris present on the exterior.

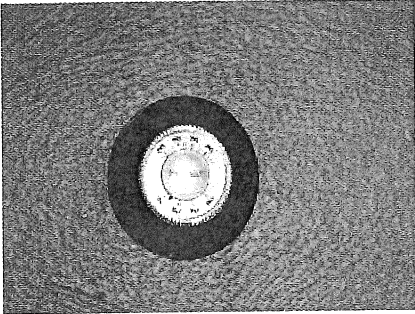
A wall mounted heating/cooling thermostat manufactured by the Honeywell Company controls the condensing unit and the air handling unit. The unit is located beneath the return grille and appears to be in fair condition.

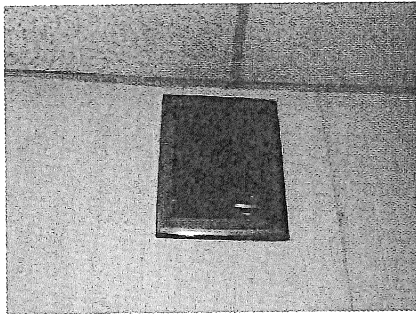
The kitchen has two (2) thru-wall exhaust fans controlled by local wall switches. The first exhaust fan is operational, has minor deterioration on the interior grille and appeared to be in fair condition.

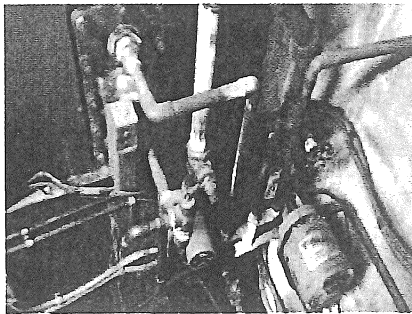
The hot water is distributed via three (3) inline circulator pumps manufactured by the Taco Company. Two (2) pumps appeared to be older and in fair condition with deterioration observed at the flanges. One (1) pump appeared to be recently installed and in good condition.

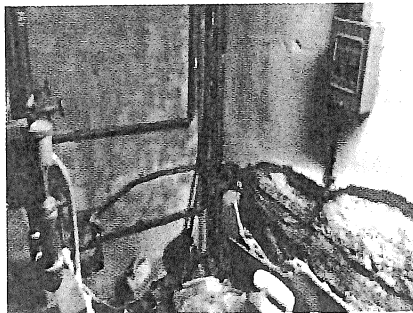
Piping for the hot water system mainly consists of copper with the exception of the boiler main piping being steel. No piping insulation was found throughout the building. The hydronic accessories included an expansion tank, pressure reducing valve, low water cut off and air vent. All the piping and accessories appeared to be in fair condition.

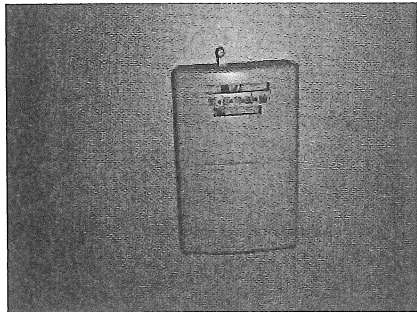
A wall mounted heating only thermostat controls the zone for the large room. The thermostat appeared to be over ten (10) years old and in good condition.

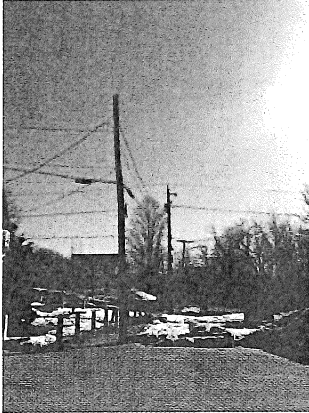
The electrical service for the building is provided via an overhead aerial service drop from a utility pole located on Main Street along the sidewalk on the adjacent property. The overhead transformer is located on the next utility pole east of the service drop utility pole.

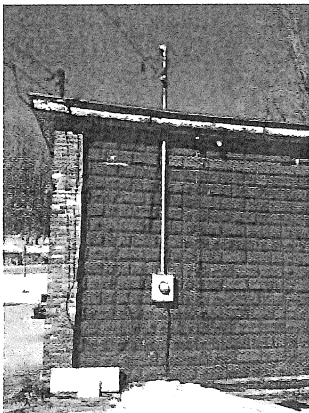
Electrical service weather-head mast, service entrance conductors and meter are located on the Southeast corner of the building. It appears as the original service mast and service entrance conductors have been abandoned in place and are located to the left of the current service.

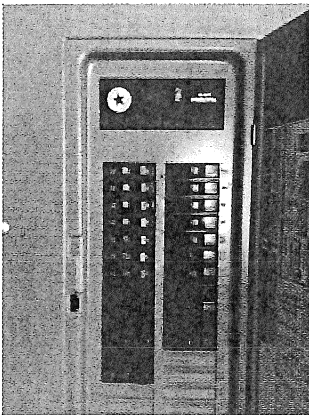
The service appears to be grounded via a ground rod at the meter location and with a ground wire run from the main electrical panel in the Southeast corner of the building to the main water service piping which is located to the left of the buildings main entry door upon entry. This ground wire is run above the ceiling and then exits the ceiling and runs exposed down the water service piping.

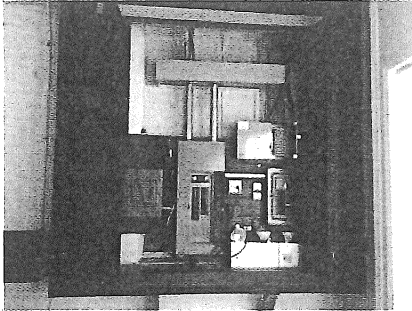
It has been in service approximately 20 years old based upon manufacturing date and seems to be in good condition for its age.

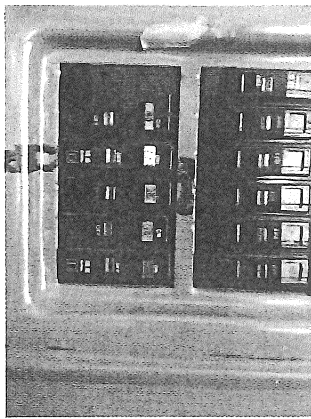
Electrical distribution within the building is provided by five (5) electrical panels in total. The main electrical panel noted above and four (4) additional electrical panels. Two (2) of these electrical panels are located adjacent to the existing main panel. The third is located in the addition at the rear of the building which contains the fire place and the fourth is located in the boiler room.

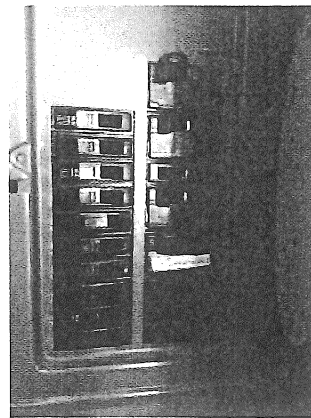
The electrical panel located to the left of the main electrical panel is a 120/240V, 1 phase, 3 wire, 12 pole main lug only (MLO) load center type electrical panel. There was no amperage rating identification for this panel. However, it is protected by a 50A, 2 pole circuit breaker in the main electrical panel. Based upon standard electrical panel ratings and the size of the circuit breaker providing panel feeder protection, it is assumed that this panel has a minimum rating of 60A.. No directory was available for this panel. This panel is older than the main electrical panel and is in fair condition for its age.

Replacement of electrical panels with the exception of the main electrical panel.

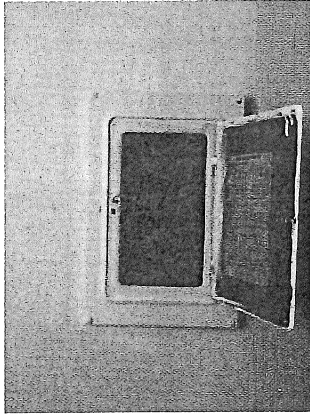
The electrical panel located to the right of the main electrical panel is a 100, 120/240V, 1 phase, 3 wire, 20 pole load center type electrical panel with 100A main circuit breaker. No directory was available for this panel. This panel is also older than the main electrical panel and is in fair condition for its age as well.

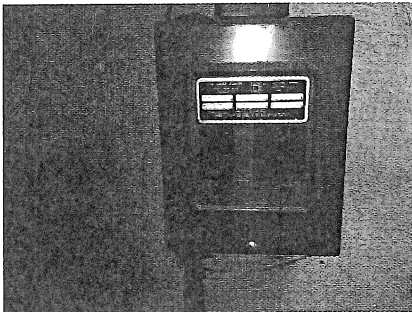
The fourth electrical panel (located in the addition at the rear of the building) is a 120/240V, 1 phase, 3 wire, 16 pole, MLO load center type panel. There was no amperage rating identification for this panel. No directory was available for this panel. Based upon standard electrical panel ratings it is assumed that this panel has a minimum of a 60A rating. The cover of this panel has been painted over in the past. This panel is older than the main electrical panel and is in fair condition for its age.

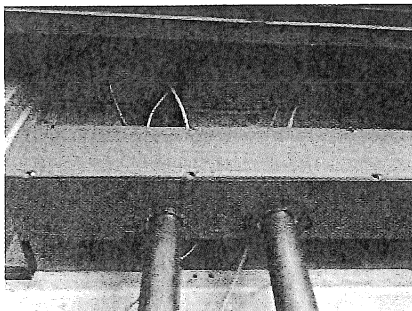
The fifth and final electrical panel is located in the boiler room. This is a 100A, 120/240V, 1 phase, 3 wire, 6 pole, MLO load center type panel. This panel provides power to the boiler, lighting and receptacles within the boiler room as well as fire hose dryer no longer in use. This panel is older than the main electrical panel and is in fair condition for its age.

The main electrical panel appears to have been replaced when the service was upgraded and has been in service approximately 20 years based upon manufacture date and seems to be in good condition. There were no manufacturing dates on the other panels however it would seem as these panels are approximately 40+ years of age and in fair condition. Consideration should be given to upgrading these panels with exception of the main electrical panel.

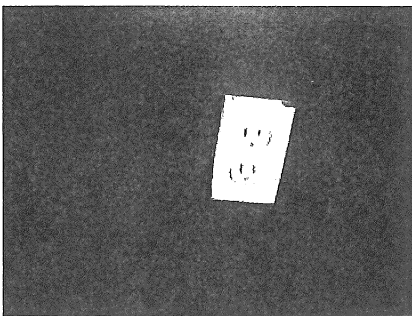
Branch circuit wiring and conduit is a mixture of different types and consists of surface mounted Electrical Metal Conduit (EMT), wiremold, flexible metal conduit and non-metallic sheathed cable as well as antiquated cloth covered type conductors. The age of the wiring appeared to vary with older wiring observed in the attic areas. The cloth covered

and non-metallic sheathed cabling should be removed and replaced with metal clad (MC) cabling.

A few electrical junction boxes located above the suspended ceiling and in the attic were missing their cover plates.

A surface mounted located on the ceiling was missing knockouts.

In addition, wiring was observed above the suspended ceiling which not terminating in an electrical box. This wiring just has the conductor ends capped with a wire nut and electrical tape.

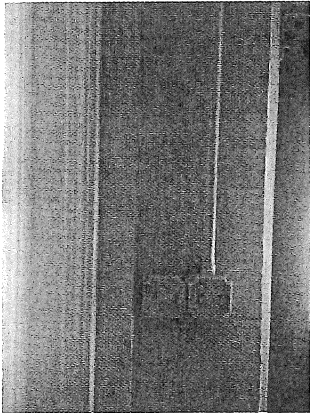
Wiring devices consisted of receptacles, switches and plug mold.

Duplex receptacles were located throughout the building. Both recessed and surface mounted types were observed.

Plug mold was observed within the office areas of the building and was in fair to poor condition. No GFCI duplex receptacles were located in the restrooms as required by Code. Only receptacles observed were part of a fluorescent vanity light which was in poor condition and an incandescent vanity light. No GFCI receptacle was located near the exterior condensing unit as is also required by current Code.

The majority of the existing receptacles, switches and plug mold observed appeared to have been in place a number of years, have been painted over in a few instances, are in fair to poor condition and should be replaced. New devices should be added as determined by proposed layout of building. Plug mold should be removed and replaced with duplex receptacles. GFCI duplex receptacles should be installed in all areas required by current Code.

Replacement of receptacles, switches and plug mold with additional added. Installation of GFCI receptacles.

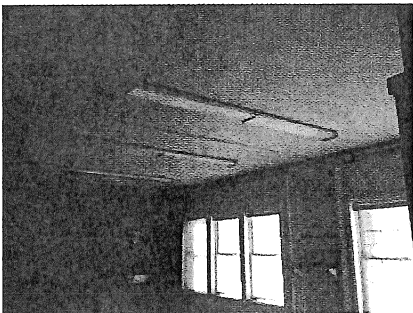
Control of the lighting was provided by surface mounted and recessed single pole and three way lighting switches.

A number of recessed electrical boxes in the addition room at the rear of the building have no devices installed and were missing cover plates thereby leaving the wiring exposed.

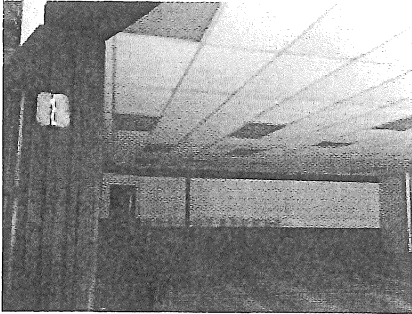
A mixture of light fixtures was observed within the building. Surface mounted 1'x4' two (2) lamp T8 fluorescent fixtures were located in the front of the building and addition at the rear. 2'x4' four (4) lamp T8 fluorescent fixtures were located in the main room, corridors and office areas. It would appear as the 2'x4' lighting in the main room was installed prior to the corridor wall being built as the corridor wall does not go from floor to ceiling but stops a few inches short. This causes some fixtures to be split with part of the fixture in the corridor and the remaining portion in the main room.

Replacement of the interior light fixtures with more energy efficient fixtures.

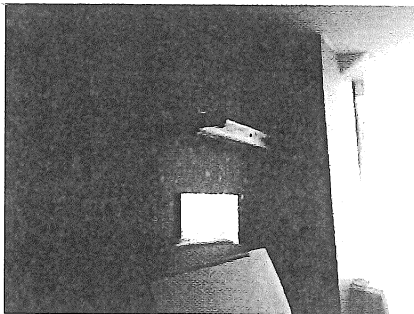
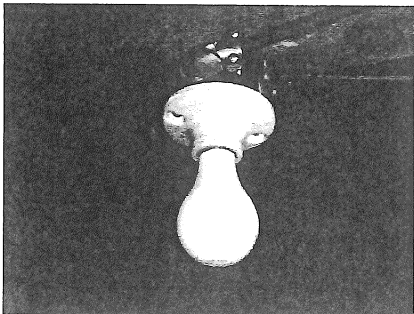
The condition of these fixtures varied greatly from good to very poor. A few 1'x4' fluorescent fixtures have broken lens, a 2'x4' fixture was missing lamping and its lens.

Incandescent fixtures within the bathrooms were missing diffusers and lamping. The existing lighting should be removed and replaced with more efficient LED fixtures and rearranged based upon proposed layout to provide better illumination levels. Proposed fixtures located within the mechanical room and attic should also include guards.

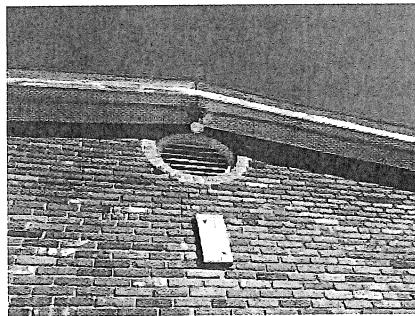
Exterior lighting consisted of two (2) High Intensity Discharge (HID) fixtures located under the front eave of the building. It appears as these fixtures are aimed to illuminate the parking area of the building. These fixtures are missing lamping, lens and their framing was damaged.

The existing exterior lighting should be removed and replaced with energy efficient fixtures with addition fixtures added to provide lighting at the side exit door as well as building perimeter. A pole mounted fixture should be installed to illuminate the parking area to avoid light pollution in lieu of flood lights directed towards the parking area.

Replacement of the existing exterior light fixtures with energy efficient fixtures. Installatio of site lighting pole.

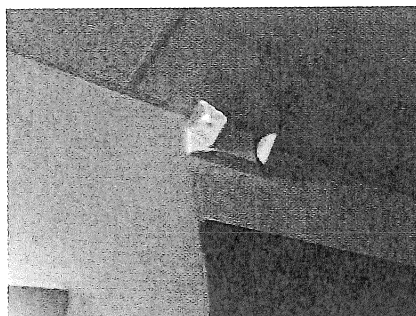
The remaining exterior lighting consisted of one (2) two lamp flood light located at the eave peak in the front of the building, one (1) one lamp flood light located at the Southeast corner and one (1) two lamp flood light at the Southwest corner of the building. These fixtures were in fair condition. No exterior light was located at the side exit door as required by Code nor is the rest of the building perimeter illuminated in any fashion.

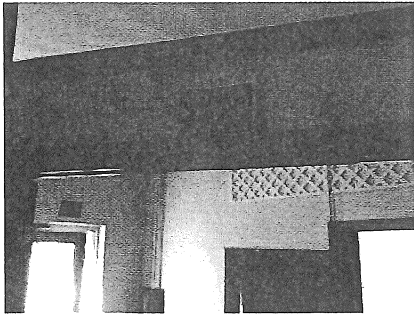
It appears as emergency lighting within the building is provided by dual head emergency lighting units with battery backup. Only three (3) emergency lighting units were observed. One (1) is located in the main room, one (1) in the corridor which runs North to South and the last one in the addition room at the rear of the building. The emergency lighting units appeared to be in fair condition. However, it

would seem as they are insufficient in quantity to provide adequate illumination of the paths of egress.

Emergency light units should be removed and replaced as remaining battery life could not be obtained. Additional emergency lighting units with 90 minute should be installed to adequately illuminate the paths of egress as required by current Code.

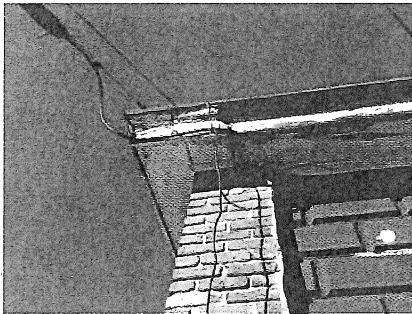
No egress lighting was observed within the building. Path of egress is indicated via signage (red lettering on black background) taped to the walls. This is allowed by Code provided the signage is illuminated by adjacent lighting under normal conditions and emergency lighting when a power failure occurs. Based upon the locations of the egress signage in relation to the emergency lighting units, the emergency lighting units would not be able to illuminate both the paths of egress (to required footcandle levels) as well as the egress signage.

The existing egress signage should be removed and replaced with AC powered units with 90 minute battery backup. Additional egress lighting units should be installed as required to comply with current Code.

Replacement of egress signage with self-illuminated egress lighting with battery backup to comply with current code.

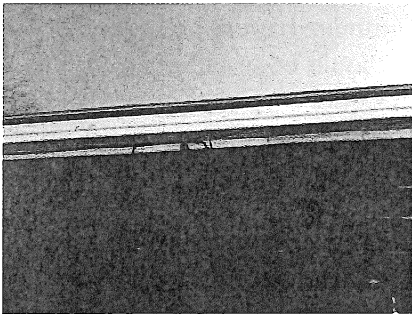
Telecommunications wiring is routed to the building via overhead cabling utilizing the same utility poles as the electrical service. The cabling is routed through the eave of the building at the Southeast corner. The demarcation equipment is located adjacent to the main electrical panel.

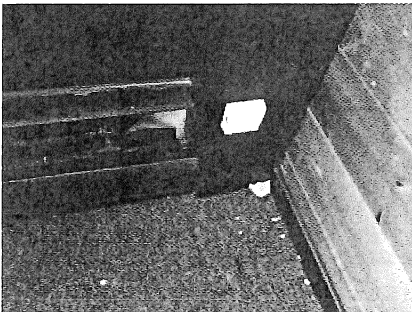
Cable wiring was observed running through the exterior wall on the Southeast corner of the building, up to the eave and along the exterior of the eave to the Northwest corner before coming down the exterior wall and back into the building in the addition at the rear.

A few tele/data outlets were observed in the office areas of the building. The wiring is routed exposed along the interior walls in some instances.

Existing tele/data and cable wiring should be removed back to the demarcation point. New tele/data and cable wiring and associated outlets should be installed and located as required by proposed layout.

Replacement of telecommunications and cabling wiring and outlets.
