Town of Sturbridge

Tree Removal Permit Application

Shrī Gaṇēsh Tree and Plant Health Care

Project Assignment:

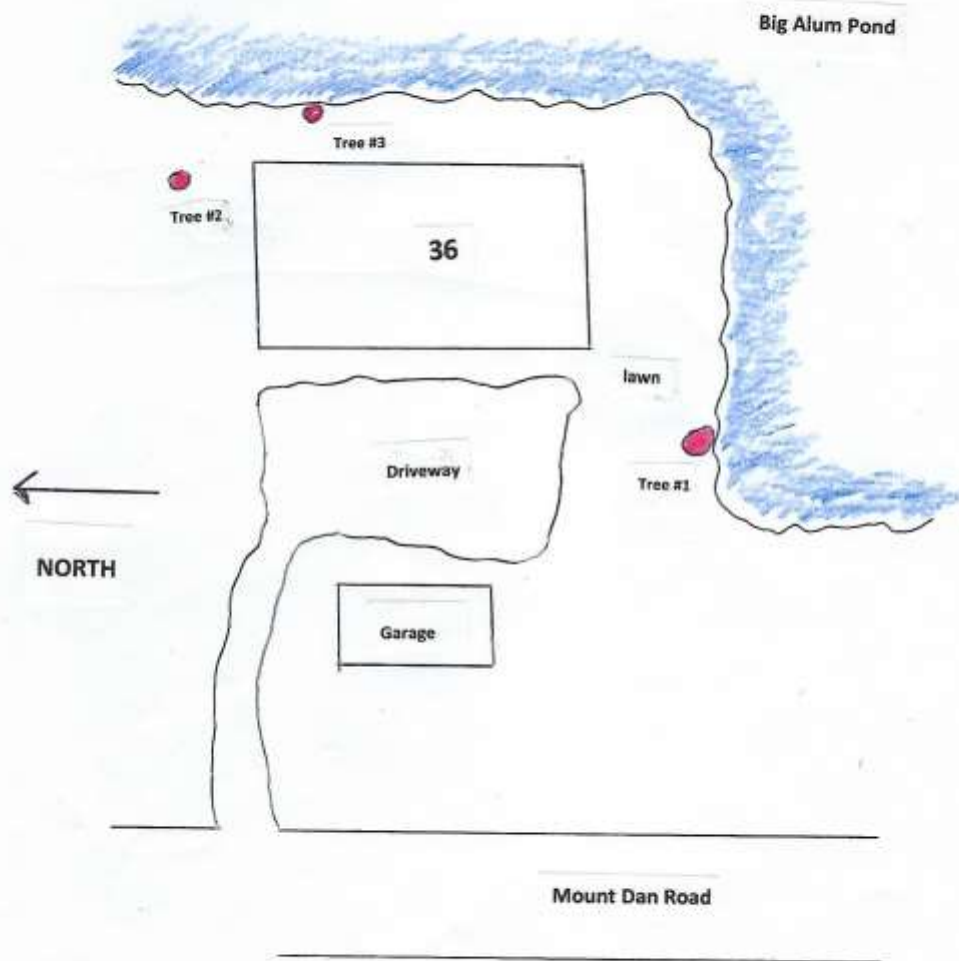
It is recommended that the tree be removed as it will continue to decline both in health and structural integrity. They would like the stump ground out also as the front yard is so minimal and it would also create a planting location for a smaller replacement tree.

RED MAPLE – Tree #1 – from the South
